REGULATORY REFORM (FIRE SAFETY) ORDER 2005 HOUSING FIRE RISK ASSESSMENT

Company Name: Winchester City Council

Address: Chesil Lodge, Winchester, SO22 4AW.

Assessment date: 9th July 2021 – Updated on 7/9/21.

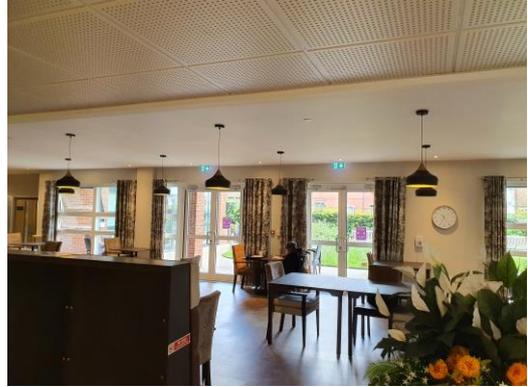
8.

B: Hazard Identification - Source of Fuel					
Ref No	Compliance Question	Yes, No or NA	Remedial Action Plan (RAP) and Comments	Risk Rating	RAP Completed
B10	Are escape routes kept free of combustible materials?	Yes		L	
B11	Is the standard of housekeeping satisfactory?	Yes		L	
B12	Is there an absence of unnecessary fire load in close proximity to the premises or available for ignition by outsiders?	Yes		L	
B13	Are the arrangements for disposal of waste adequate to prevent build-up - is secure storage provided to prevent unauthorised access to combustible materials?	Yes		L	
B14	Are the walls, floors and ceiling coverings free from combustible products?	Yes		L	
B15	Where furniture and furnishing are provided in common areas and means of escape routes, are they fire retardant in accordance with the Furniture and Furnishings (Fire) (Safety) Amendment Regulations 1989?	Yes	See photos 8 and 14 for examples.	L
