# Winchester City Council v Collins Snr & Collins Jnr

Report of Andy Sherlock  
16<sup>th</sup> December 2020

**Subject matter:** This report relates to the felling, and damage to trees at Dagswell Copse and the Shedfield Equestrian Centre.

**Inspection dates:** 22<sup>nd</sup> October 2020

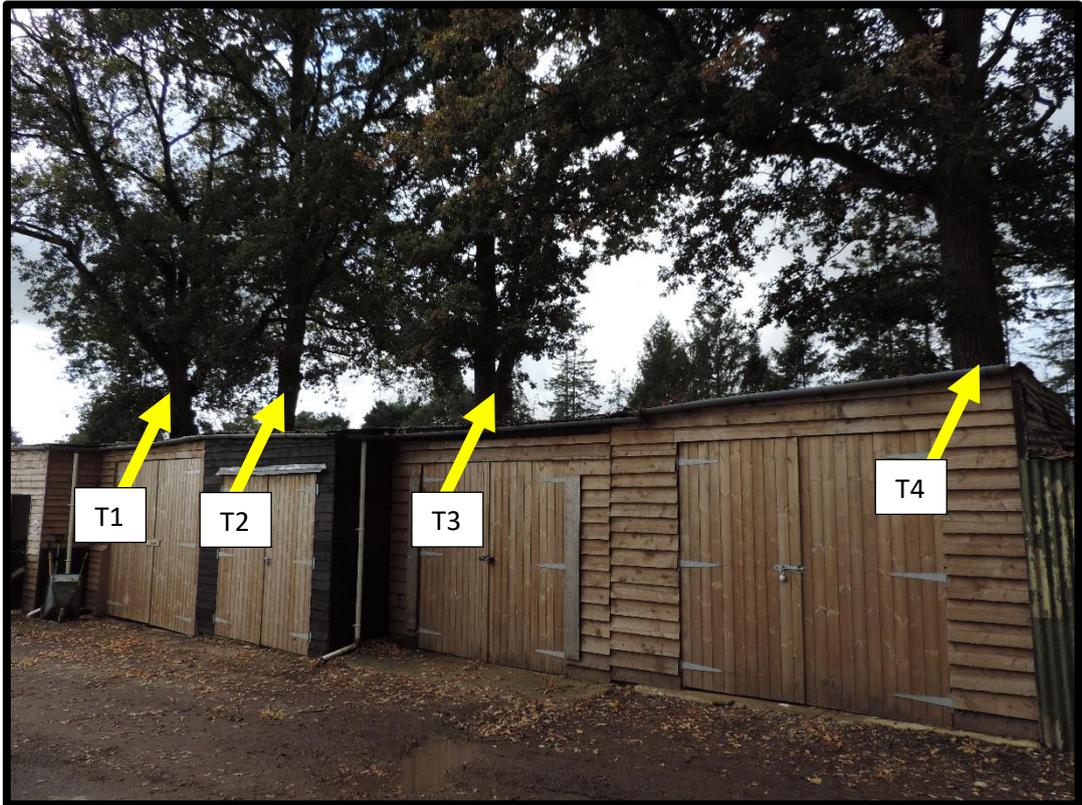
**Figure 2:** View of tree T1, T2, T3 and T4 growing out through stables and sheds.

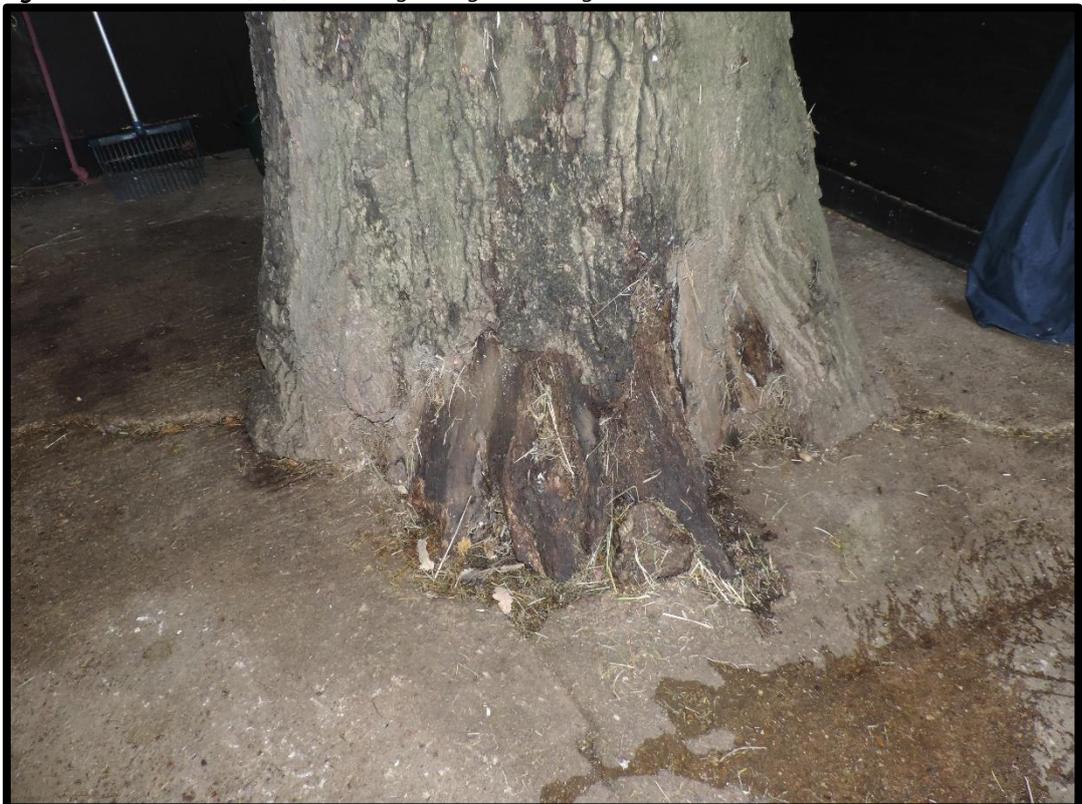
**Figure 3:** This image shows the base of T1, the damage to the bark on its eastern side and the cracking of the concrete.

212           The concrete over the roots of the trees will have caused damage at the time of  
213           construction, which appears to have been several years ago. Except for T4, the trees have  
214           managed to cope with the damage, and they have recovered, adapting to the new  
215           environment, which is evident from their current normal crown density and leaf colour.  
216           However, in the long term as the trees grow, they will be inhibited by the concrete and it  
217           will create weak points leading to a higher chance of failure.

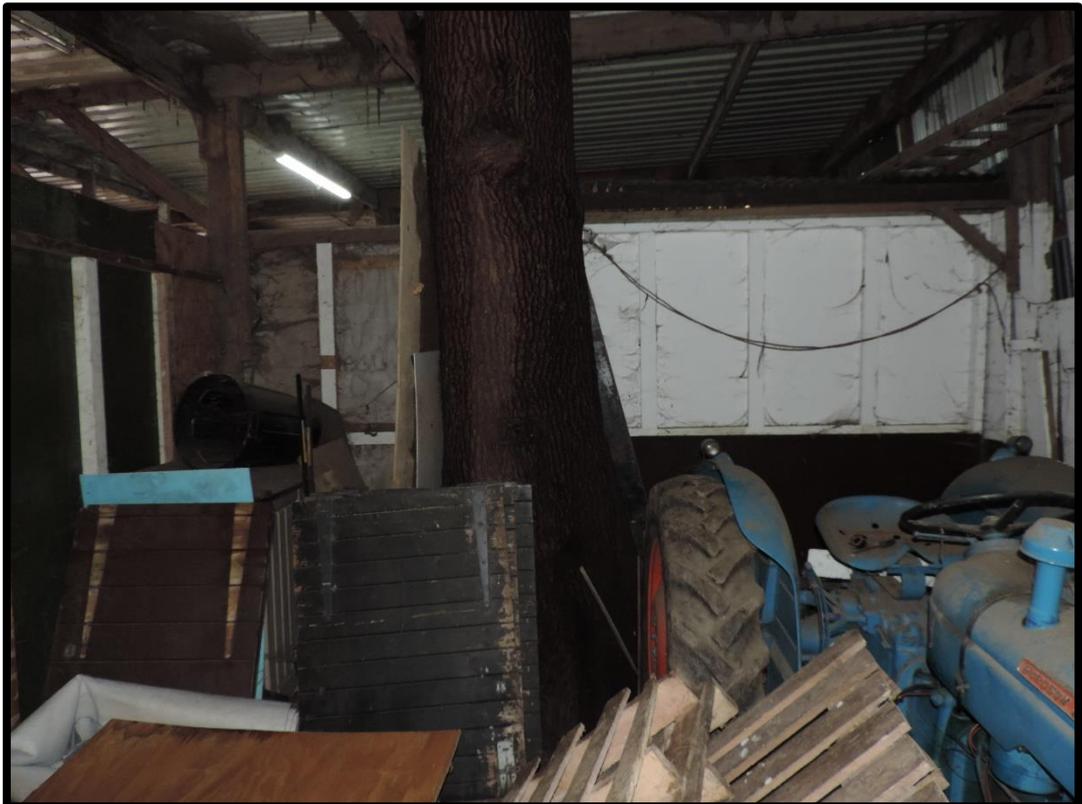
**Figure 4:** View of the trunk of T2 inside the storage building.

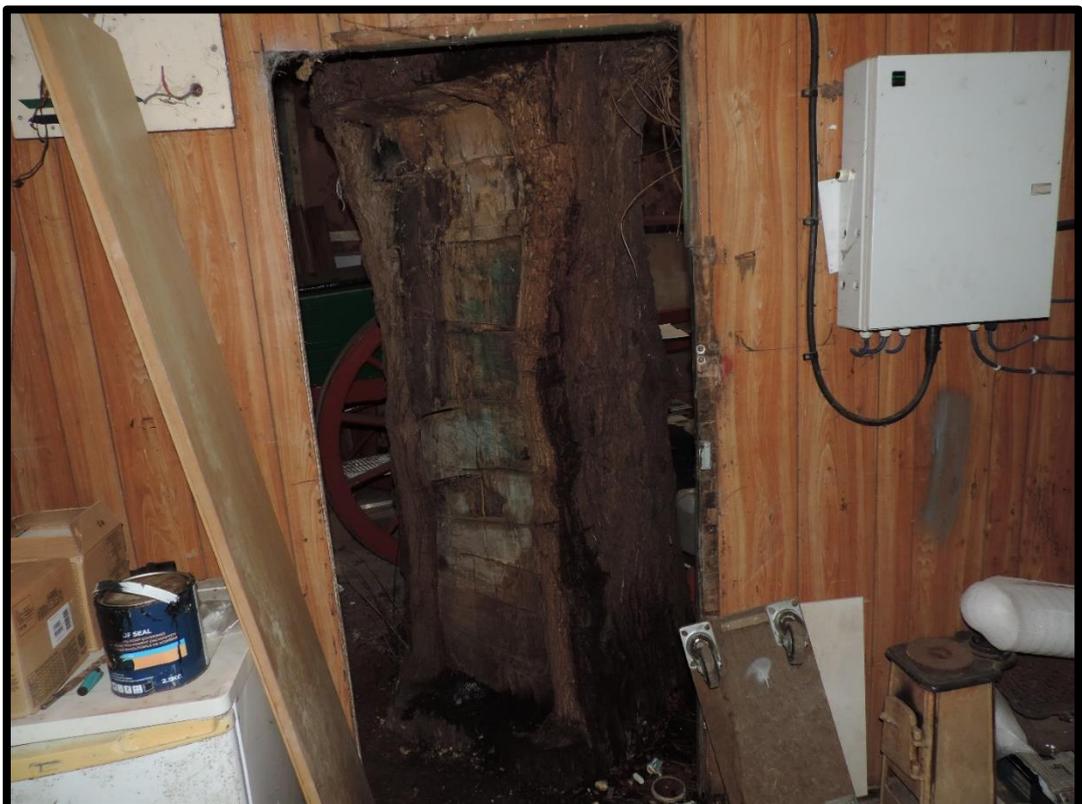
**Figure 5:** View of the trunk of T4 inside the storage building with the lower trunk cut away to gain access through the internal door.

227           3 **What are the effects to the tree's health from the damage to the lower stems of the oak**  
228 **trees within the stable block:** Trees T1, T2, T3 and T6 have coped very well with the  
229 damage which will have been inflicted on them during the construction of the structures.  
230 Tree T4 has had a huge section of its trunk cut away (Figures 5 & 6). Whilst the tree has  
231 managed to respond remarkably well to this damage with good reaction growth, the  
232 wound is far to big for it to survive long term. The canopy of the tree is now showing  
233 signs of die-back with branch ends dying and excessive deadwood in the canopy. The  
234 leaf coverage is also very thin compared to the adjacent trees. The wound has also  
235 created a weak point on the tree stem which makes it more likely to failure at this point  
236 during adverse weather. Tree T4 is currently still alive, but it is dying as a result of the

237 wounding that was carried out several years ago.

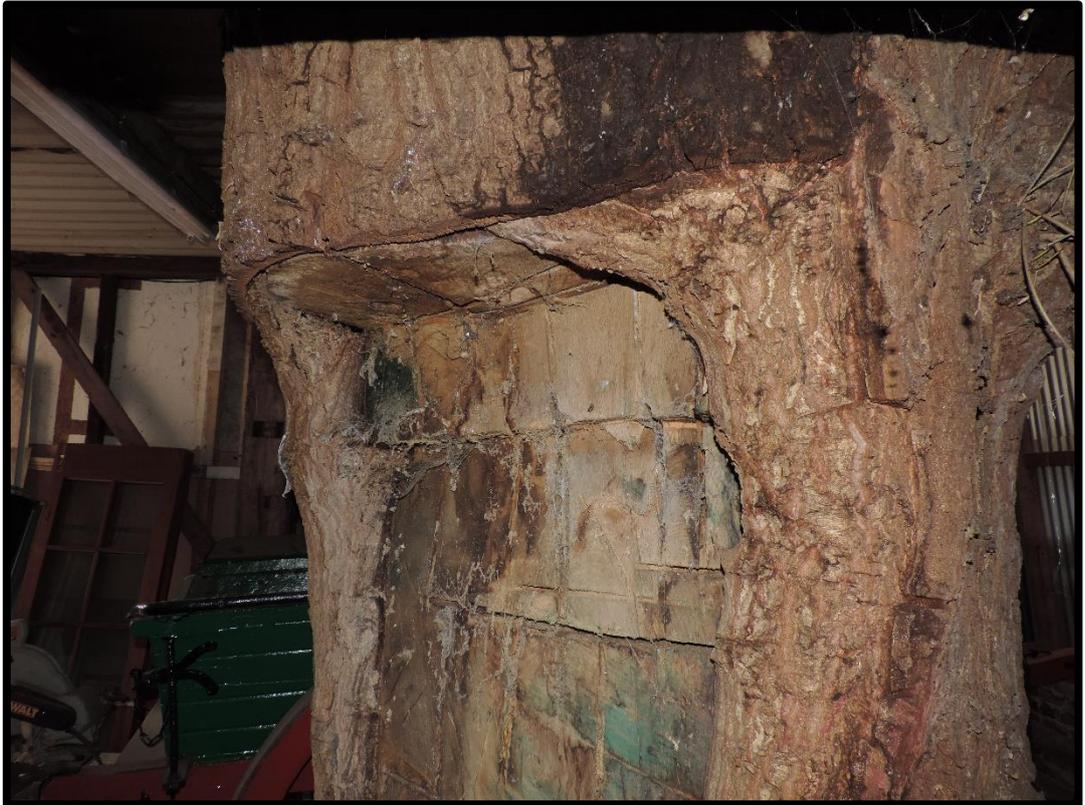
**Figure 6:** View of the trunk of T4 inside the storage building. Chainsaw marks are visible where the tree was cut several years ago.

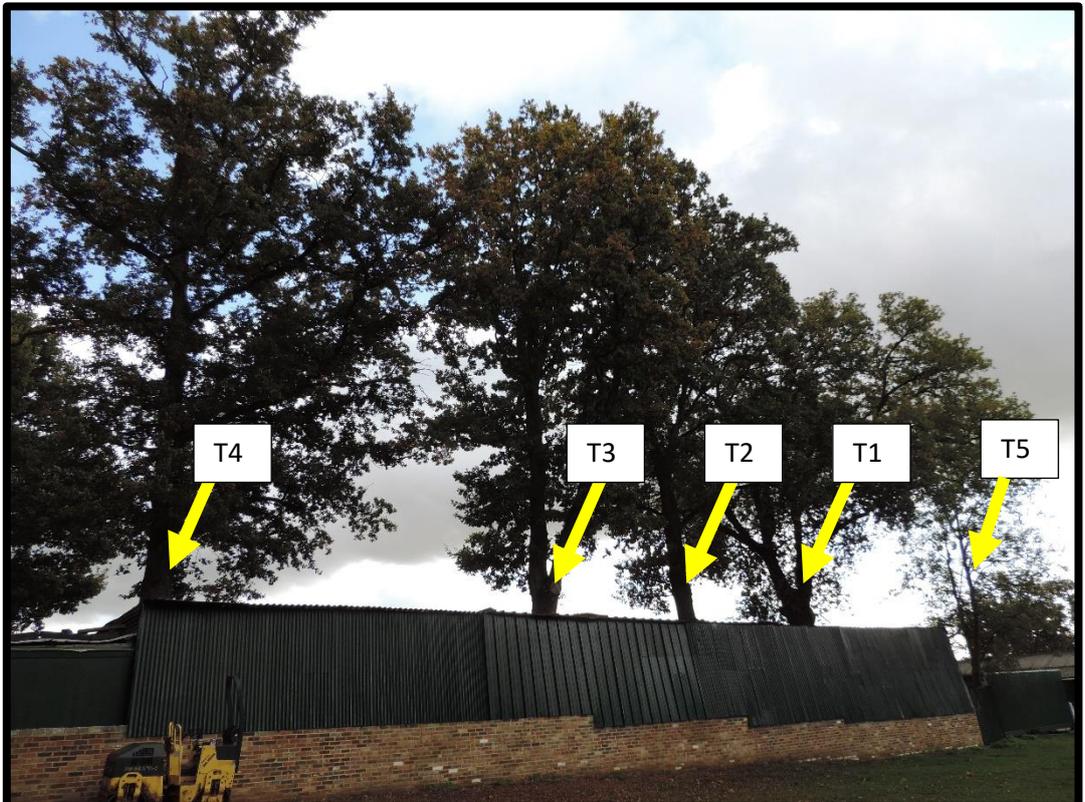
**Figure 7:** View of a new looking wall at the rear of a stable/storage unit of buildings, and trees T1, T2, T3 and T4 with the buildings constructed around them.

218           2 **Has the building of a brick wall to the rear of the oak trees within the stable block had an**  
219 **effect on the health of the oak trees:** The brick wall at the rear of the stable block stands  
220 on ground that is approximately 40cm lower than the ground where the stables/storage  
221 buildings are. The roots from the trees T1, T2, T3 and T4 will follow the contours of the  
222 ground, so the difference in levels has no impact on the potential for roots to exist in this  
223 location. If the new wall has new strip foundations the trenching work required to form  
224 the new foundations will have severed any roots which grew towards the adjacent field  
225 for the entire depth of the foundation. The impact of this root severance will take several  
226 years to become evident in the trees canopy.

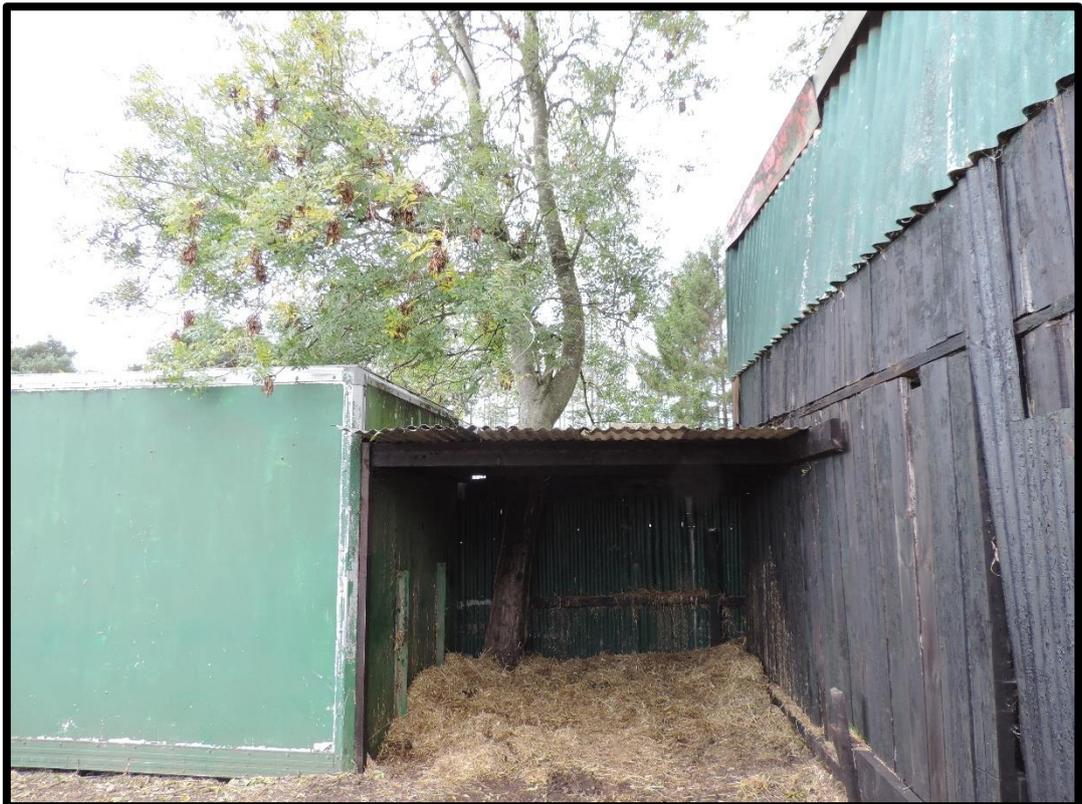
Figure 8: View of ash T5 growing out through a horse shelter.

294 2 **What are the effects of horses removing bark from a tree trunk:** Tree T5 has had bark from  
295 ground level, up to 2m stripped on 50% of its circumference by horses (figures 7, 8 and 9).  
296 The impact of this is that the wood which is now exposed by the removed bark is  
297 difunctional and more likely to decay or break as it is not as flexible. Also, the tree only  
298 has half the vascular system connecting the roots to the canopy which makes it less  
299 efficient and less able to cope with changes to its environment. It also means that it is less  
300 able to cope with ash die-back which is spreading across the UK.

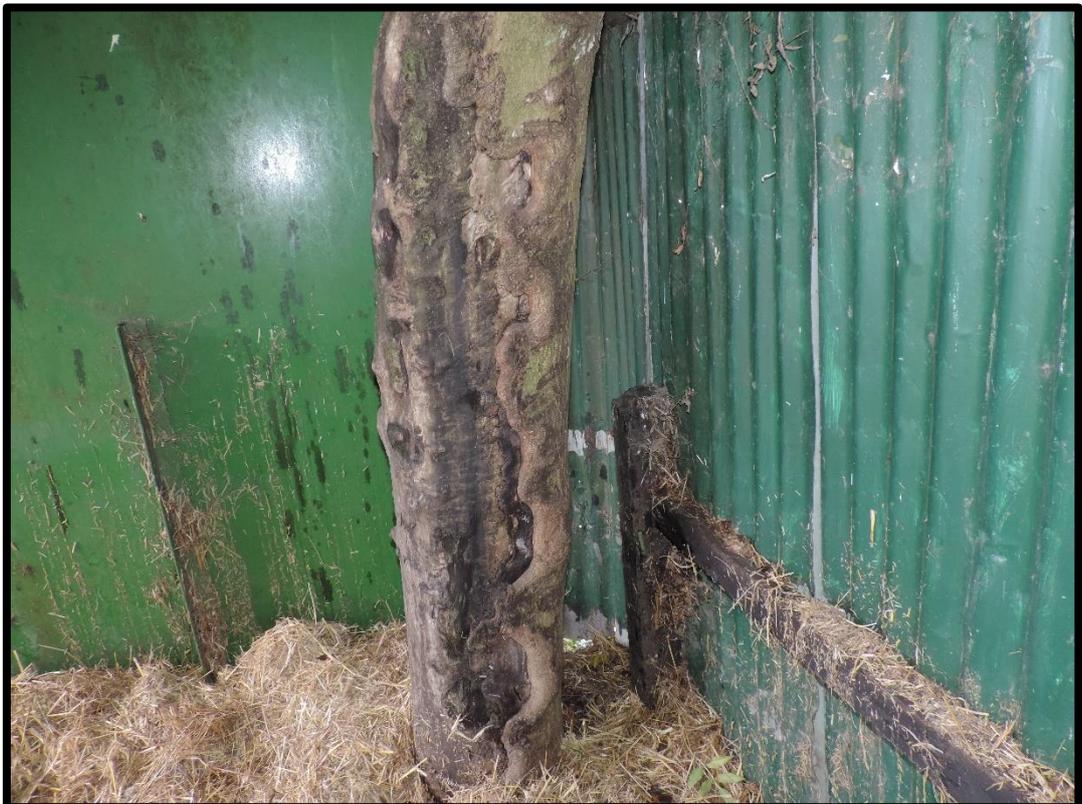
Figure 9: View of the trunk of T5 and the stripped bark.

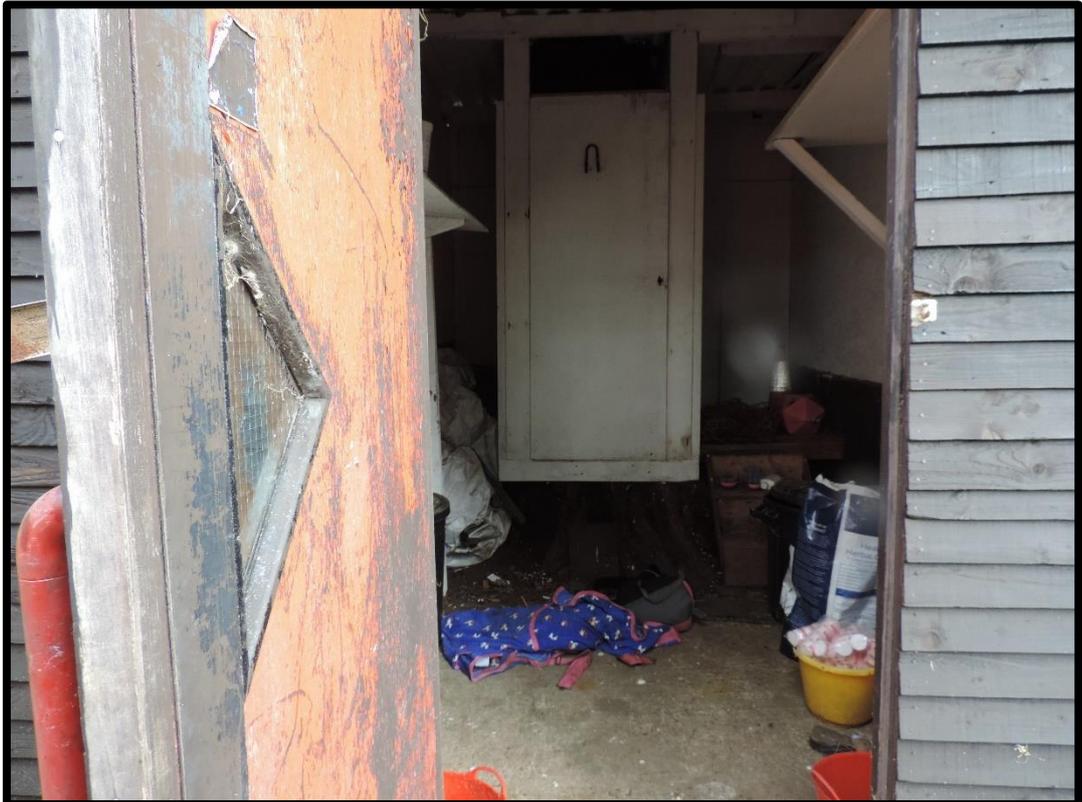
**Figure 10:** The trunk of T6 is behind the white wooden panel.

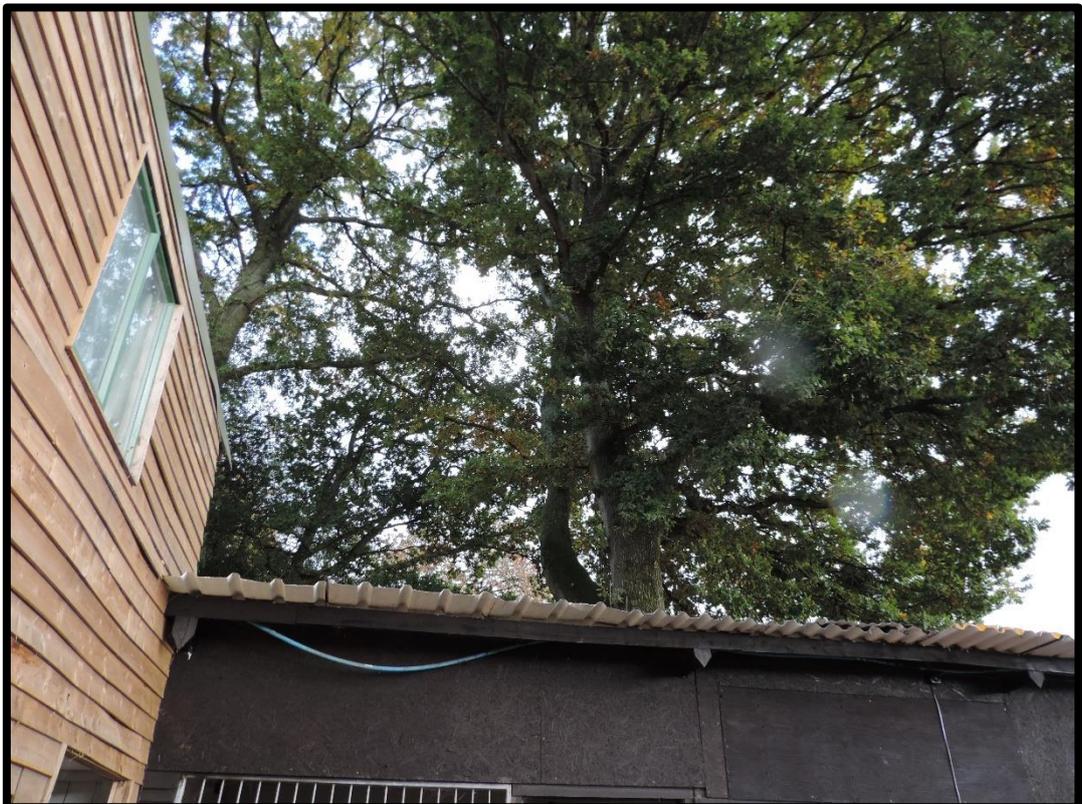
**Figure 11:** View of T6 growing out of the roof of the shed/storage/stable building.

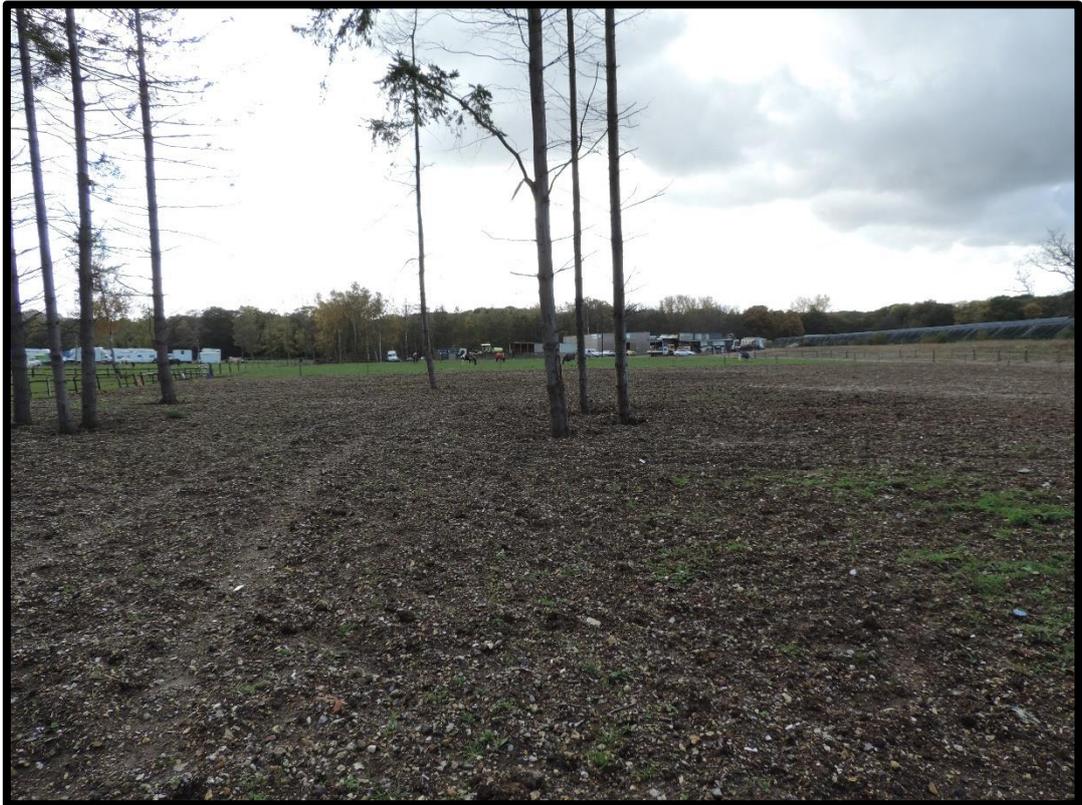
Ground level within the field has recently been raised by approximately 30cm. The raised soil at the base of the trees has been pulled back so it is not on the trunk of the trees. Recent bark damage on several trees. Figures 12 and 13.
A8	N/A	N/A	N/A	This area does not have any trees on it. The ground level here has been raised by approximately 30cm. There appears to be a layer of manure covered with soil.
G9	N/A	N/A	N/A	This area does not have any trees on it. The ground level here has been raised by approximately 40 - 150cm.
T10	Oak	22	90	Maturing oak with a thin canopy. Ground level surrounding the tree appears to have been raised by 50cm. A new building has been erected 5.8m from the tree. Figures 14 and 15.
T11	Oak	5m	60	This is a dead oak stump.
G12	4 x scots pine, 5 x birch, 3 x oak	15	35	Group of maturing trees, including four dead scots pine. The remainder of the trees have thin canopies. The soil level has been raised by 50 - 100cm. Figure 16

**Figure 12:** View of some trees within group G7, showing new raised soil levels.

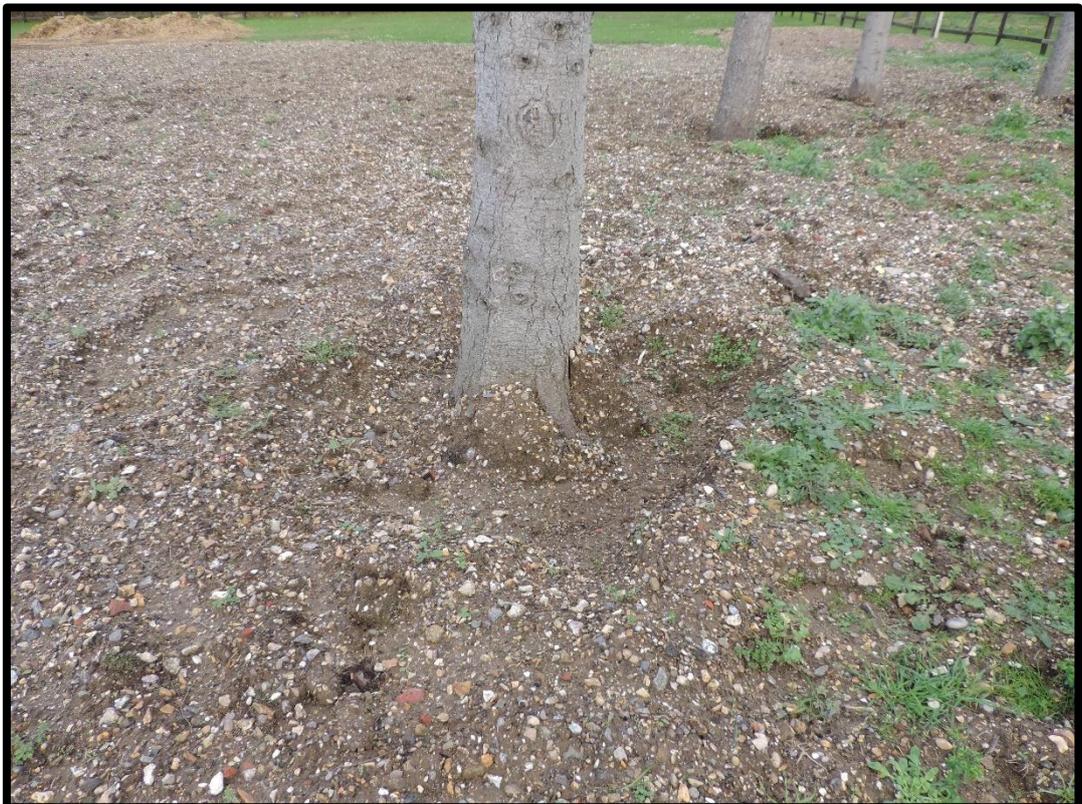
**Figure 13:** View of the soil pulled back from the trunk of some of the trees in G7.

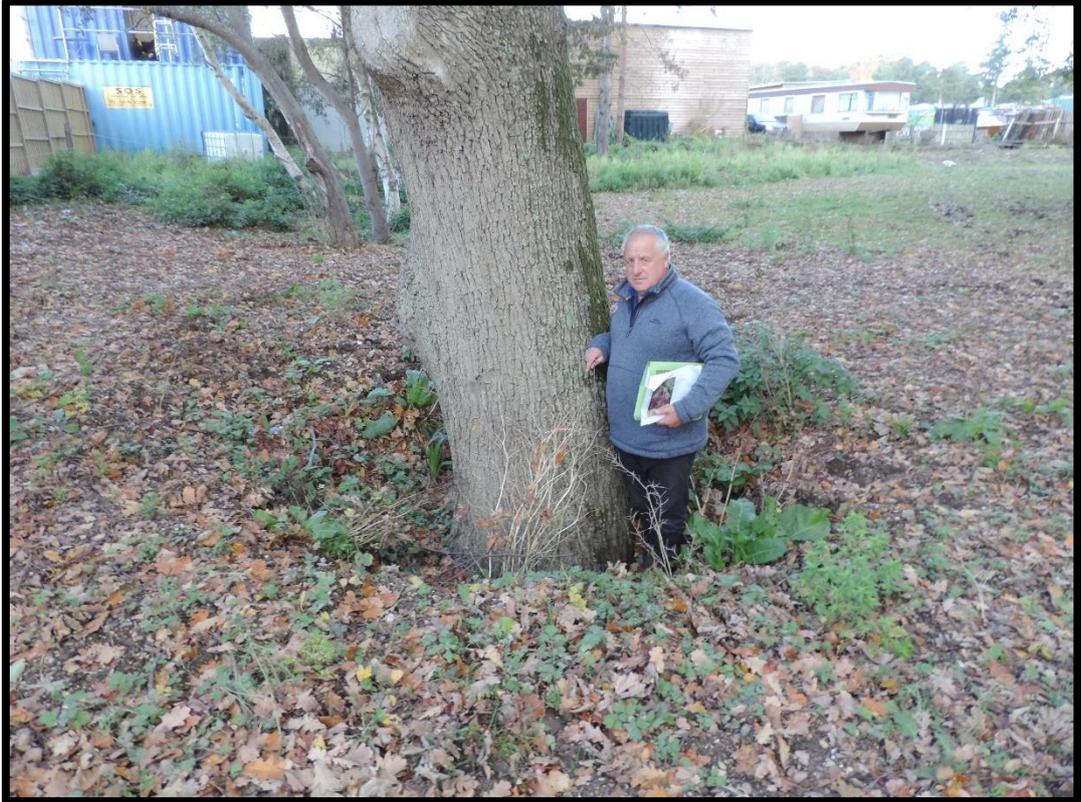
**Figure 14:** View of the trunk of T10 with Mr Gurdler standing on the original ground level.

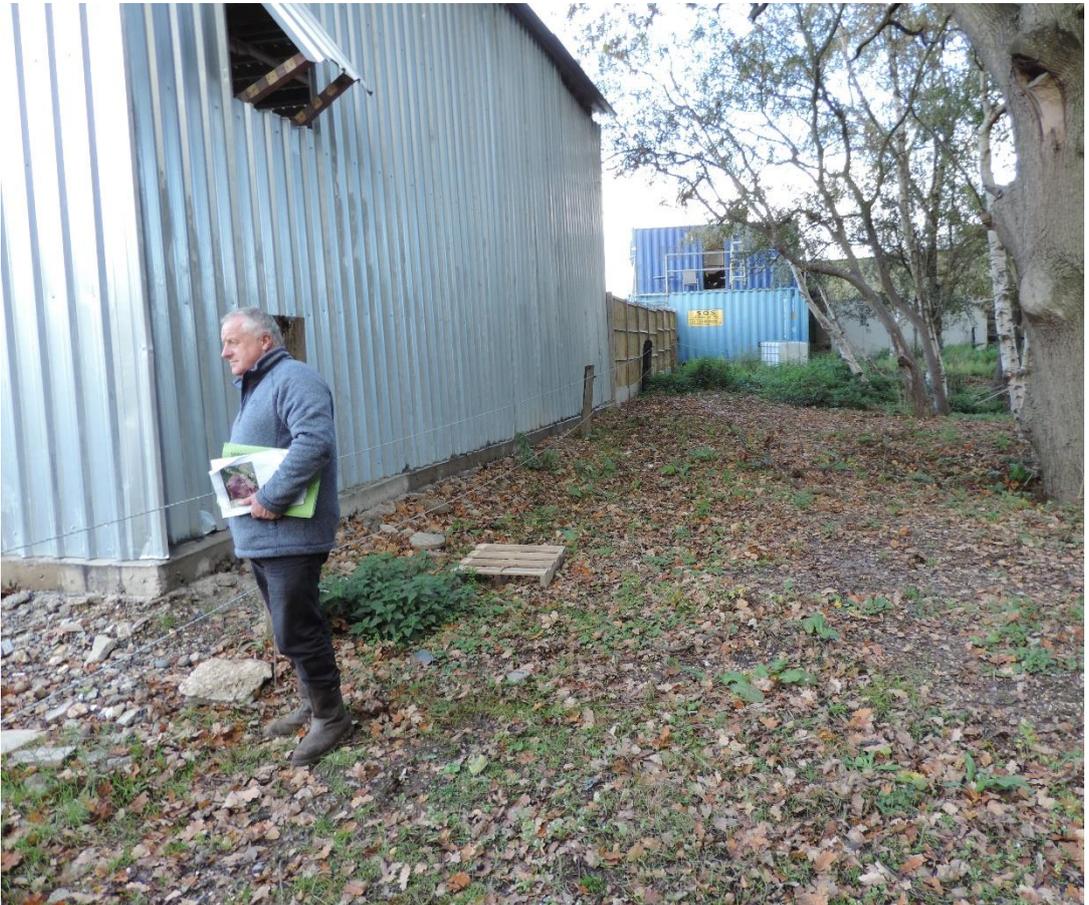
**Figure 15:** View of the trunk of T10 and the new building recently erected.

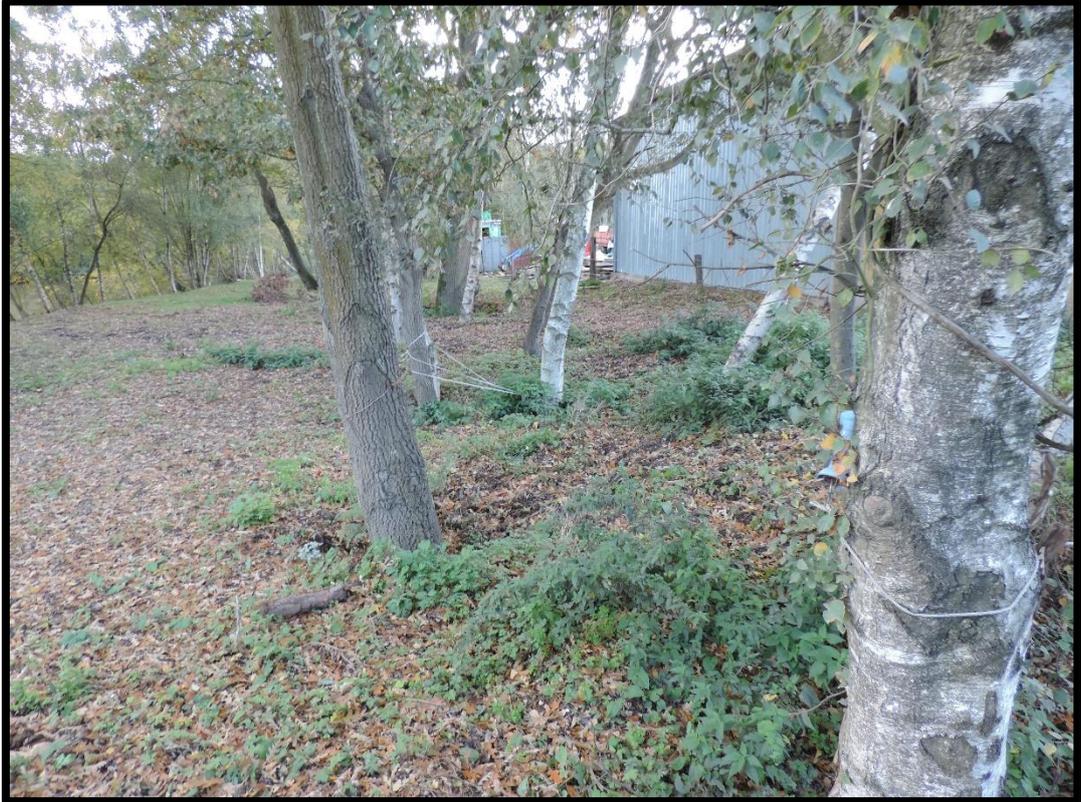
**Figure 16:** View of trees G12 with the soil level surrounding them raised.

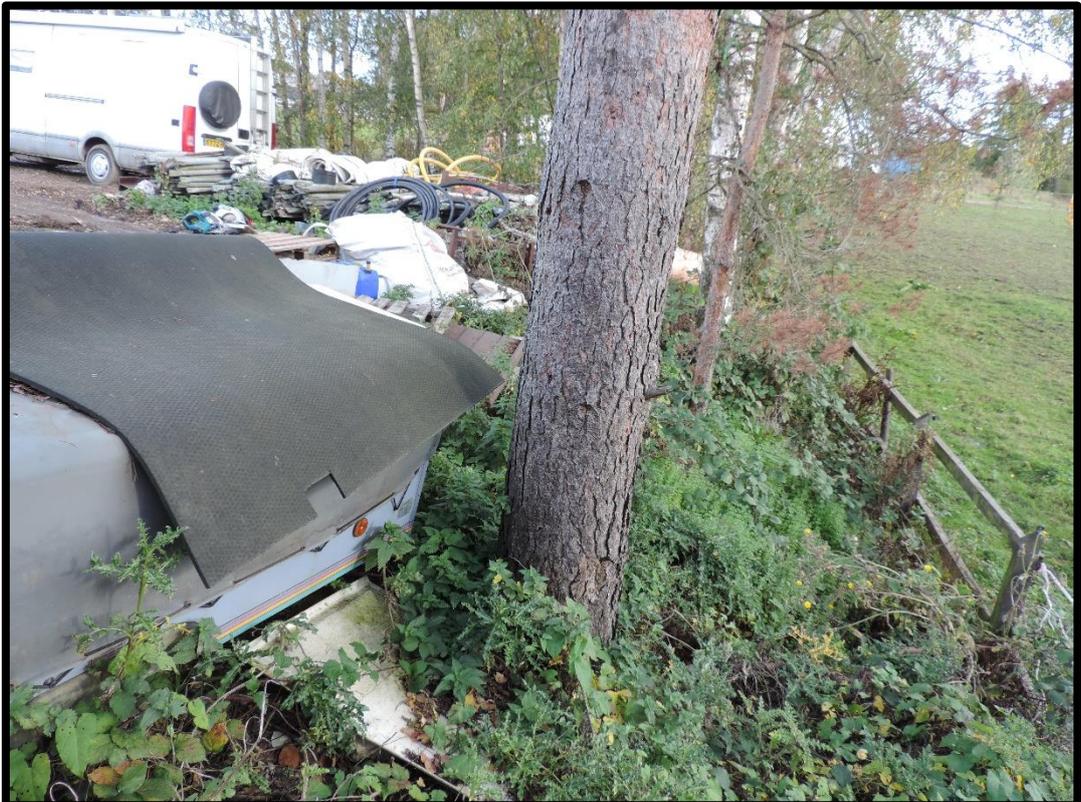
G13	Birch, scots pine	15	30	Group of maturing trees, including one dead scots pine and three dying birch. Soil levels raised by up to 1.8m. Figures 17 and 18.
G14	3 x scots pine	12	30	Standing dead trees. Soil level in the adjacent field raised by 40cm. Figure 19.
T15	Oak	16	75	Maturing oak. Canopy with heavy die-back. Soil bund 3m high and 4m wide formed adjacent to the tree. Figure 20 and 21.
T16	Poplar	22	55	Maturing tree with a very small, thin canopy and extensive deadwood (50% of the canopy is dead). Ground surrounding the tree is covered with tarmac. Figure 22.
G17	3 x Poplar	22	55	Maturing trees with a tarmac car park on one side and a tarmac road on the other.

**Figure 17:** View of part of G13 with soil level raised.

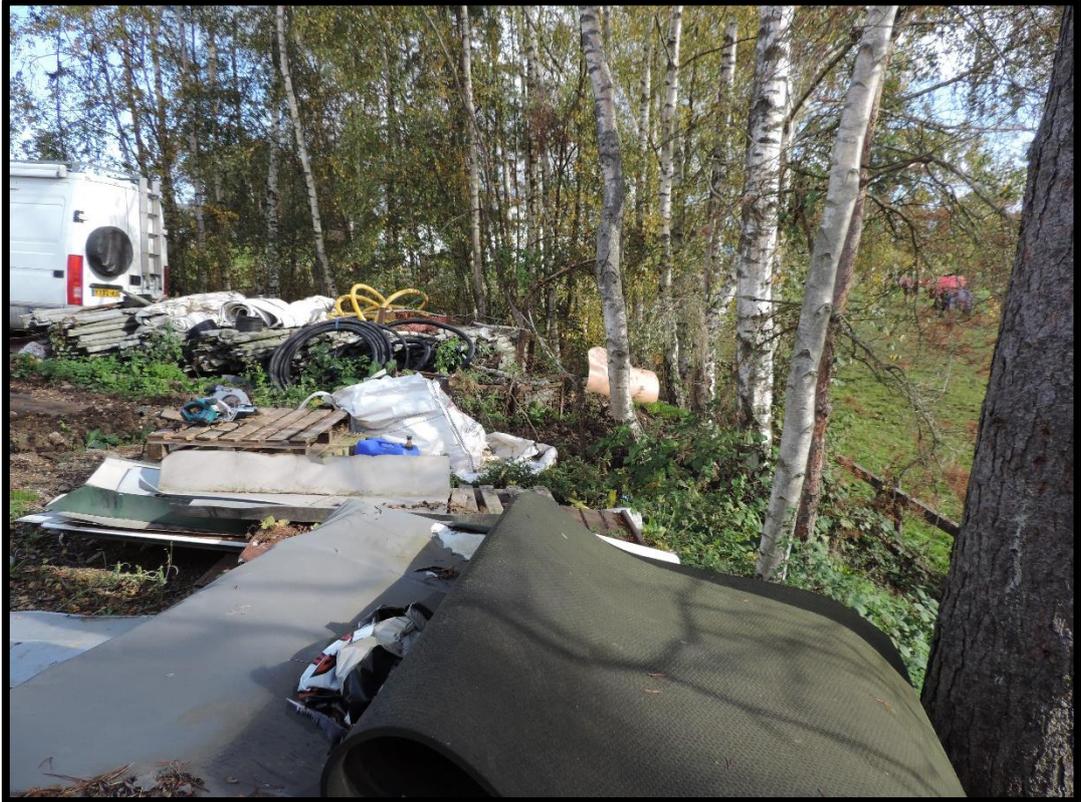
Figure 18: View of part of G13. Soil level raised around all the trees.

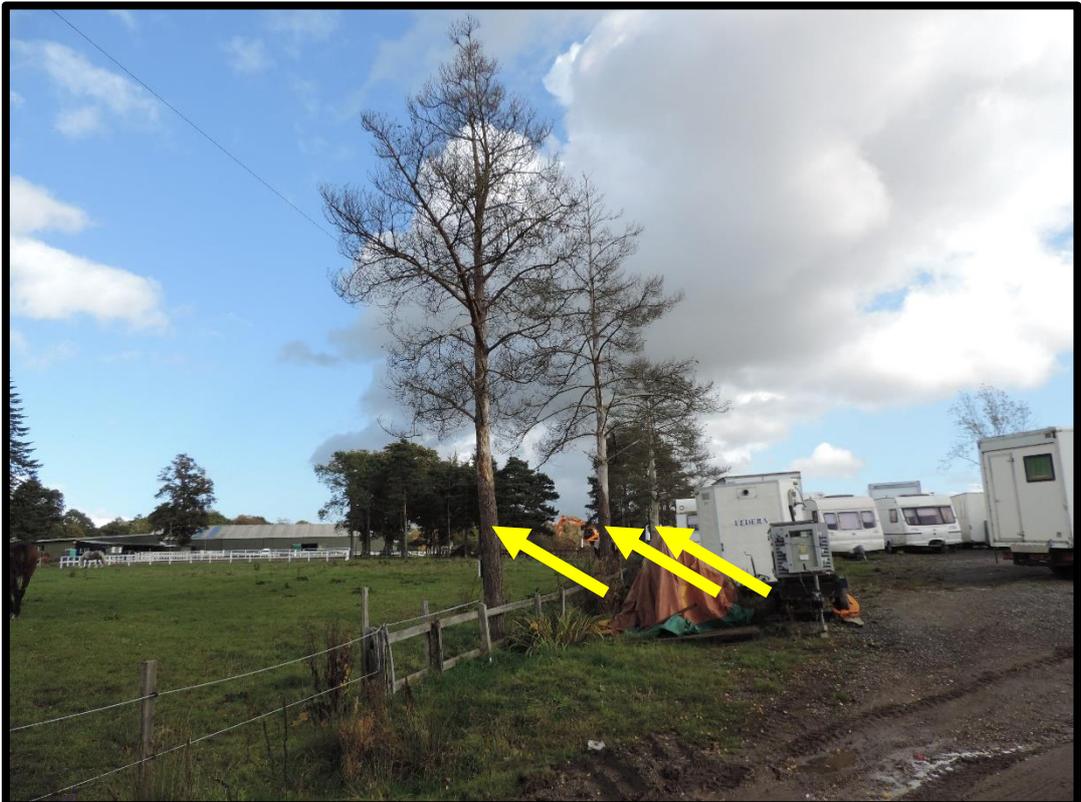
Figure 19: View of the three dead scots pine in G14 and the field with raised soil level.

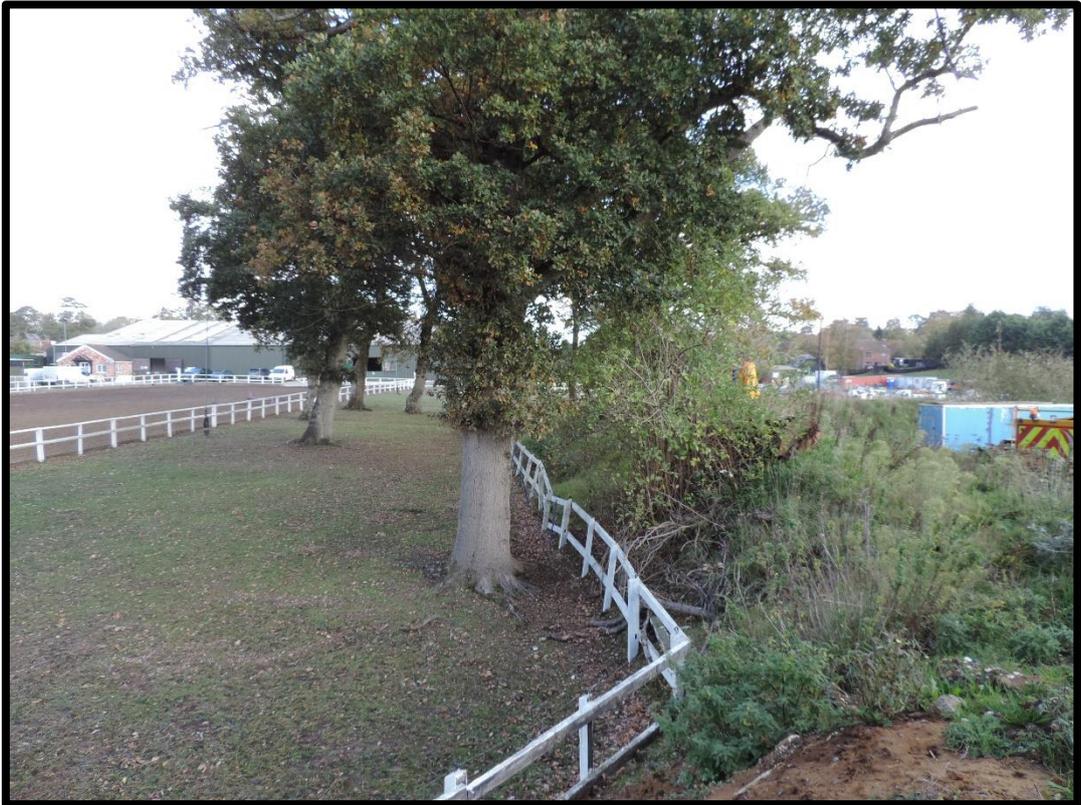
Figure 20: View of T15 with the soil bund adjacent.

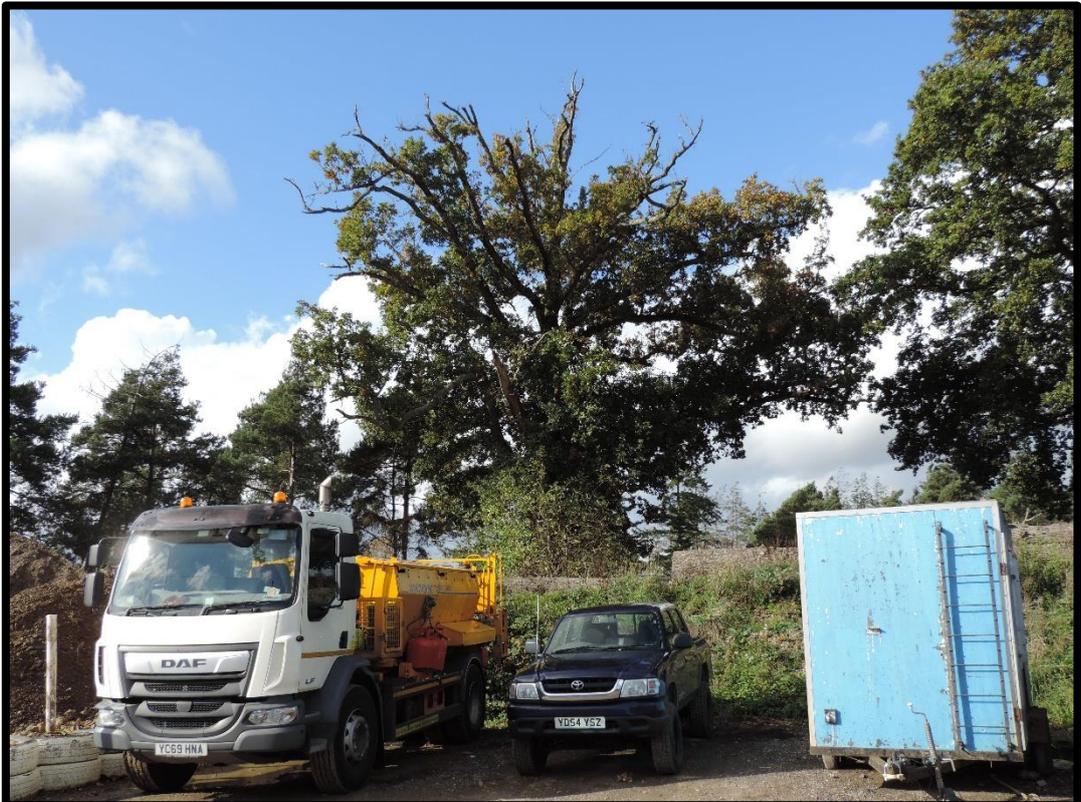
Figure 21: View of the die-back in T15.

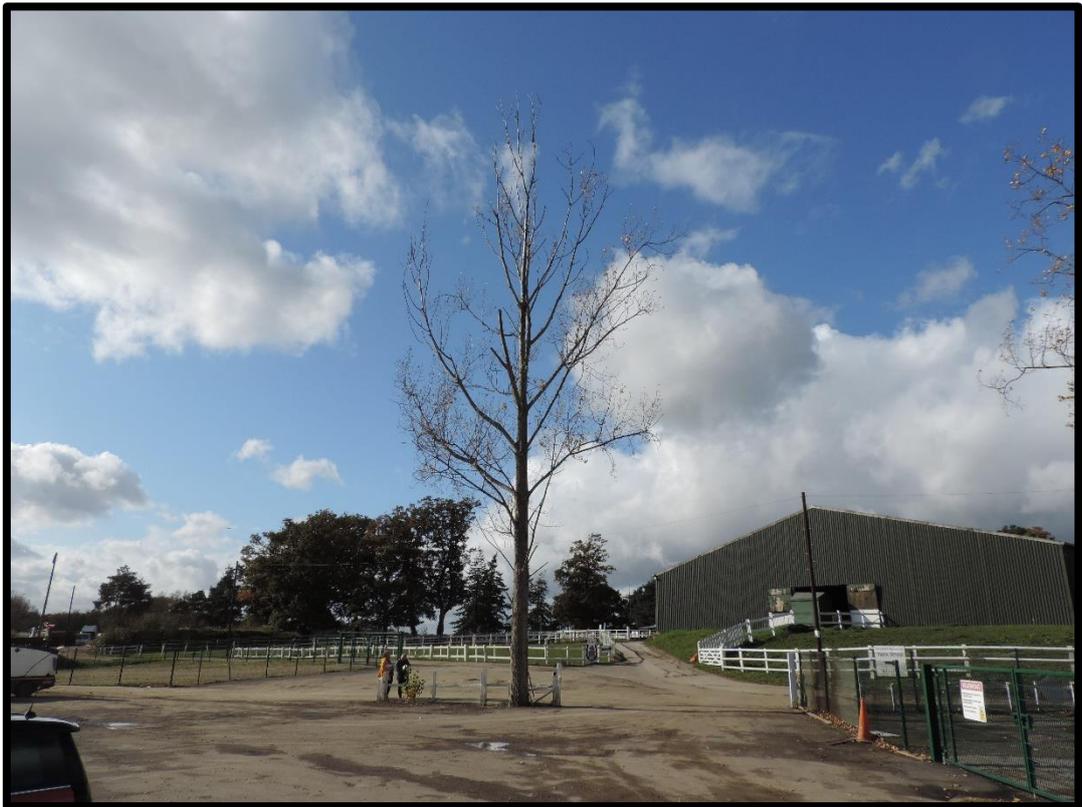
Figure 22: View of T16 surrounded with tarmac.

286 1 **What are the effects of surrounding a tree with tarmac:** Tree T16 has all its rooting area  
287 covered in tarmac (figure 22), and G17 has a large percentage of its rooting area covered  
288 in tarmac (figure 23). The effect of covering the rooting area with tarmac is that it caps  
289 the soil. It creates an impermeable layer which prevents moisture penetration and  
290 gaseous exchange taking place. It can also cause direct damage as the installation can  
291 cause direct physical damage to the roots. Based on this, if the entire rooting area of a  
292 tree is covered, there is a high chance that the tree will slowly die as a result in the change  
293 in environment.

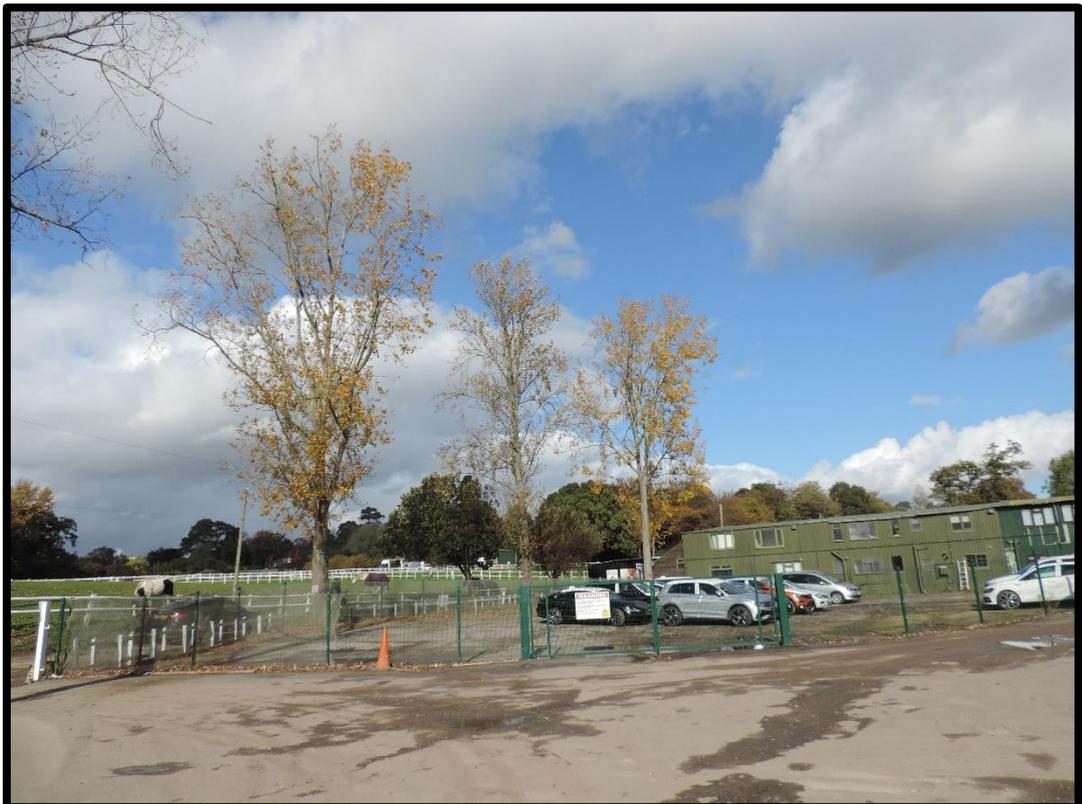
Figure 23: View of G17 growing adjacent to the car park and road.

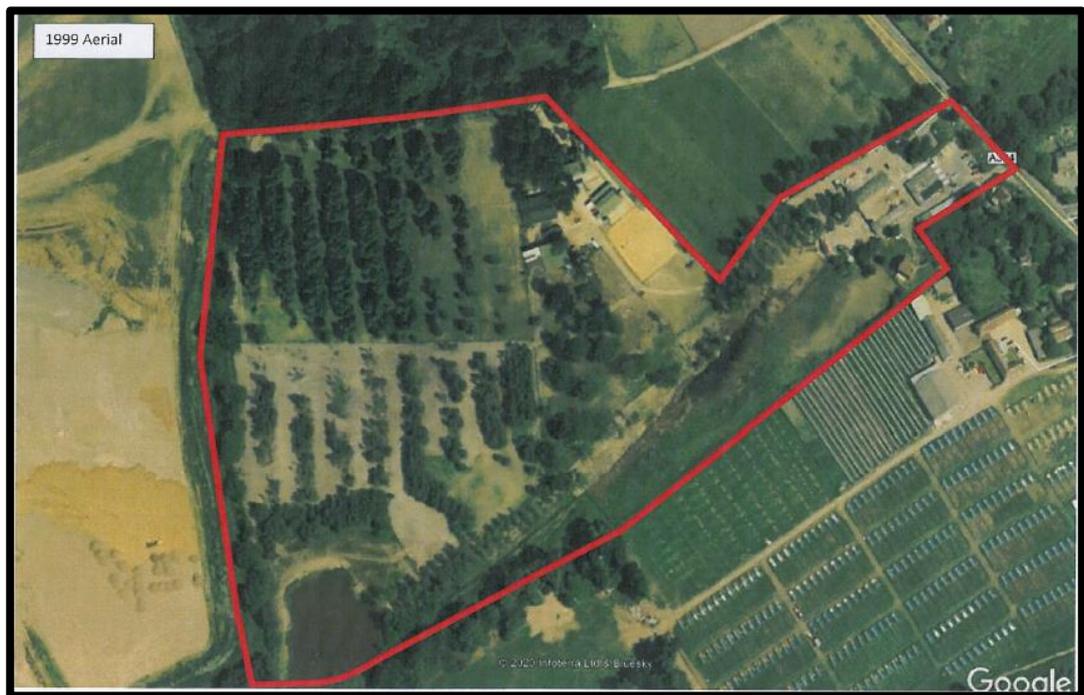
Figure 24: 1999 aerial view showing most of the site with a good covering of trees

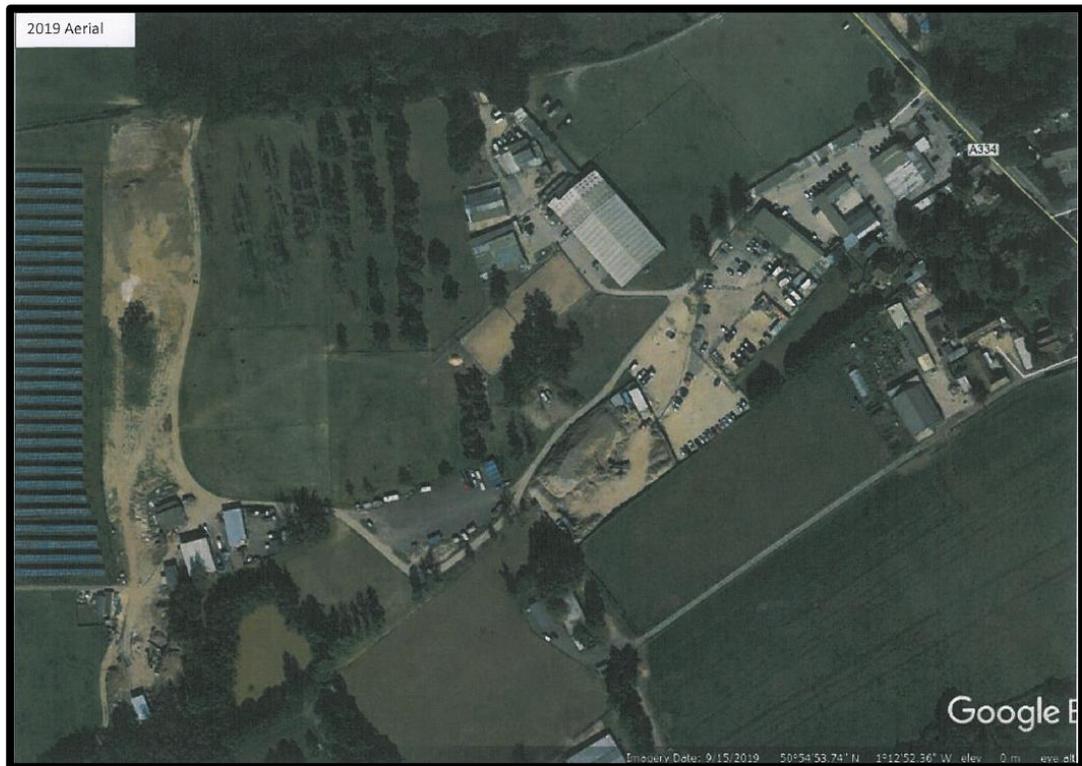
**Figure 25:** 2019 aerial view of the site showing trees significantly thinned out and areas completely cleared.
