PHILIP HUGHES ASSOCIATES
HISTORIC BUILDINGS CONSERVATION CONSULTANTS
OLD MANOR STABLES, TOUT HILL, WINCANTON, SOMERSET BA9 9DL
Tel: 01963 824240 Email: info@pha-building-conservation.co.uk www.pha-building-conservation.co.uk

BUTTERCROSS MONUMENT

REPORT on REPAIRS and PIGEON DETERRENTS

January 2024

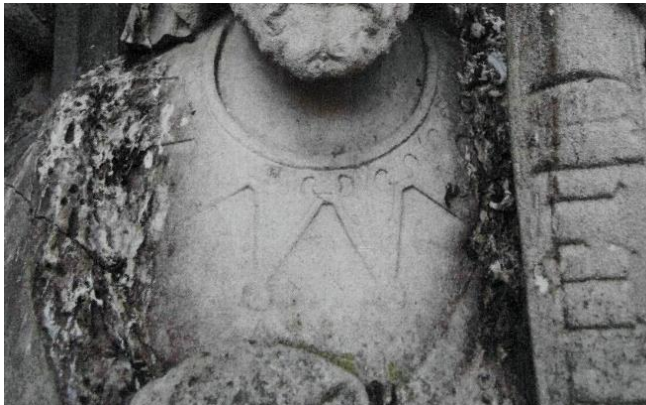
- 7.5. **Cracks** – some areas of masonry are identified as cracking. In particular this is noted across the statue of Lawrence de Anne on the east elevation of stage 3 (survey ref 4.45). Compared with photographs taken in 2015 and 2018 the crack appears to be wider and more extensive in the photograph included in the condition survey which suggests that this has worsened. It is unclear what is causing this and we will need to carry out further investigation to determine this. Possible causes are corroding ironwork (though no corroding ironwork has been identified anywhere else on the monument), instability in the fixings of the statue or movement in the surrounding fabric. It is noted that the statues of William of Wykeham on the north elevation and King Alfred on the west elevation have evidence of previous cracking across their chests though both have been repaired and are not currently showing any signs of movement.

Fig 9 – photo of statue of Lawrence de Anne taken in 2015 from Martin Kirby Associates Report.

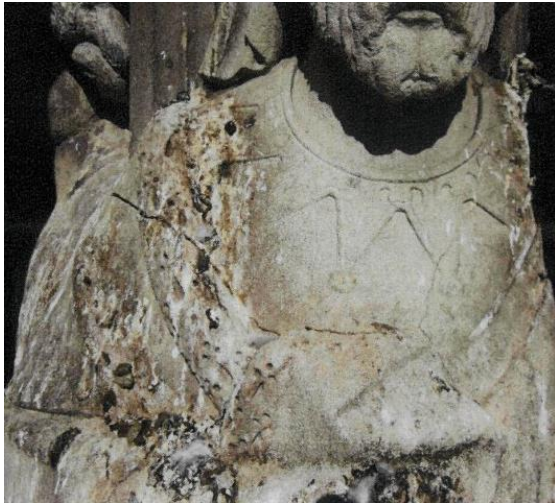
Fig 10 – photo of statue of Lawrence de Anne taken in 2018 from Martin Kirby Associates Report.

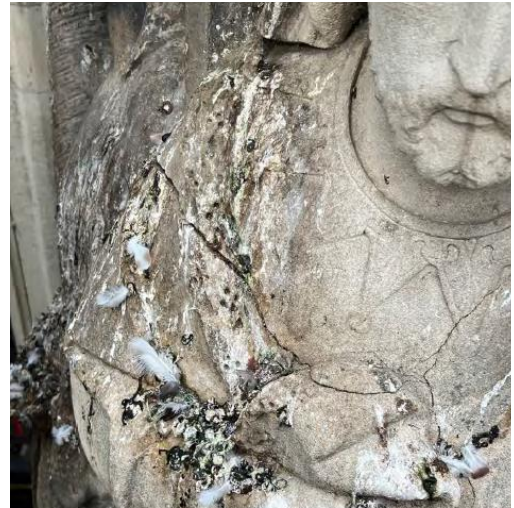
Fig 11 – photo of statue of Lawrence de Anne taken in 2022 from Vallis & Hall Condition Survey.

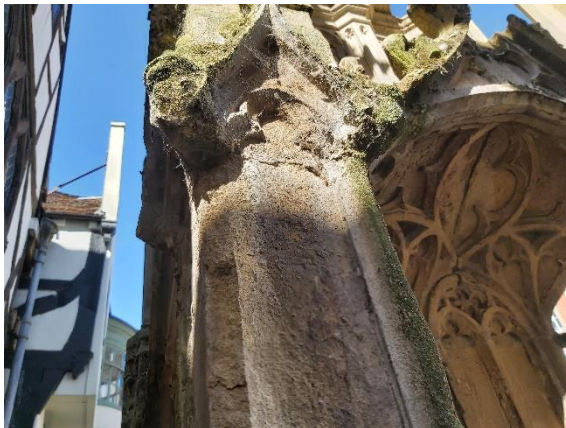
- 7.6. **Friable and decayed stonework** – areas of friable and decayed stonework are identified in the condition survey and these will be inspected and a suitable repair determined. Areas of friable masonry which do not require replacement are proposed to be first consolidated with applications of lime water.

Fig 12 – friable masonry around the outer shafts at stage 1.

Following this local mortar repairs using a lime putty based mortar and ceramic armatures (where the repair is deep) would be carried out to small areas where the stone has been lost and to aid water shedding from the face of the stone. In some areas stone replacement may be required where decay is severe and the need for this will be assessed based on whether the strength and integrity of the stone has been lost, the nature of the stone and the amount of detail lost through decay. The intended approach is to preserve as much of the existing stone as possible and this would incline us to undertake mortar repairs in the first instance and consider stone replacement only where absolutely necessary.

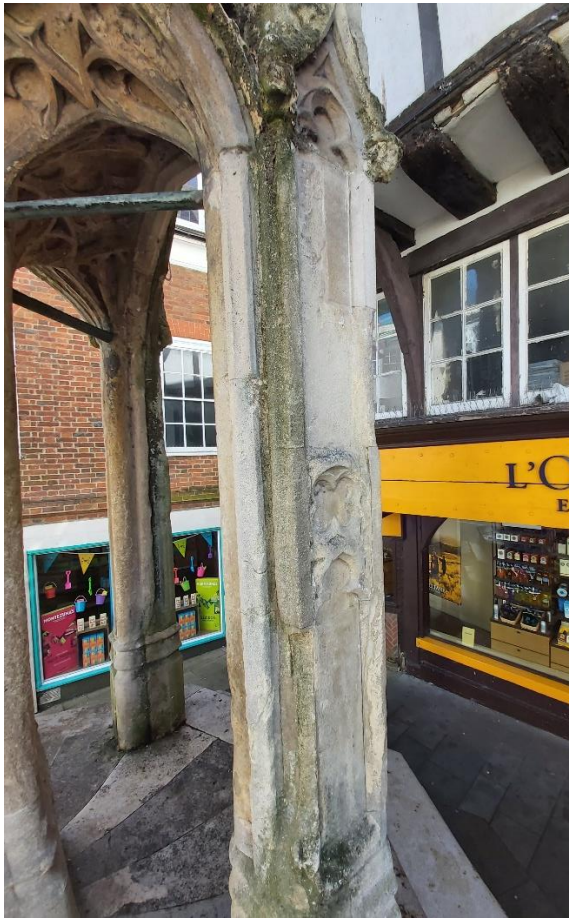
Fig 13 – the outer shafts at stage 1 have been the subject of continual repair and replacement stone could be considered where a previous repair has failed. However, where the moulding has been lost or damaged and not yet repaired we would be hesitant to propose replacement because of the potential loss of original fabric that would be required to put in place a robust repair.

off and micropinning where stone is cracked or damaged. Though where a previous repair has failed consideration could be given to replacement of this if it did not cause further loss of fabric.

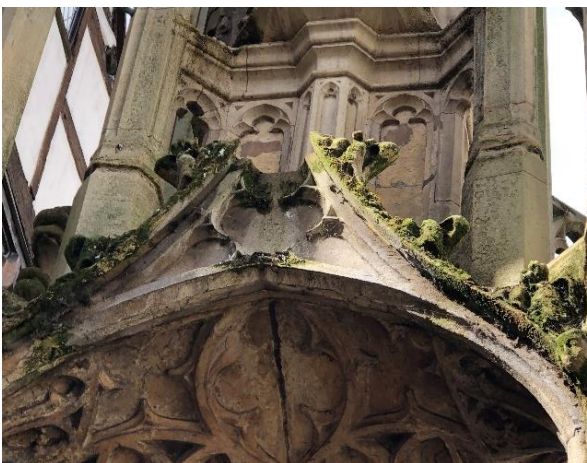
- 7.8. **Reinstatement of the arch gable finial** - three large pieces of the fallen gable arch finial from the east elevation of stage 1 have been retained. The finial has been detached horizontally at the joint between it and the gable arch over the lierne vault and then broken into three pieces with further damage to the lower ribs of the bottom piece where stone has broken off, presumably when the piece fell and impacted on the ground. Some of the pieces of the ribs remain and can be fitted up to the lower part of the finial.

Fig 14 - view of the east facing gable arch where the finial has been lost.

The three parts of the final could be individually pieced together using stainless steel pins and then remounted on to the main body of the monument. However, the final is of some size and weight and pinning on two horizontal lines with further pinning where it meets the monument means that it might be vulnerable to movement and eventual damage. We would therefore propose that a more robust

approach is taken whereby continuous rods are used to join and fix the elements together. There is a risk, however, that thermal movement in a continuous stainless steel rod could crack the finial and we would therefore split the repair in to two parts: joining the lower part to the monument with pins and then using a continuous pin(s) to join the two upper parts together and to the lower part.

The finial was originally fixed down to the head of the arch with two vertical bronze or copper rods to the rear of the base and would have relied on the bracing from the ribs to the front to stabilize it. The loss of these ribs means that the finial is less secure if refixed this way and we would suggest adding a further pin in the rear of the base to provide additional support. The fragments of the ribs can then be micropinned in place and missing elements of stone reinstated with mortar repairs.

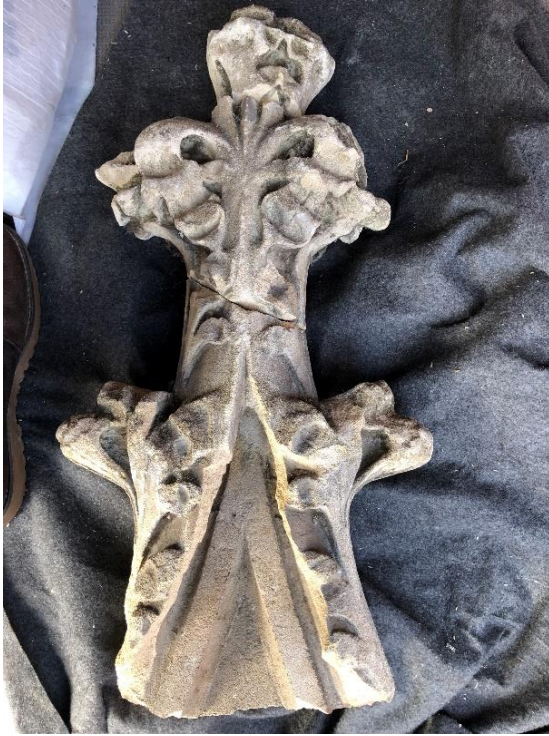
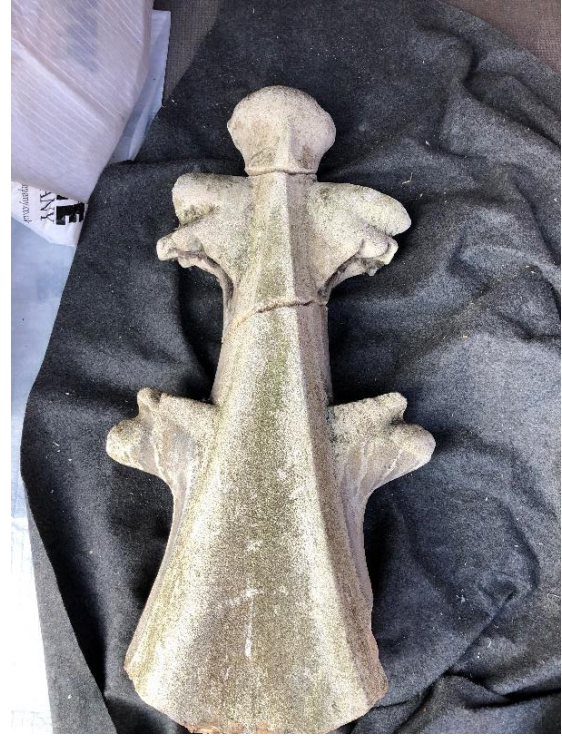
Fig 16 – Front of assembled finial

Fig 17 – Rear of assembled finial

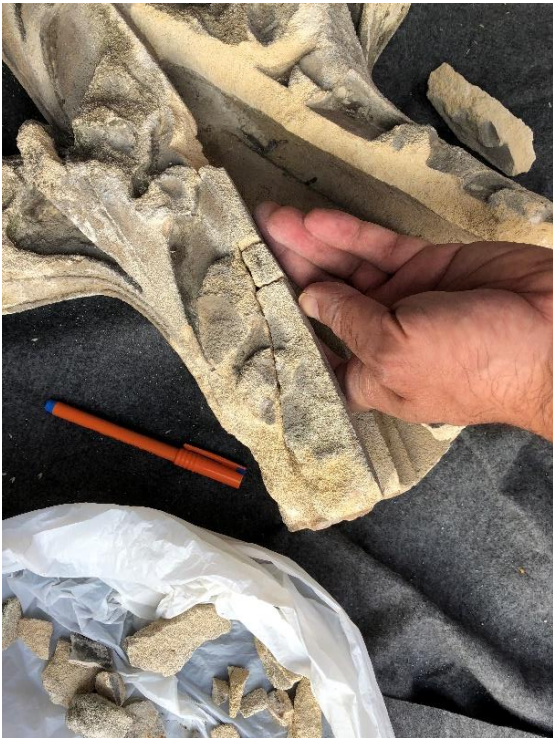
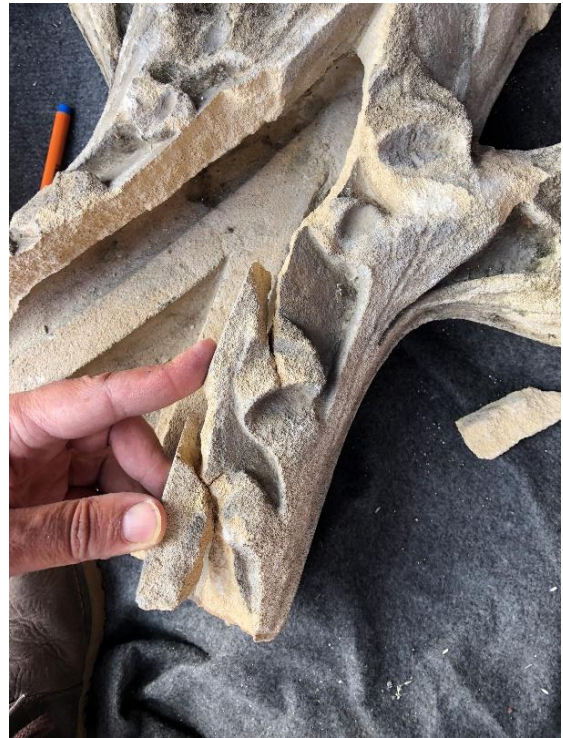
Fig 18 & 19 – reassembled fragments from the base of the finial.

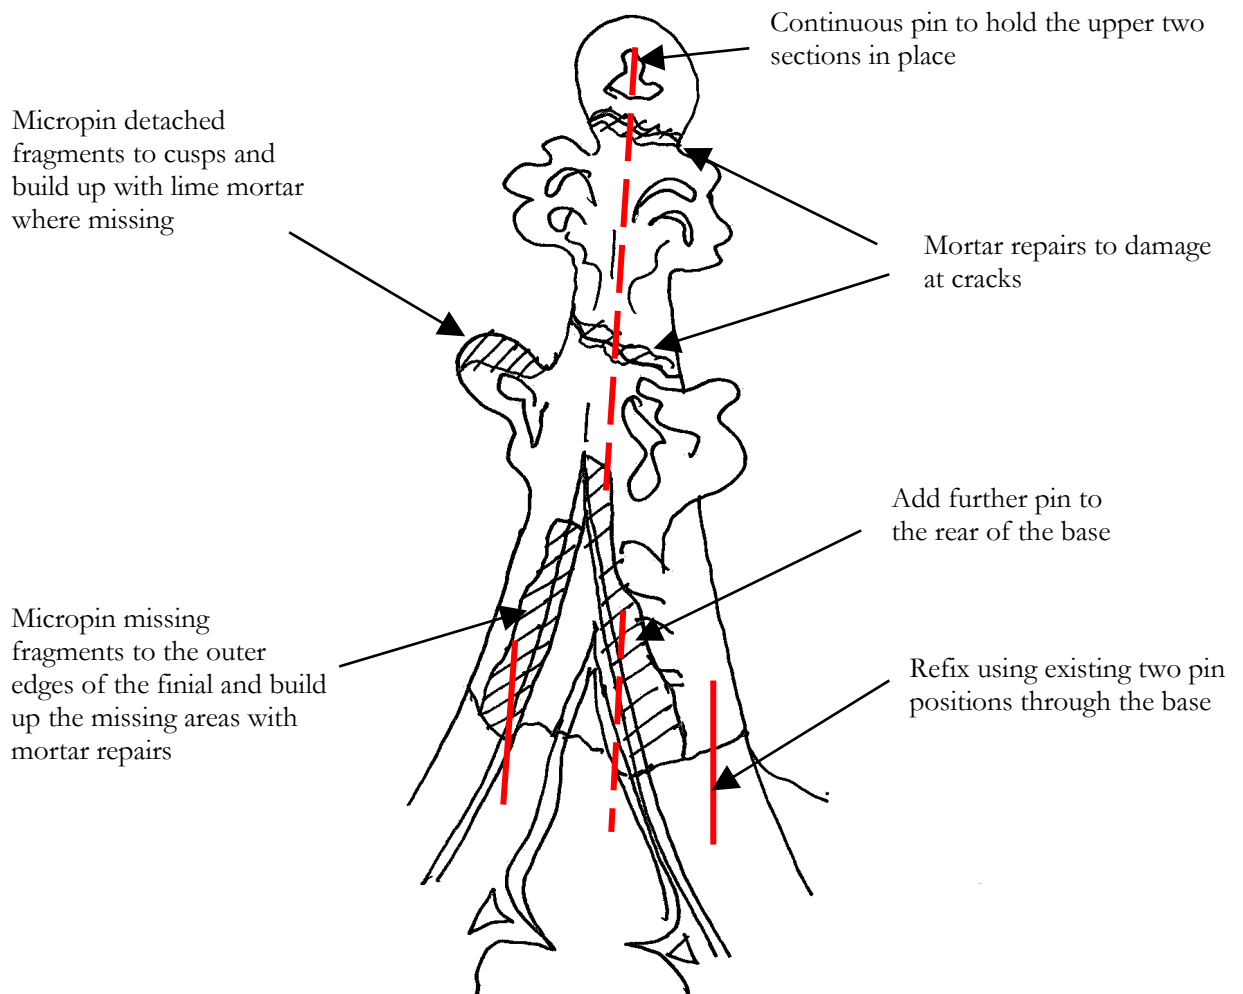
Fig 20 – proposed repairs and fixing method for gable finial.

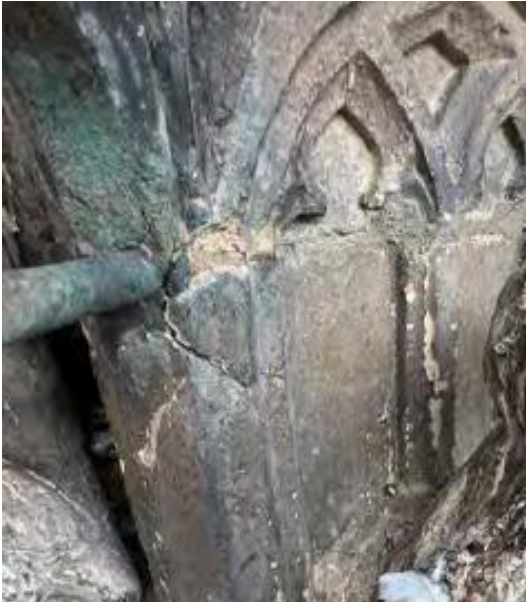
- 7.10. **Further investigations** – the condition survey identifies a number of areas for further investigations. These relate to the junctions of the bronze or copper tied rods to the stonework where the masonry has spalled or been repaired. Other than here there are no indications elsewhere of corroding ironwork in the structure and it is possible that the spalling may have been caused by thermal movement. These areas will be carefully inspected and previous repairs carefully dismantled to expose the junction to allow an understanding of the cause of the spalling.

Fig 21 – tie rod junction to masonry with spalling masonry at junction.

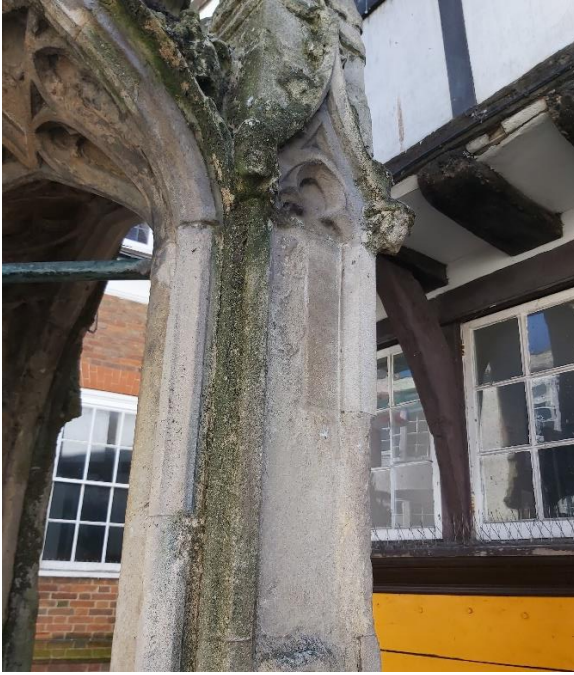
- 8.1. The monument was cleaned using a sand blasting process in 1991 and then further cleaned on a yearly basis until 2008. This cleaning has resulted in a monument that does not suffer significantly from the pollution or ingrained staining that would have been sustained over a long period. An examination of the monument indicates that the primary staining that it suffers from are deposits of bird guano, debris from pigeon perching and roosting and lichen, algae and moss build up which have accumulated within a relatively short period. The deposition of guano appears to be worst on the sheltered south side of the monument. Runoff from the guano deposits is staining the monument and encouraging biological growth.

Fig 22 – runoff from guano deposits causing staining to the stage 1 shafts

- 8.11. The delicate nature of the structure suggests that sponging and brushing would be the most appropriate method of water based cleaning as it is can be a highly controlled process. Sponging and brushing is methodical and labour-intensive and its controlled nature ensures that the minimum amount of water is used and that damage to delicate surfaces can potentially be avoided.

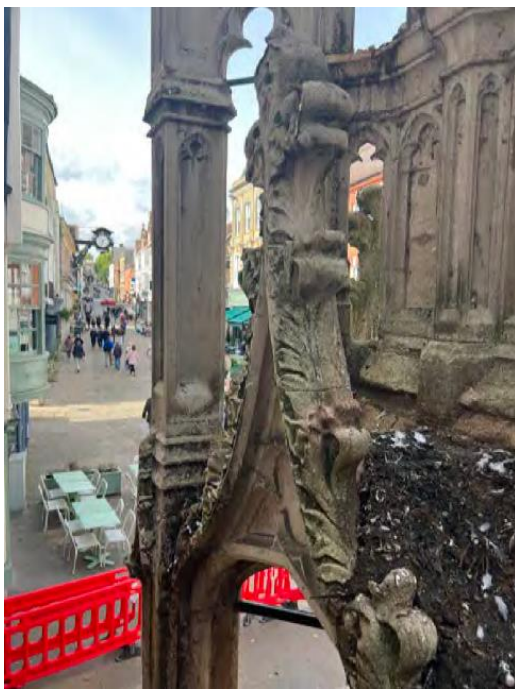
- **Stage 2** – above and behind the four gable arch pinnacles over the stage 1 lierne vault. There is significant deposited material on the south elevation.
- **Stage 3 & 4** – on the heads and shoulders and around the feet of the four statues. The monument also offers a multitude of other sky facing surfaces where they can perch in particular flying buttresses and pinnacles.
- **Stage 4** – behind pinnacles below stage 5 shaft though the extent of the problem is unclear from the condition survey photos.

Fig 23 – Stage 2 area behind gable finials showing significant deposits and staining from pigeons.

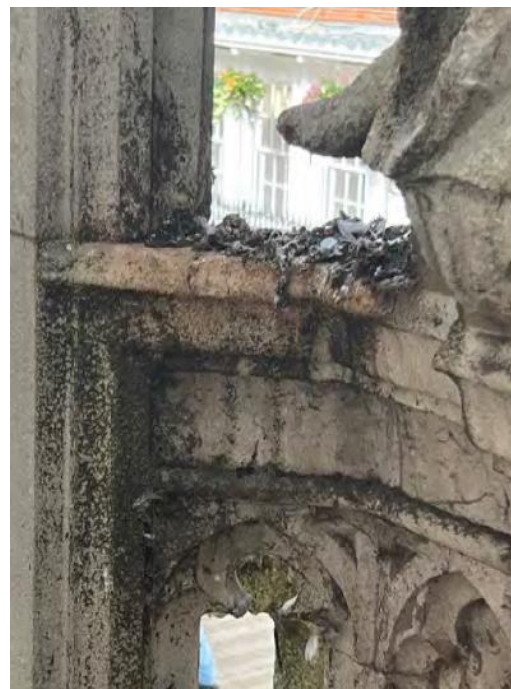
Fig 24 – Stage 2 area around the feet of St John the Baptist on the south elevation.

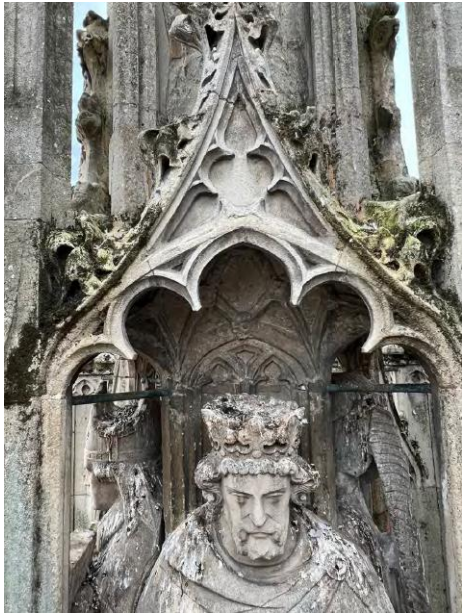
Fig 25 – Stage 3 area of the head of King Alfred on the west elevation.

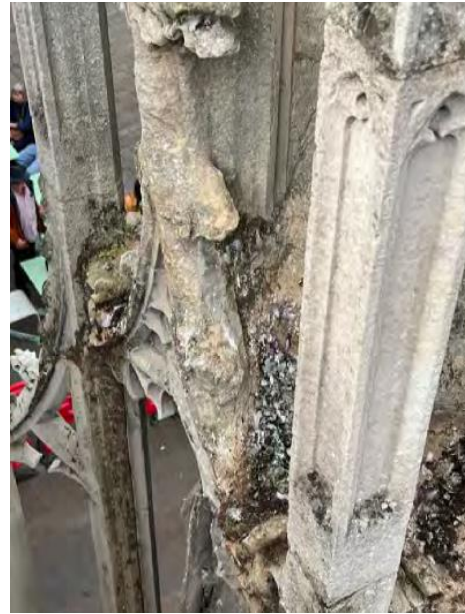
Fig 26 – Waterways between stage 3 and 4 statues.

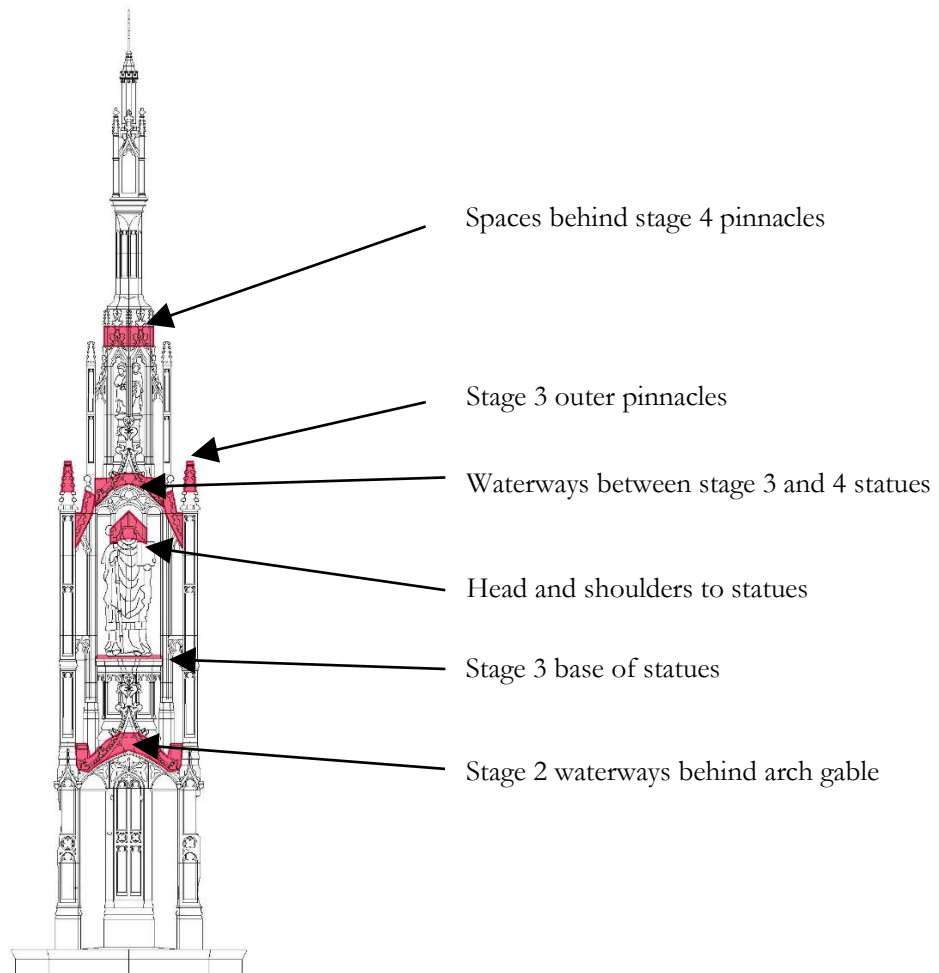
Fig 27 – principal areas affected by bird perching and roosting.

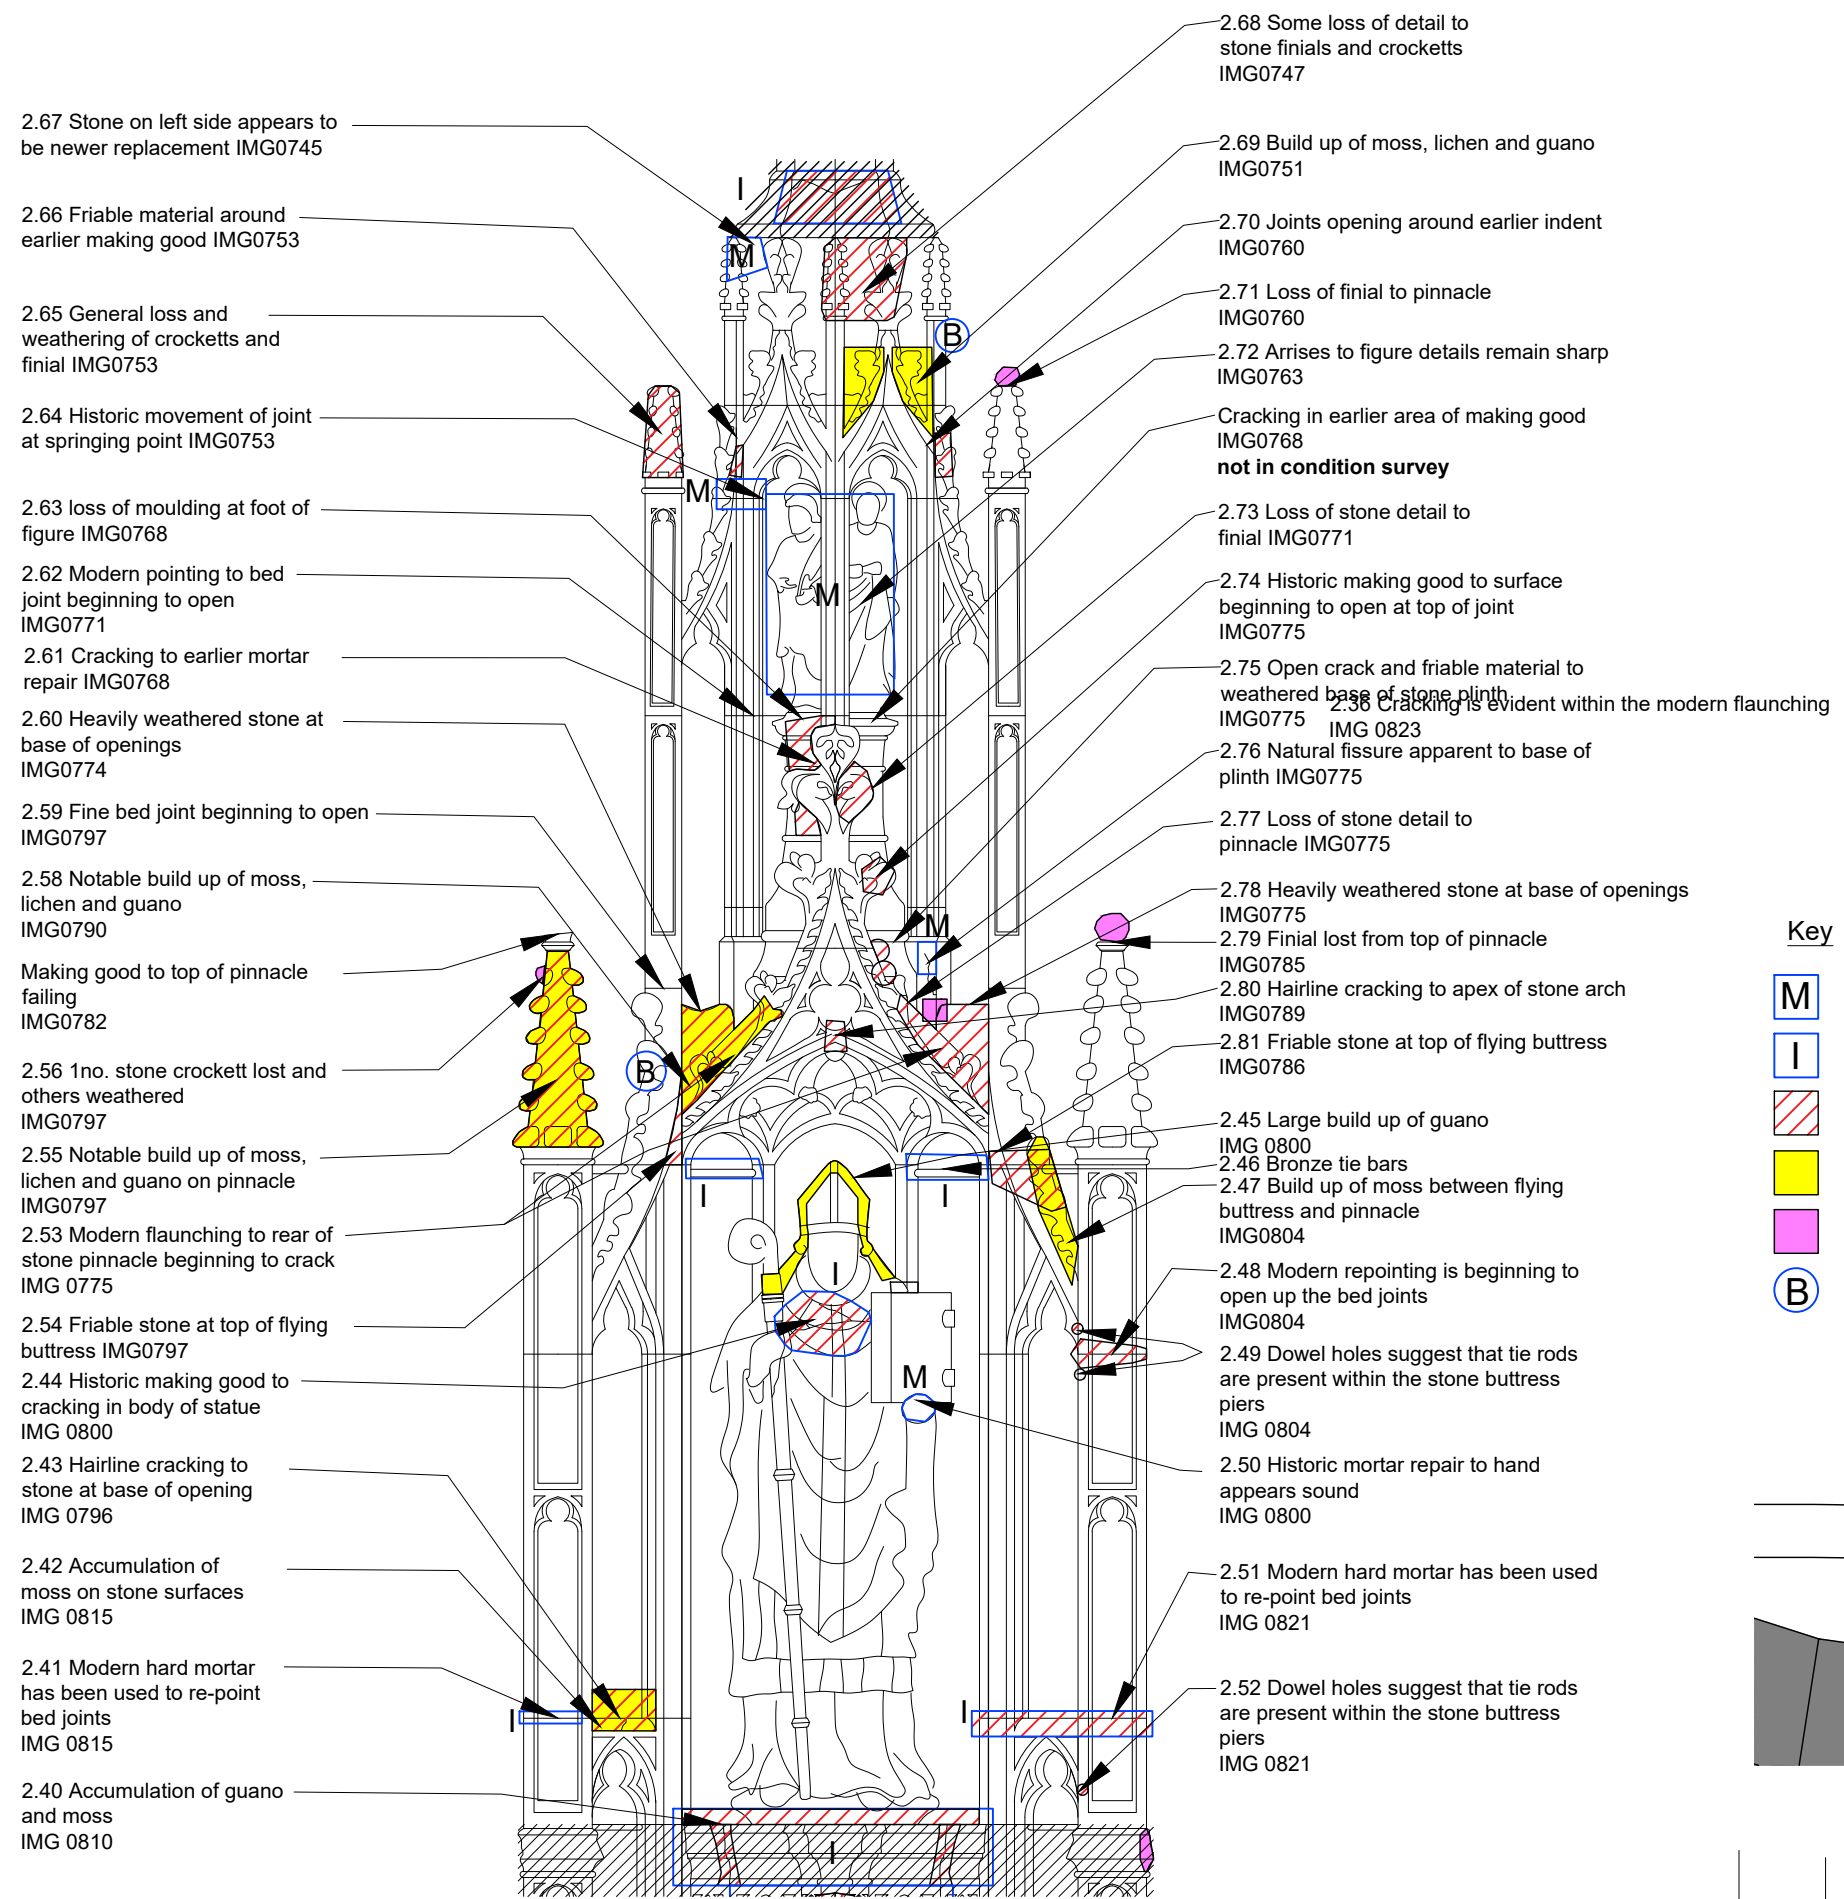
- 2.67 Stone on left side appears to be newer replacement IMG0745
- 2.66 Friable material around earlier making good IMG0753
- 2.65 General loss and weathering of crockets and finial IMG0753
