Abbots O Worthy

CONSERVATION AREA

A Technical Assessment

Winchester
City Council

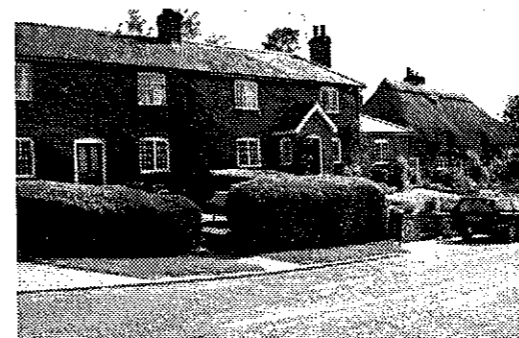
Photograph 2

- 4.2 The oldest buildings are to be found in Mill Lane and Park Lane, close to its junction with Mill Lane. The eastern side of Mill Lane is comprised of a series of 17th and 18th Century detached and semi-detached cottages, for the most part, one and a half storeys in height, set parallel and end on to the lane. There is a mix of materials ranging from brick with slates, timber frame with brick or flint infill under thatch and brick and flint with clay tiles (Photo 2).

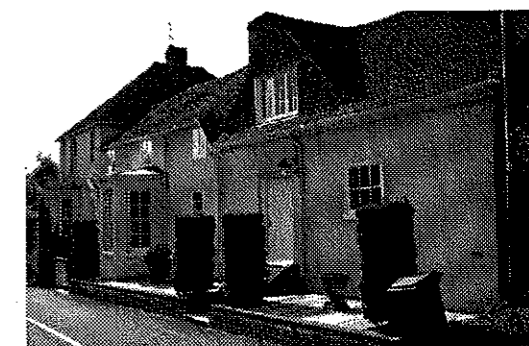
Photograph 3

- 4.6 Mill House (Photo 3), opposite Keepers Cottage is constructed of 3 distinct parts and is a Listed Building. The oldest section at the centre is comprised of a 17th Century cottage with an 18th extension to its north and a two storey 19th Century house to its south. The whole of the eastern elevation and a small part of the western elevation of the building has been rendered. There are clay roof tiles.

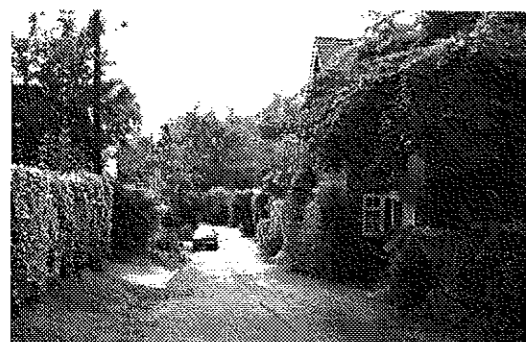
Photograph 4

4.8 Mill Cottage and Meadow Cottage (Photo 4) begin the transition from older buildings to more recent development. The buildings at the southern end of the lane (Photo 5) were constructed during the 1970's and are all of individual modern designs and of a larger scale and massing than the cottages at the northern end of the lane.

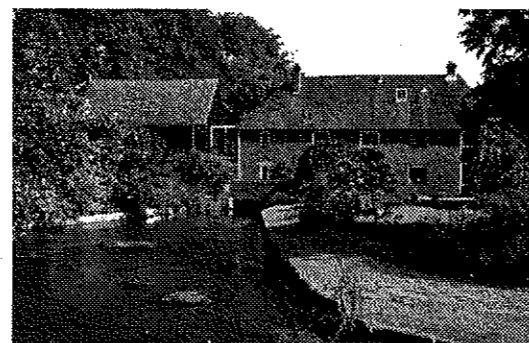
Photograph 6

4.9 Towards the foot of the lane a track runs eastwards to Worthy Park Home Farm, a mix of steel span and brick built agricultural buildings with a modern farm house. Mill Lane originally forded the river but now continues as a footpath over the water meadows. From the footbridge, the 18th Century Abbots Worthy Mill (Photo 6), which is a Listed Building, is situated on almost an island and screened by groups of trees. The former water mill was used for processing corn but is now a private residence and is comprised of a brick mill and weather boarded barn, both with a clay tiled roof and linked by a glazed walkway.

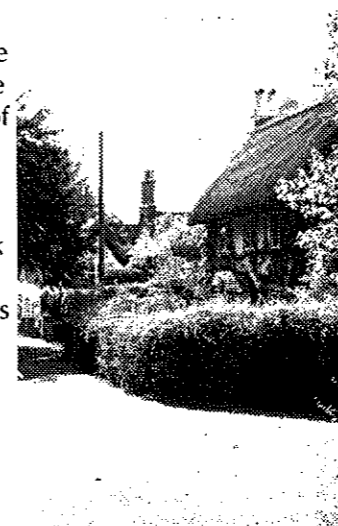
Photograph 8

4.13 The Hurst and No 2 Park Lane (Photo 8) at the southern end of the lane are two Listed Buildings set parallel to Park Lane. No 2 Park Lane dates from the 19th Century and is constructed from colourwashed flint with brick dressings, a thatched roof and a tiled porch. The Hurst dates from the 17th Century having a timber frame core and 19th Century and 20th Century extensions. The framing is infilled with flint and has been completely colourwashed. It is thatched, has eyebrow dormers and a striking flat roofed porch supported by oversized curled brackets.

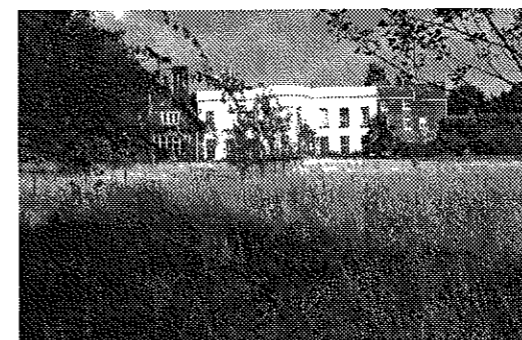
Photograph 9

4.15 The south side of the B3047, west of its junction with Mill Lane is dominated by the grounds of Abbotsworthy House (Photo 9). The house itself was constructed in 1836 by John Buckler for the Rev. Charles Baring in a gothic style, as a rectory. In the early 1950's the top two floors were removed and the main body of the house was remodelled in a neo-georgian style. It is now constructed of

brick and is part rendered, part colourwashed under slate and flat roofs. Very little of the building is visible from the B3047, however from Long Walk on the southern side of the valley, the white facade of the house is clearly visible as a landmark, as are other buildings along the B3047 and at the southern end of Park Lane.

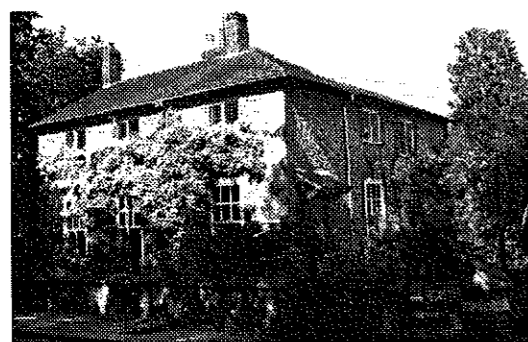
Photograph 10

4.20 To the west of Old Kingsworthy School lies an even earlier school building now known as Old School House (Photo 10). It is a Listed Building built in the late 18th Century from knapped flint with brick dressings and a slate roof. The western boundary wall of the adjacent Kings Worthy Grove reaches to the height of its eaves but curves down to a lower level at either side.

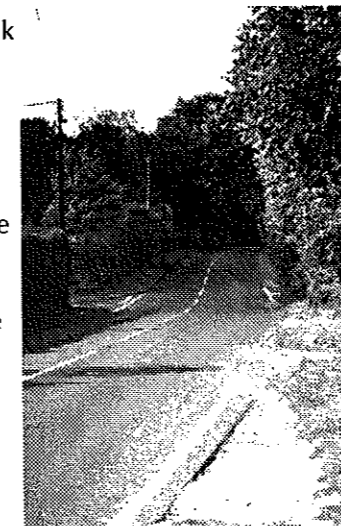
Photograph 11

- Boundary wall to Abbotsworthy House (see Map 4, 1 and Photo 11). This is constructed of coursed flint with brick lacing courses and varies in height from approximately two metres to three and a half metres.

It has a brick base with a series of brick piers standing slightly proud of the wall which taper towards the top in the form of buttresses. The wall is topped by several courses of brick and clay tiles.

Access into Abbotsworthy House is via two gateways with tall brick piers topped with stone. The original gates still stand at the western entrance. A doorway into the grounds through the wall is set opposite Garden Cottage while on the corner of Mill Lane a post box has been set into the wall. The length and height of the wall creates a highly dominant and impressive feature along both Mill Lane and the B3047 and provides a strong sense of enclosure, channelling views along the B3047.

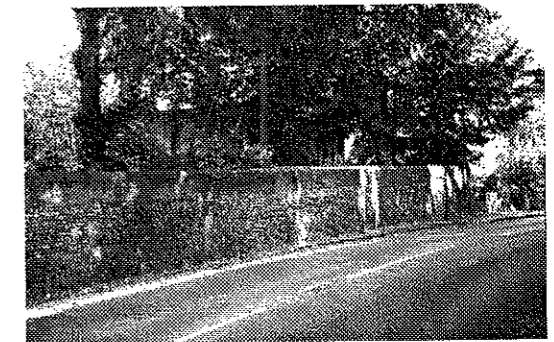
Photograph 12

- Brick wall and brick and flint wall along the south west and south east boundary of Kings Worthy Grove (2, Photo 12). The south east boundary is defined by a two metre high coursed flint wall with brick lacing courses and half round coping bricks. The north east boundary is marked by a curving wall reaching to around four metres in height.

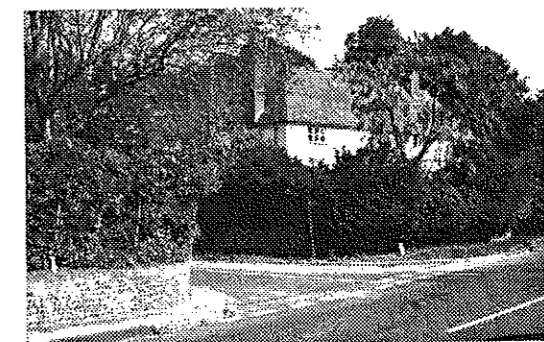
Photograph 13

- Low flint walls along the boundaries of Old School House, Well Cottage, Garden Cottage, The Hurst, No 2 Park Lane and Old Farm House (3, Photo 13). These walls are for the most part approximately one metre high with a brick base and coursed knapped flint capped with brick headers or coping stones. The walls stretch almost continuously from Well Cottage along the B3047 and turn the corner into Park Lane. In front of The Hurst a slightly taller wall of flint then continues to No 2 Park Lane. The western and southern boundaries of Old Farm House are also defined by a mix of brick and flint and brick walls.

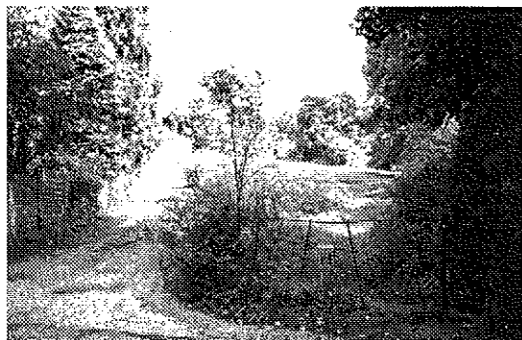
Photograph 14

- Railings south of Abbotsworthy House and south of Worthy Park Home Farm (4, Photo 14). These are black metal railings approximately one metre high comprised of three horizontal lengths with uprights one metre apart and are situated adjacent to public footpaths.

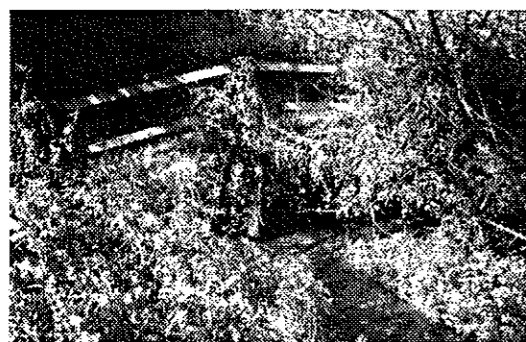
Photograph 15

- 5.2 Bridges south of Mill Lane. A three arched brick footbridge with plain parapets dated to the 18th or 19th Century crosses the mill stream west of Abbots Worthy Mill. A smaller

red brick two arched footbridge (Photo 15) crosses one of the tributaries of the River Itchen north west of the Fulling Mill.

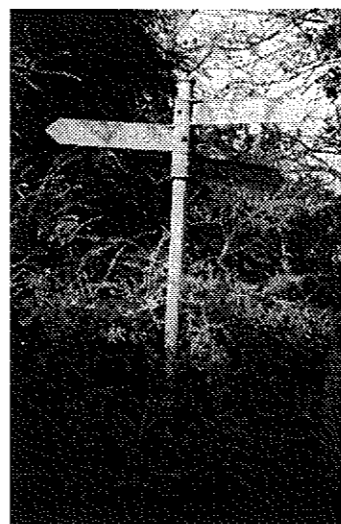
Photograph 16

- 5.4 Sign south of the Fulling Mill (Photo 16). Metal footpath sign giving directions of public footpaths.

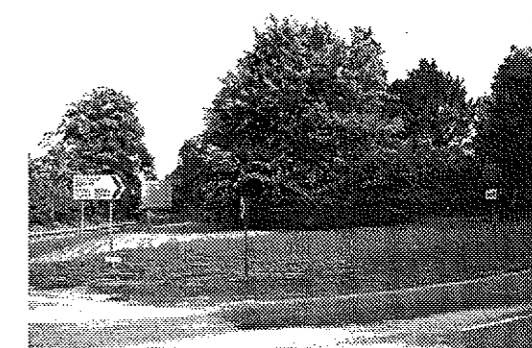
Photograph 17

- 6.6 Trees within the grounds of Kings Worthy Grove (B) include a variety of mature individual specimens such as Sycamore, Lime and Yew. These form a prominent feature at the junction of the A33 and B3047 (Photo 17) and along both these roads. Outside the boundary wall a single Beech forms part of this general tree cover. Along the southern boundary of Kings Worthy Grove, a single Lime is particularly prominent within the general street scene.

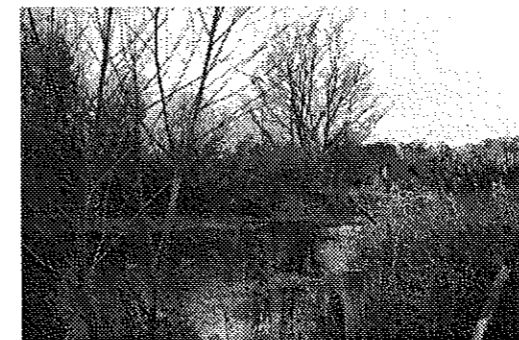
Photograph 20

7.15 The area adjacent and to the south of Abbots Worthy Mill has limited access with a small number of footpaths providing views into and across the area (Photo 20). Despite this, a large section of the conservation area to the east is not accessible or visible to the general public. From the end of Mill Lane, there are three footpaths leading to the west, north east and south, all forming part of the network of footpaths running along the river valley. The footpath leading west links Abbots Worthy with Kings Worthy and runs along the southern boundary of Abbotsworthy House for much of the way.

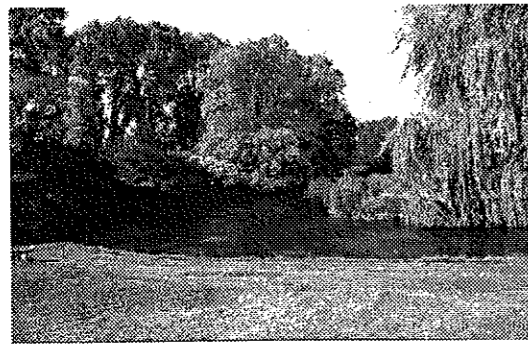
Photograph 24

- 7.20 The final stage of this footpath offers the only opportunity within the conservation area to experience the landscape of the River Itchen at close quarters. Views up and down stream (Photo 24) of the main river and its other channels, the noise of the fast flowing water, varying vegetation and wildlife form a distinct and pleasing scene.

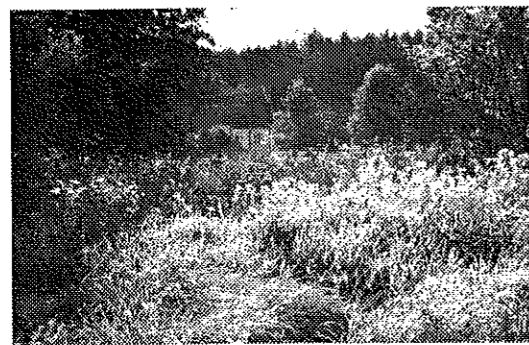
Photograph 23

- 7.21 There has been a Fulling Mill (Photo 23), where woollen cloth was worked with fullers earth, in this area since medieval times. The building is a one and a half storey clay tiled roof with eyebrow dormers, colourwash walls and brick and tile hanging at second storey. A single storey building of a similar design is sited at the eastern end of the site. The current building was probably constructed in the 20th Century and the use of traditional materials has allowed the building to mellow and the growth of vegetation over parts of the building helps to soften its appearance within its rural setting. On account of its location and historical associations the Fulling Mill is an important unlisted building (see Map 4).

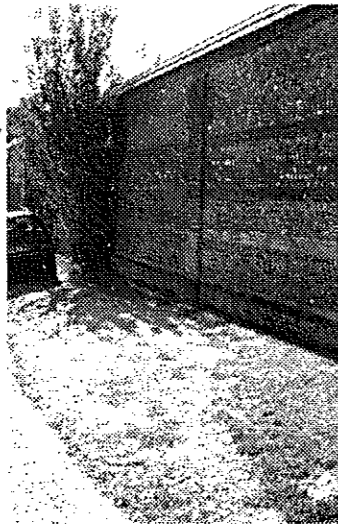
Photograph 26

8.9 The area immediately below the walls of Abbotsworthy House at the northern end, forms a wide bare verge (2, Photo 26). There is an opportunity here for new low level planting of a form which would not harm the structure of the wall but would improve the appearance of the verge. Informal parking provision for walkers might also be considered. In addition, the flints within the wall are beginning to fall out and will require attention.
