CONSERVATION AREA

A Technical Assessment

Winchester
City Council

February 1998

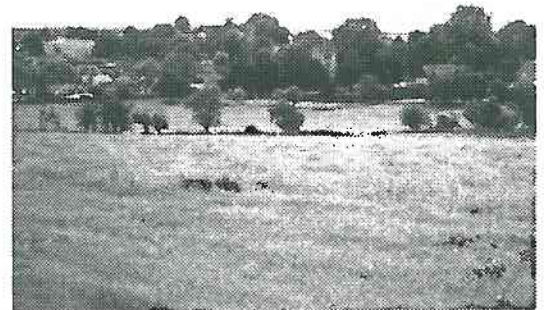
Photograph 1

- 2.5 Views from the west of the village from Hill Houses provide the best impression of the valley setting of the village (Photograph 1). From here, at a height of about 100 metres, there are views across open fields to the western edge of the village and beyond to the far side of the valley. The roofs of cottages to the north of the church stand out, while trees within the churchyard and grounds of the Old Rectory obscure buildings at the core of the village, so that only the Church, Garden House and properties at Brandy Mount are visible. From the junction of the B3046 with Hill House Lane there are glimpses of the valley sides, particularly to the north west where the valley side steepens with a strip of woodland marking the skyline.

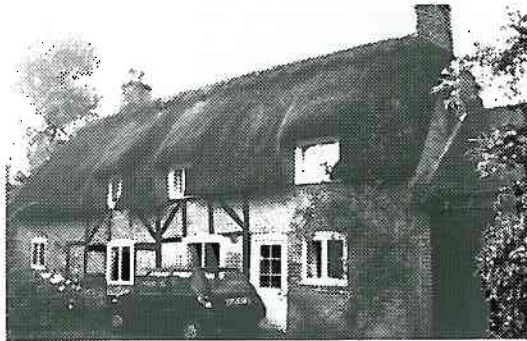
Photograph 2

- 4.2 There are five Listed Buildings which date from the 16th Century but which all have 17th to 19th Century extensions and alterations. These buildings are located in two groups, Holbrook, Brookside and Old Kennetts (Photograph 2) along The Street and School Lane and 1 and 2 Brandy Mount and Vine Cottage, south of the Church. These are all small scale domestic cottages of a mix of one and a half and two storeys in height. The buildings are all of timber frame construction with either brick infill or an encasing brick skin and with slate, thatch or clay tiled roofs. Dormer windows also vary in style and there are examples of gable dormers, flat roofs and eyebrow dormers.

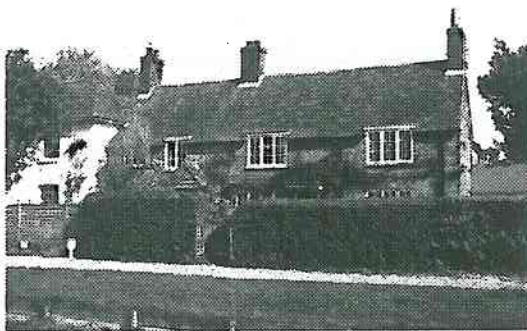
Photograph 3

during the 18th and 19th Centuries. Quince Cottage, with its fire insurance plaque, Colyton (Photograph 3) and Burnt Platt all have timber framed cores encased in flint or brick infill, brick or colourwashed brick and are one and a half or two storeys in height with casement windows. Roofing materials are either clay tiles or thatch. The fourth building in this group is the Old Rectory (Photograph 4) which is a Grade 2* Listed Building. It dates from the late 17th Century and is of brick and clay tile construction. The building is two storeys with a semi-basement and hipped dormers in the attic. There are steps up to the front and rear doors and prominent sash windows.

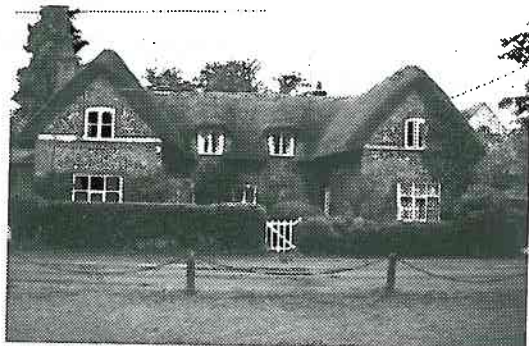
Photograph 5

- 4.5 The remaining Listed Buildings; Rectory Cottages (Photograph 5), Goodwins Cottage, The Old Post Office and Lime Tree Cottage, date back to at least the 18th or 19th Century and again are a mix of one and a half and two storeys in height. Materials vary between flint with brick lacing courses, brick buildings with blue headers and blue brick string courses. Roofing materials range from slates to tiles or thatch with eyebrow or dormers with a sloping roof.

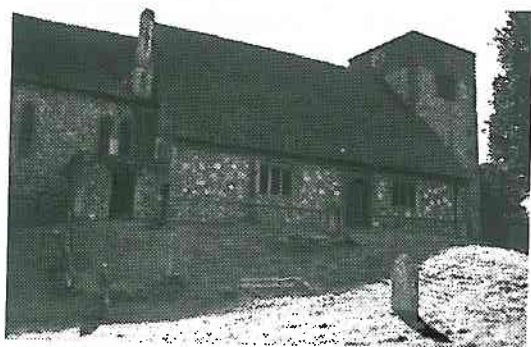
Photograph 6

- 4.7 Possibly the most important building within the conservation area is the Church of St Michael's dating from the 13th Century (Photograph 6). Constructed from rubble flint with stone and brick dressings it has a clay tiled roof. It was extensively rebuilt following a fire in 1744 and underwent a Victorian restoration in the 19th century. The Church is built on what is believed to be prehistoric burial mound and from its main

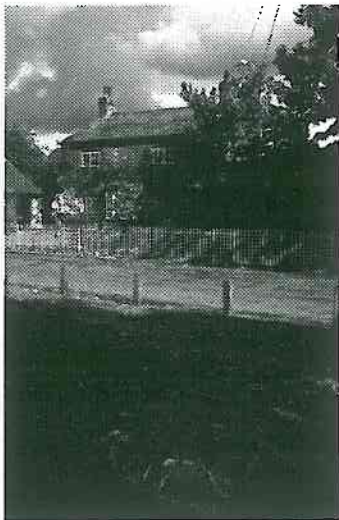
Photograph 7

5.3 The Forge (B, Photograph 7) is located along the eastern side of the Street. It is shown on the 1837 Tithe Map as a blacksmith's shop and dwelling. The two storey brick built cottage has two light casement windows with cambered brick arches, a brick dentil course

under the eaves and a slate roof. The former forge lies in front of the house, flush with the road and is constructed from flint with brick lacing courses and a mix of clay tiles and corrugated iron roofing. The well maintained buildings with their simple design, brightly coloured painted doors and window frames create an interesting focal point complementing the semi-rural appearance of this part of the conservation area.

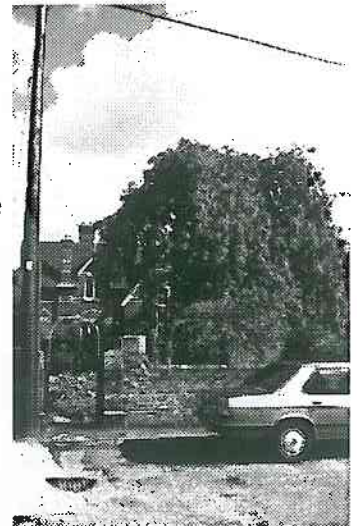
Photograph 8

5.5 Cheriton Primary School (D, Photograph 8) was constructed in 1875 and extended at the rear in the 1980's. It is a red brick building with buff yellow brickwork used to decorative effect and ornate chimneys stacks. The building is especially striking from the front and it fits comfortably into the streetscene echoing the massing of the Congregational Church.

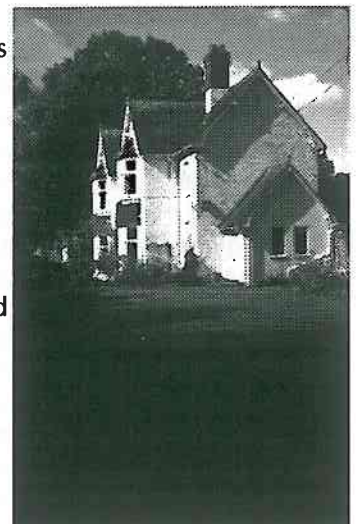
Photograph 9

5.6 Martyrwell (E, Photograph 9) is tucked away at the southern end of School Lane. Set at right angles to the road, it is well screened by the brick and flint wall abutting School Lane and the trees immediately to the rear. Despite this, glimpses from the public

footpath running adjacent to the southern boundary are possible. This long, narrow brick built two storey house has been colourwashed and has a clay tiled roof with rows of decorative fishscale tiles. Narrow one, two and three light windows as well as a pair of two storey bay windows add to its attractive appearance, as do the brick detailing and clay pots on the chimneys. Martyrwell lies close to two Listed Buildings and the northern elevation is made up of flint and brick lacing courses. This elevation is visible from the rear of the Primary School and helps to enclose the space around the rear playground.

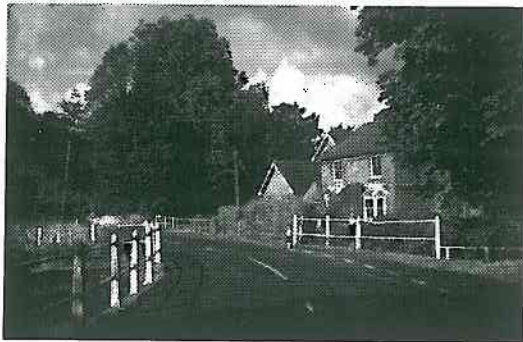
Photograph 10

- 5.7 Brooklyn (F, Photograph 10) first appears on the 1909 Ordnance Survey Map. It is a two storey brick building with canted bay windows on the ground floor and a slate roof, decorative string courses at second floor level and a decorative bracket under the soffit. This is an attractive simple building in a prominent position at the south eastern entrance to the conservation area.

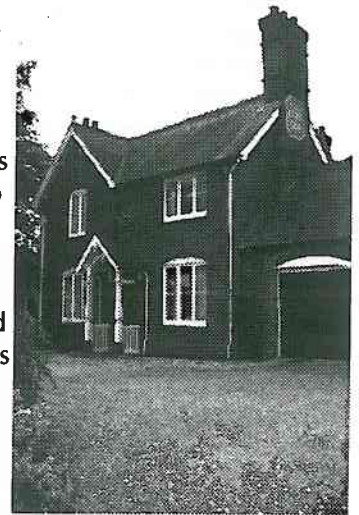
Photograph 12

- 5.10 The HH Inn (I, Photograph 12) which was converted to a dwelling in the late 1980's, was built in 1894 to replace the Fleur de Lyss Inn which was situated on land opposite. It was called the Hampshire Hunt Inn after the hunt kennels were moved to Cheriton in 1837 for a short period of time. The building bears the Prince of Wales feathers which were the emblem of the hunt and which are positioned just under the eaves on the front gables.

- 5.11 In addition to its historical connection to the Hampshire Hunt, the building is extremely attractive being constructed from red brick with brick arch details over the two and three light casement windows and brick detailing around the two decorative panels. The building has a slate roof and decorative ridge tiles, tall chimneys with clay pots and end finials on the porch and gables and painted panels on its northern elevation.
- 5.12 The building stands at the northern tip of the 'The Green' and is surrounded by Listed Buildings and accordingly contributes to their setting. It is prominent within the street scene when viewed from both directions,

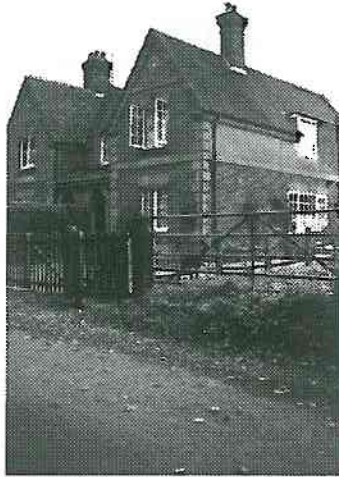
Photograph 13

Cottages (J, Photograph 13) are semi-detached dwellings first appearing on the 1909 Ordnance Survey Map, having replaced an earlier building. It is a two storey brick building with stucco dressings and part rendered upper storey under a clay tile roof.

The bricks were made locally at Shorley Copse just south of Cheriton. Further detailing includes ornate brick chimneys with clay pots, moulded brick detailing under eaves and decorative ridge tiles along part of the roof. The building is attractive and prominent in the streetscene when viewed from Hill Houses Lane and makes a significant contribution to views of the group of buildings, a number of which are Listed, seen from the public footpath to the north of St Michael's Church.

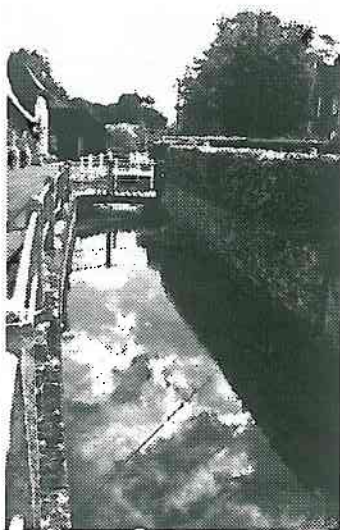
Photograph 14

- 7.4 Railings, flint wall and hedgerow, 1 Garden Cottage and Goodwins Cottage (2, Photograph 14). The one and a half metre high flint wall capped with two courses of bricks forms the boundary of the two cottages and lies flush with one of the channels of the

River Itchen. The cottages are linked to the road by simple planked bridges and the bank of the stream nearest to the road is lined with concrete posts and white painted metal rails. The wall to Goodwins Cottage is backed by a beech hedge completing the complex layers of this boundary which together create an attractive and distinctive feature.

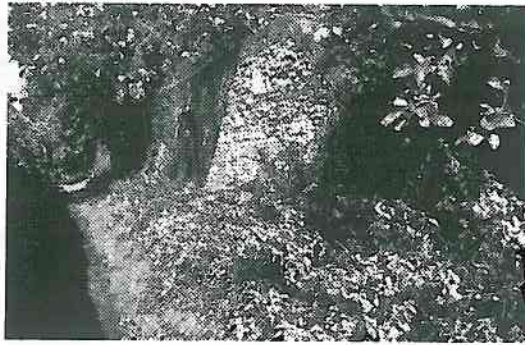
Photograph 16

- 7.6 The western boundary to the Garden House (5) is marked by a substantial wall consisting of coursed flint with vertical and horizontal courses of brick (Photograph 16). Capped with bricks on edge, the wall is fragmented by a section of corrugated iron fencing and obscured by ivy and young trees growing in front. A public footpath to the recreation ground runs alongside the wall and is adjacent to the conservation area boundary. Consequently the entire section of the wall can be viewed.

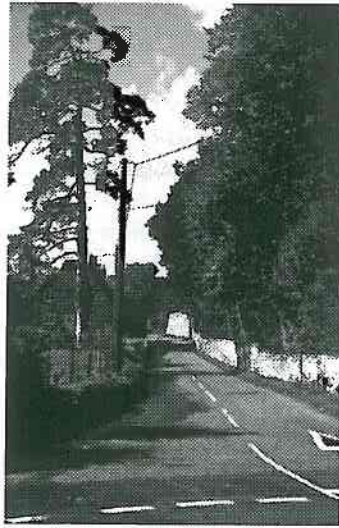
Photograph 17

- 7.7 The southern and eastern boundary of The Old Rectory is bounded by one continuous stretch of brick and flint and brick wall (6, Photograph 17). The brick portion of the wall dates from the 18th Century and is Listed. When viewed from the west, the wall is

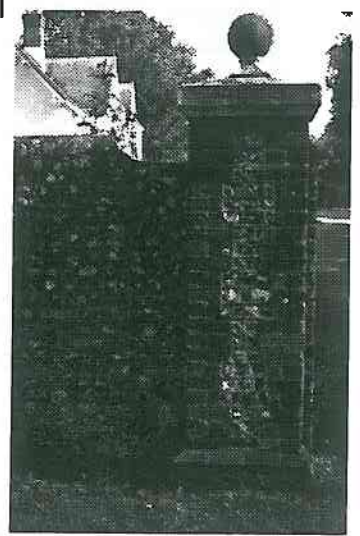
Photograph 19

- 7.10 A two metre tall coursed flint and brick wall (9) extends along the east and northern boundaries of Martyrwell (Photograph 19). It contains brick string courses curved coping bricks with brick and flint piers finished with a stone ornament. Backed by pollarded limes, the wall provides an attractive enclosure to School Lane.

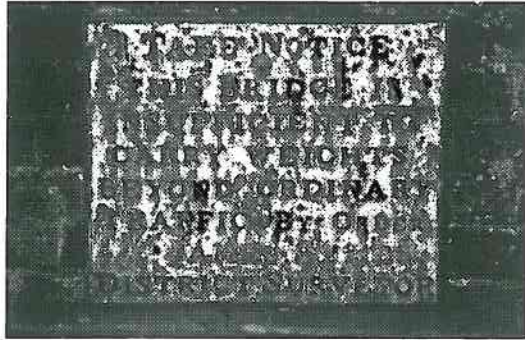
Photograph 20

- 7.13 The two channels of the River Itchen are crossed on a number of occasions by roads. Single arch brick bridges (12) cross the streams, two of which have low brick parapets with the rest marked by concrete bollards and thick metal rails. Several of the bridges bear old weight restriction plaques (Photograph 20).

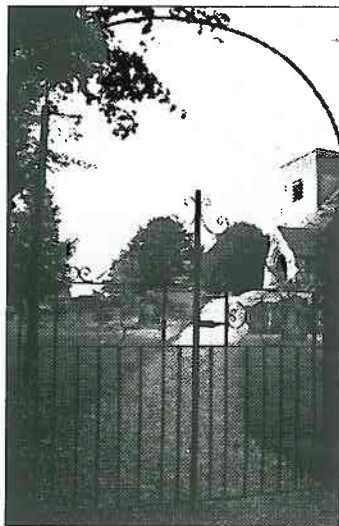
Photograph 21

- 7.15 The pathway between Dayton and Rectory Cottages to the Church has a delicate wrought iron gate marking the entrance into the church yard, inside the gate on the left hand side a single lamp standard provides light (14, Photograph 21). These features contribute to the historic quality of the churchyard area.

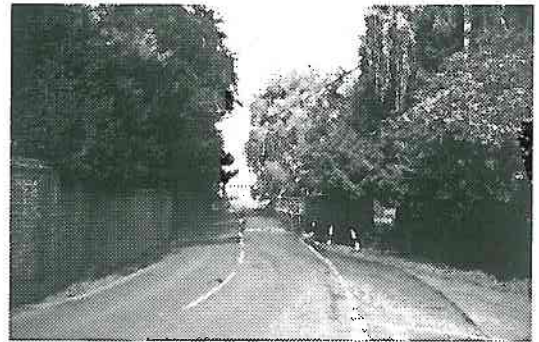
Photograph 23

8.3 A Willow, Beech, Lime and Conifer hedge (2) in the grounds of the Old Post Office, together with the trees in the grounds of Cheriton Cottage, on the opposite side of the B3046, form a tunnel in the road and provide an entrance feature into the conservation area from the north (Photograph 23).

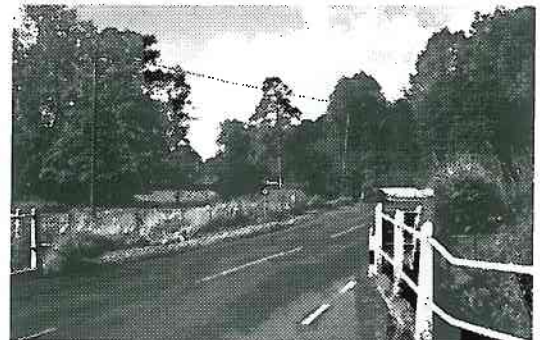
Photograph 24

8.4 Trees along the southern boundary of The Old Rectory (3) consist of a mix of Yew, Conifer, Holly, Beech, Copper Beech, Lime, Sycamore, and Field Maple with an understorey of Yew forming a hedge on the eastern boundary. Situated on the corner of the B3046 and the road to Brandy Mount, the vegetation again forms a prominent feature (Photograph 24). When approaching

the conservation area both from an easterly and westerly direction, the vegetation, full of contrasting shades of green, in conjunction with the brick boundary wall, forms a strong feature, enclosing and screening the grounds of The Old Rectory. Looking north from the

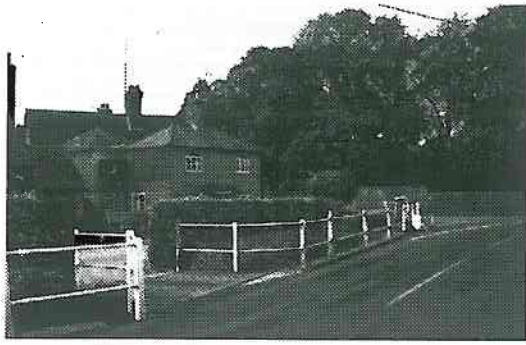
Photograph 28

8.11 The open space of The Green is broken at the southern end by two Horse Chestnuts, a small Willow and a Prunus (17, Photograph 25), on its north western side two Horse Chestnuts (18) (Photograph 28) flank the entrance to Burnt Platt and a dense hedge screens the building. Further to the north on the western side of the B3046, the Beech

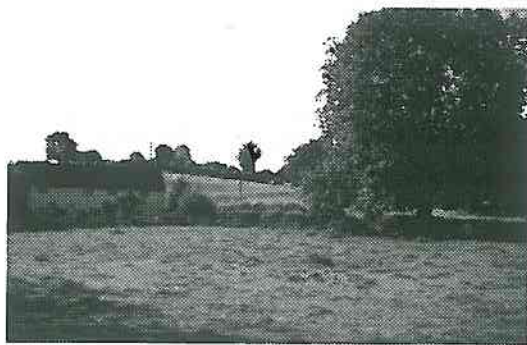
Photograph 30

close to the north west tip of the building and a Willow and small Copper Beech (21) on the grass verge south west of Old Rose Cottage. Further south, close to Malthouse Farm a large Ash (22, Photograph 30) and Pine (23, Photograph 17) both form prominent features along with a group of Yews (24) to the rear of Brandy Mount. Buildings to the south of Malthouse Farm are screened by a group of deciduous trees (25) partially outside the conservation area boundary.

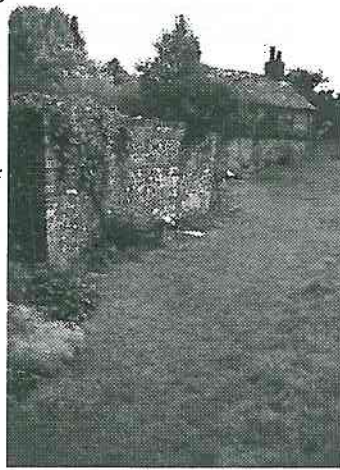
Photograph 32

- 9.16 The flint and brick wall of the western boundary with the barn incorporated into the wall provides enclosure around the churchyard. The eastern boundary is marked by a brick and flint wall, beyond which lie the buildings which front The Green. The flint sections of Church Cottage and Burnt Platt complement the materials within this wall and create a link between the Church and the village as a whole (Photograph 32). The mound on which the Church is sited is of a sufficient height to afford views to the

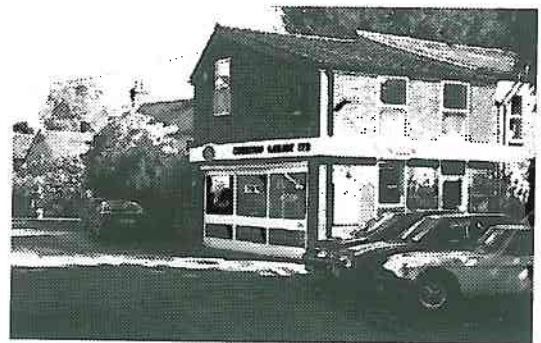
*Photograph 35*

- 10.6 Stretches of overhead cables constitute visual clutter, particularly at the northern end of The Street detracting from the pleasant semi-rural nature of the area. Where possible the undergrounding of cables should be encouraged.
- 10.7 Better quality signage to the former Cheriton Garage (Photograph 35). Should the opportunity arise, signage appropriate to the historic centre of the village should be encouraged. This would not only improve the appearance of this modern building but also enhance views across The Green.
