Conservation Area Character Appraisal and Management Plan

Exton

November 2015

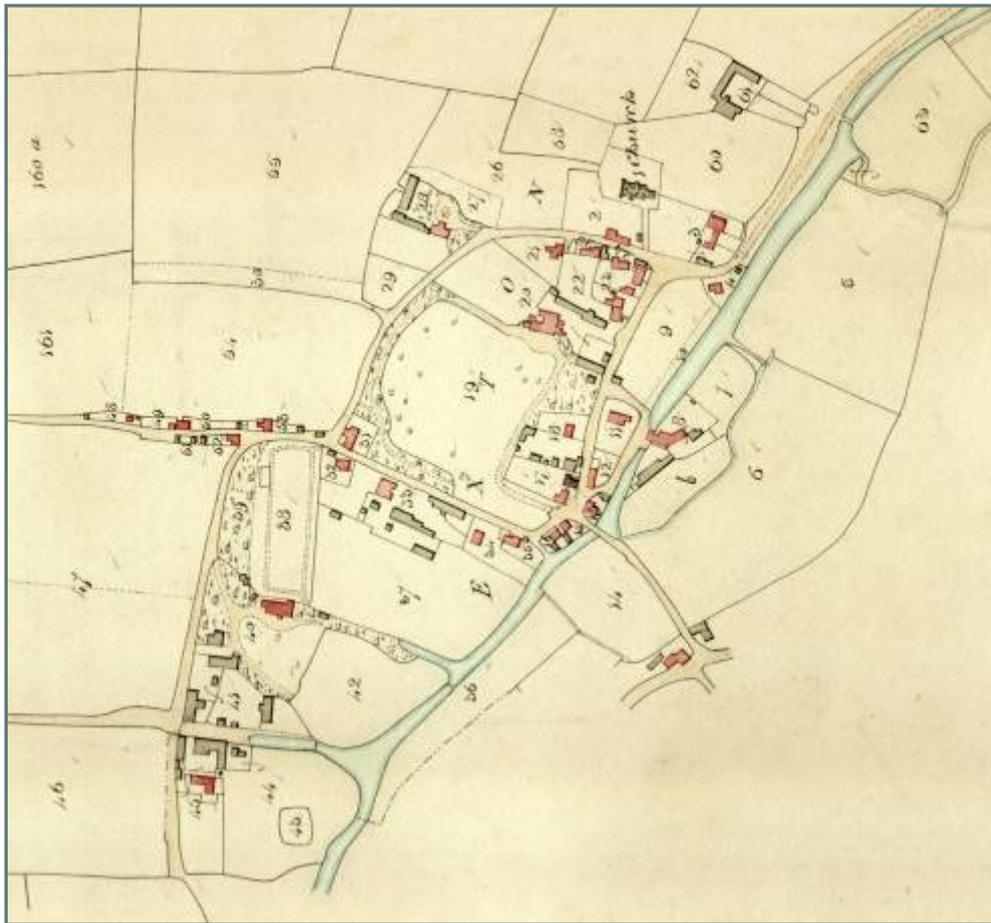
3.9 The extent of the village in the 19th century can be seen in the Tithe map and the Ordnance Survey mapping of 1897 (both Figure 4). It is little changed today.

Figure 4: Exton as it appears on the Tithing Map (above) and the Ordnance Survey mapping of 1897 (below)

4.3 These boundaries have been drawn to encompass the extent of the village on the west side of the Meon at the end of the 19th century (see Figure 4). The river forms a clear boundary on the south and eastern side and elsewhere it is drawn to include the settlement buildings but little open land beyond. However, this open land defines the edges of the settlement and makes a crucial contribution to the character and rural setting of the village.

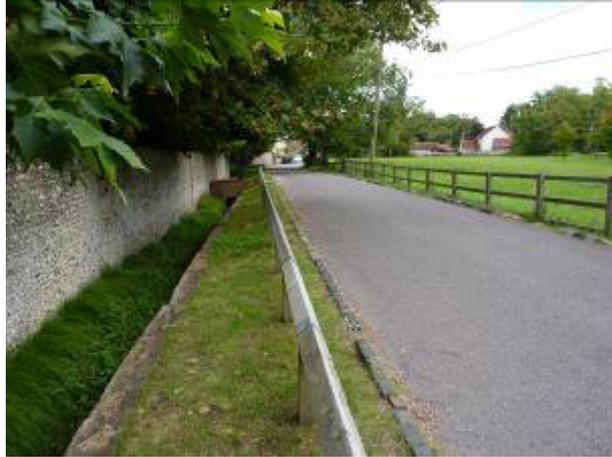
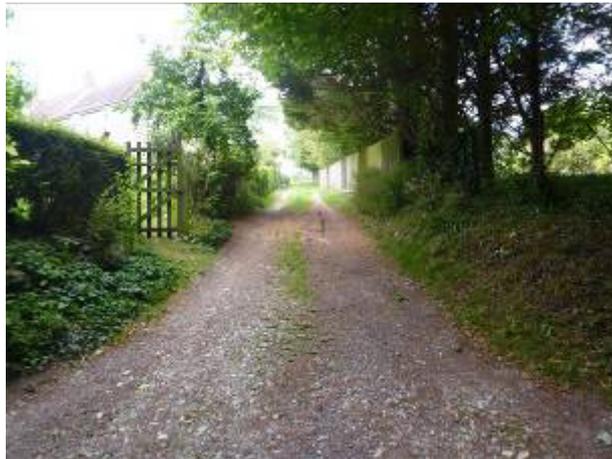
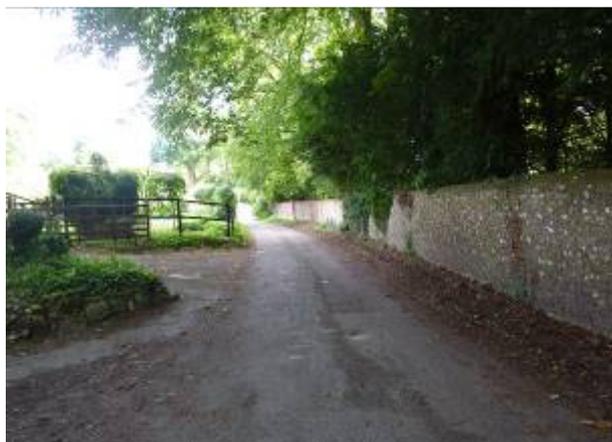
Figures 7-9; **Street scenes within the Conservation Area**, showing the rural and informal nature of the lanes. Also note the intrusive overhead wire-scape in Shoe Lane (top)

5.3 A second potential enhancement would be the undergrounding of the overhead wires and removal of telegraph poles within the village. In places, especially on Shoe Lane, these are quite obtrusive features which detract from character.

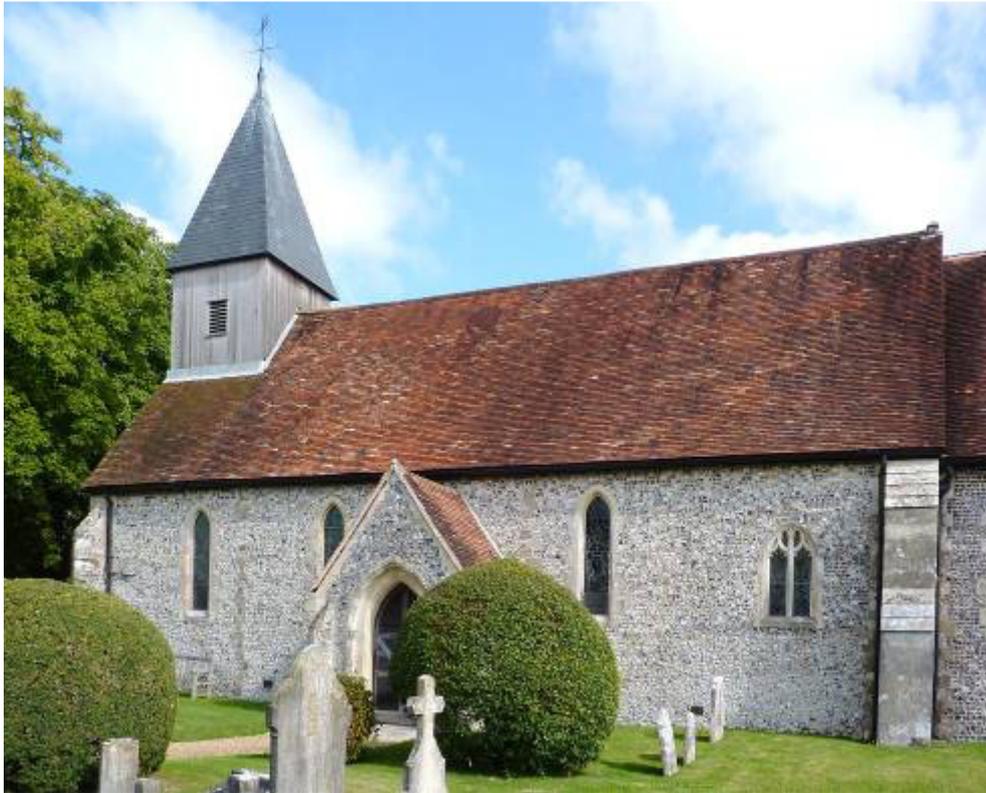
Figure 10: **Parish Church of St Peter and St Paul**

4.10 The Domesday Survey records the presence of a church in the late 11th century and this must have been replaced by the existing *Church of St Peter and St Paul*, which is largely 13th century in origin but heavily restored in the mid 19th century (Figure 10).

4.11 The church is a relatively modest example, Grade II listed, comprising an aisle-less nave, chancel and a bell-turret. It combines an attractive mix of materials, with the walls being mostly of flint, clay tiles on the nave and chancel roofs, and a bell turret of vertical timber boarding topped by a shingle-covered spire. Monuments in the churchyard possess great evidential value as a historical resource.

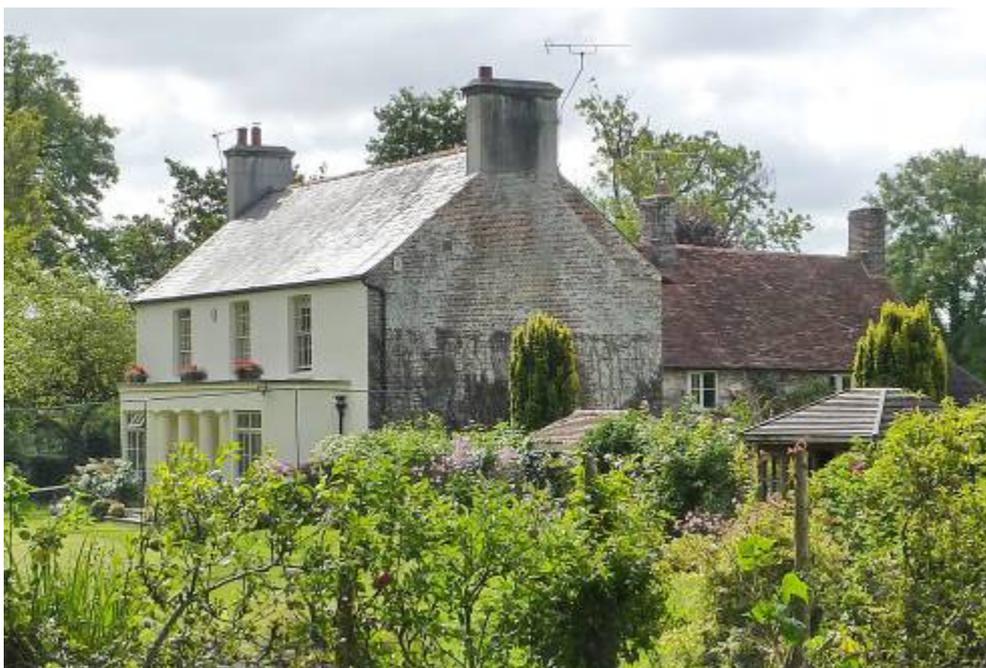
4.12 The site of the medieval *Manor House* is 50 metres south-east of the Church. However, the existing building is not the original. It is L-shaped in footprint, with the north-south range being 18th century in date and the taller east-west range being an early 19th century addition. The building is largely brickwork, with a mix of English and Flemish bonds with blue headers, but the north elevation facing the garden has a more ‘polite’ feel with a short colonnade and is stuccoed. Clay tiles are used on the roof on the original building, with slate for the addition.

Figure 11: The garden frontage of **Manor House** seen from the churchyard

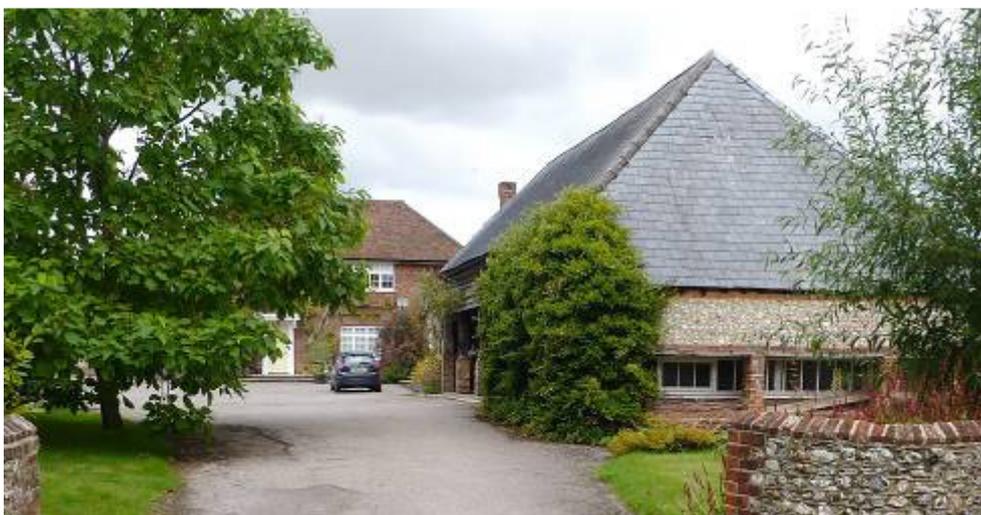
Figure 12: **Manor Farm**

4.13 The buildings of *Manor Farm* are north-east of the manor and church (Figure 12) and include the farm house, a staddle stone granary and a long range of farm buildings. These are all within the boundaries of the Conservation Area but just beyond that boundary is the village *pound* (Figure 13), which should be brought into the Conservation Area. It may also be included on a local list.

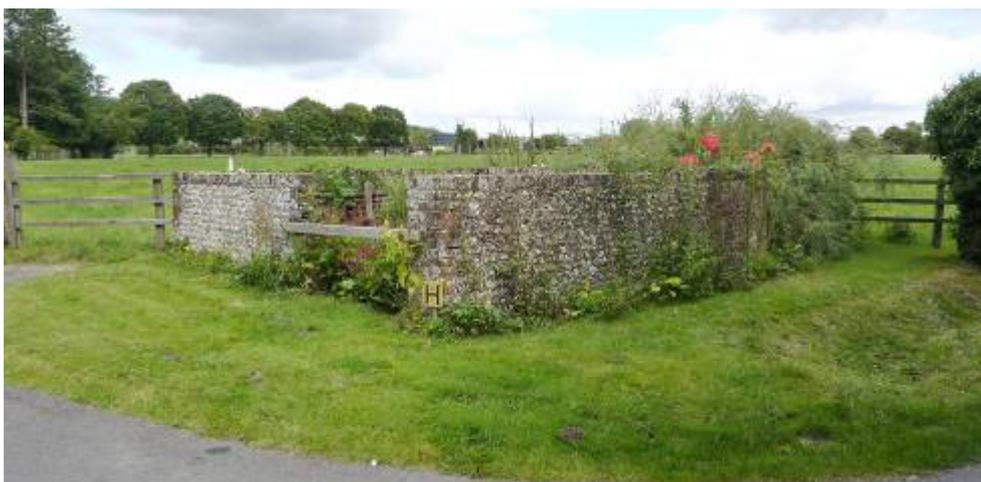
Figure 13: **The Village Pound** which is currently just outside the conservation area boundary

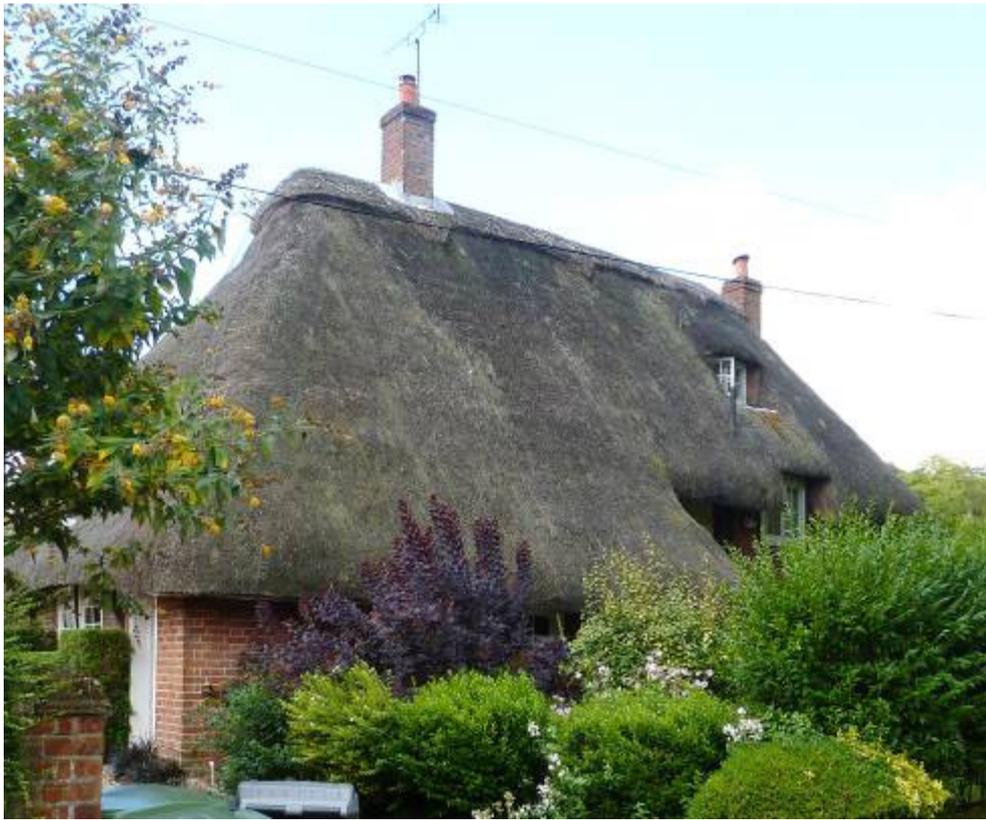
Figure 14: **Marriner's Cottage**

4.14 Other early buildings in this group are *Marriner’s Cottage* (Figure 14) and *Church View* (Figure 15). Both have 16th century timber frames with brick infill. The former is thatched (albeit not the long-straw thatch that appears in old photographs) whilst the latter has clay tiles. However, old photographs show that it too was originally thatched in long straw. Of comparable antiquity is *Grove*

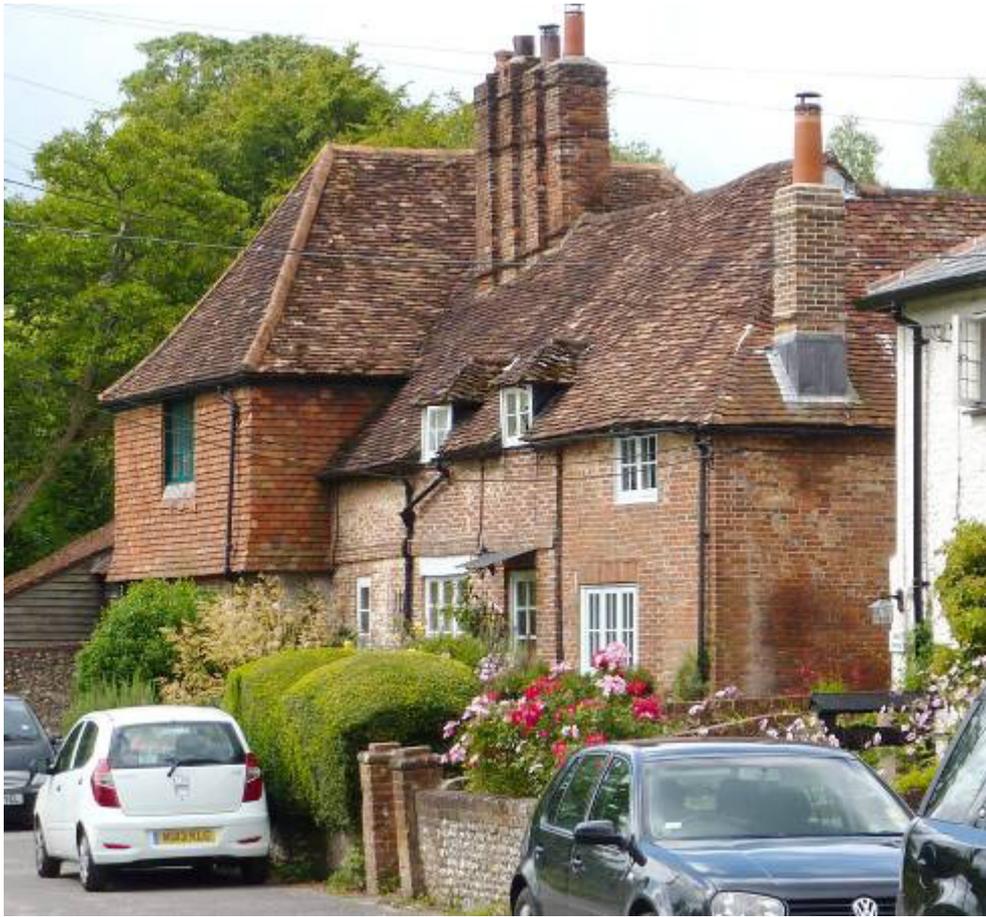
Figure 16: **I Grove Cottages, Middle Cottage and Sunnyside**

Cottages (Figure 16), a late medieval hall with cross-wings, subsequently subdivided to form three cottages.

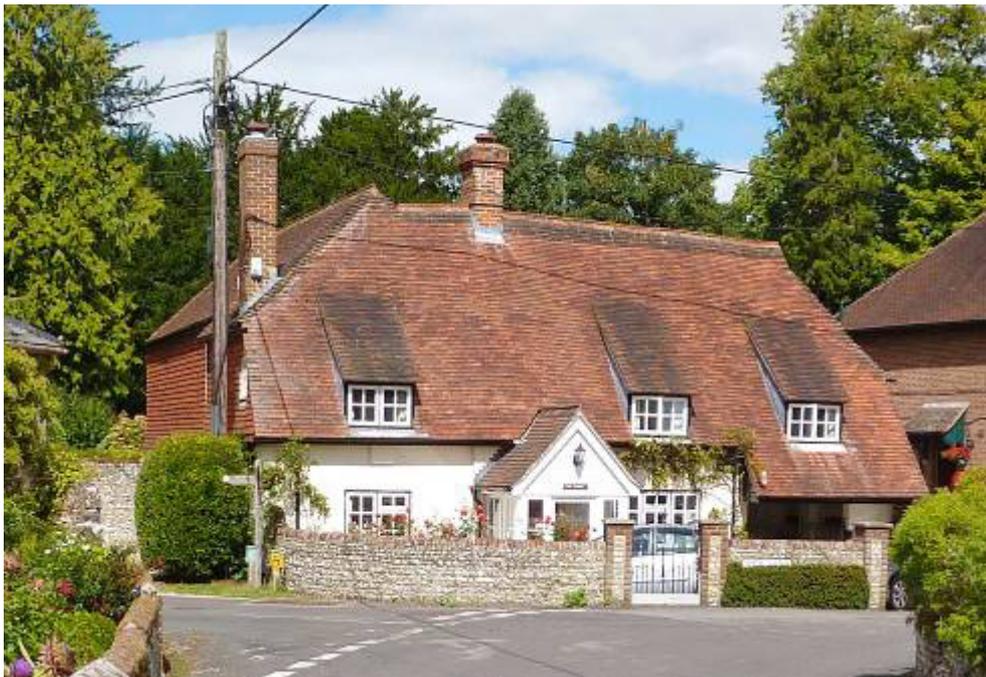
4.16 Prominent in views across the bridge is *Shoe Cottage* (Figure 17), with its large and attractive clay tile roof. Interestingly, photographic regression demonstrates that it too was originally thatched in long straw. None of the buildings in this node are included on the statutory list but most make a positive contribution to the Conservation Area, including *Bridge End Cottage* (figure 18), and *Bridge Cottage*, the former Post Office and Village Store (Figure 20), which retains its former shopfront and the attached cottage (Figure 21). The boundary walls, whether flint and brick, are particularly important in this part of the village. Also significant is the presence of the well maintained *K6 telephone kiosk*, designed by Giles Gilbert Scott in 1935.

Figure 17: **Shoe Cottage.** This cottage sits in a prominent position when viewed from across the bridge into the Conservation Area. Removal of the telegraph pole and undergrounding of the wires would produce a significant visual improvement.

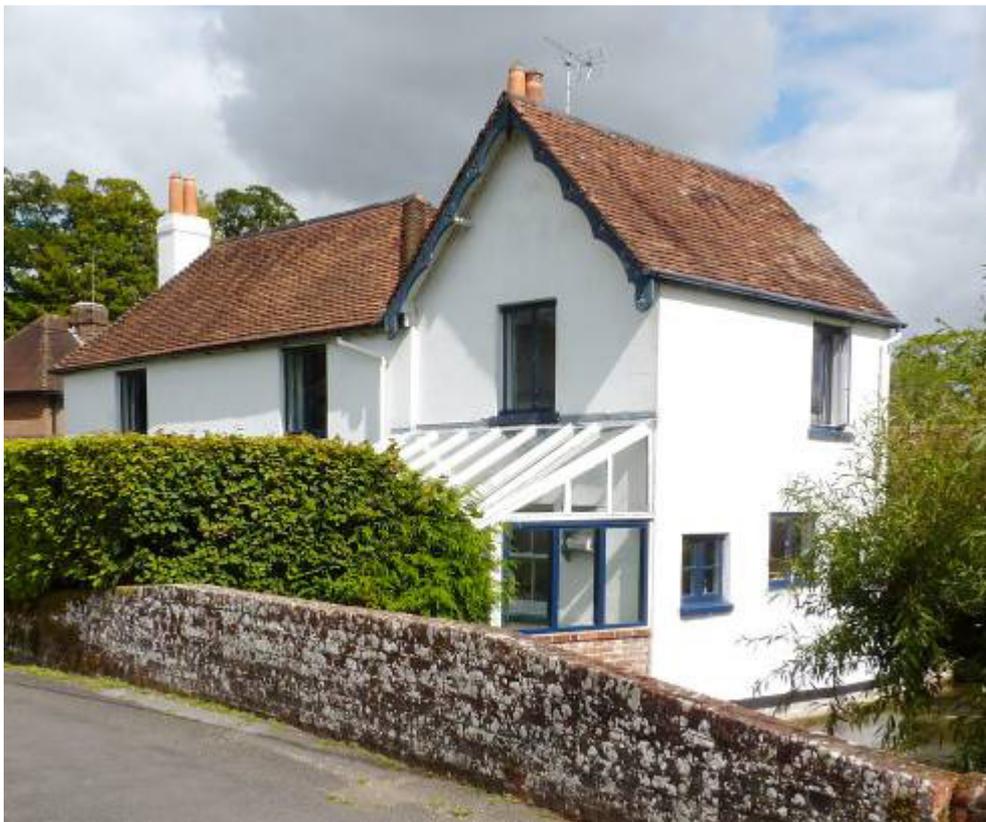
4.17 *The Shoe Inn* is a 1930s replacement of the original pub, which once stood on the opposite side of the road in the current beer garden. The building itself is quite traditional in form and materials and makes a positive contribution to the Conservation Area. However, the same cannot be said of the bare expanse of tarmac forming the car park around the pub. Some improvements to this area – a front boundary wall or some planting – would help to soften and mitigate this negative impact.

Figure 22: **The Shoe Inn**. The existing building replaced the original pub, which stood on the opposite side of the road, in the 1930s (or '50's?). The addition of a flint and brick boundary wall combined with planting within the car park would knit the site back into the village-scape and soften the visual impact of the tarmac.

5.2 There is little need or opportunity for works in the public realm. The character of the lanes and tracks is informal and this is a central component of character. One exception to this is the car park of the Shoe Inn, which is currently an open expanse of tarmac (figure 22). The addition of an attractive flint wall on the boundary with the road would help to knit the site back into the village scene and some well-judged planting would soften the impact of the hard surface

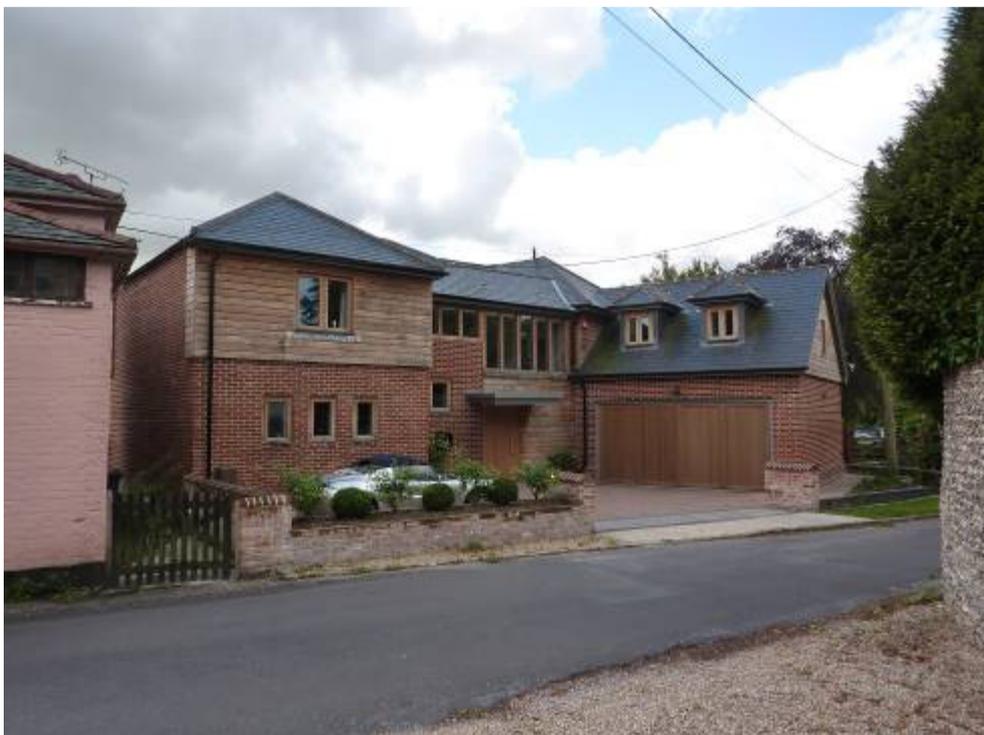
Figure 24: **Exton Cottage**

4.19 At the southern end of the village, grouped along Allen’s Farm Lane, is another cluster of buildings. *Exton Cottage* (figure 24) is a melange of different periods, predominantly 18th century in date but including assorted 19th century extensions and possibly an earlier core.

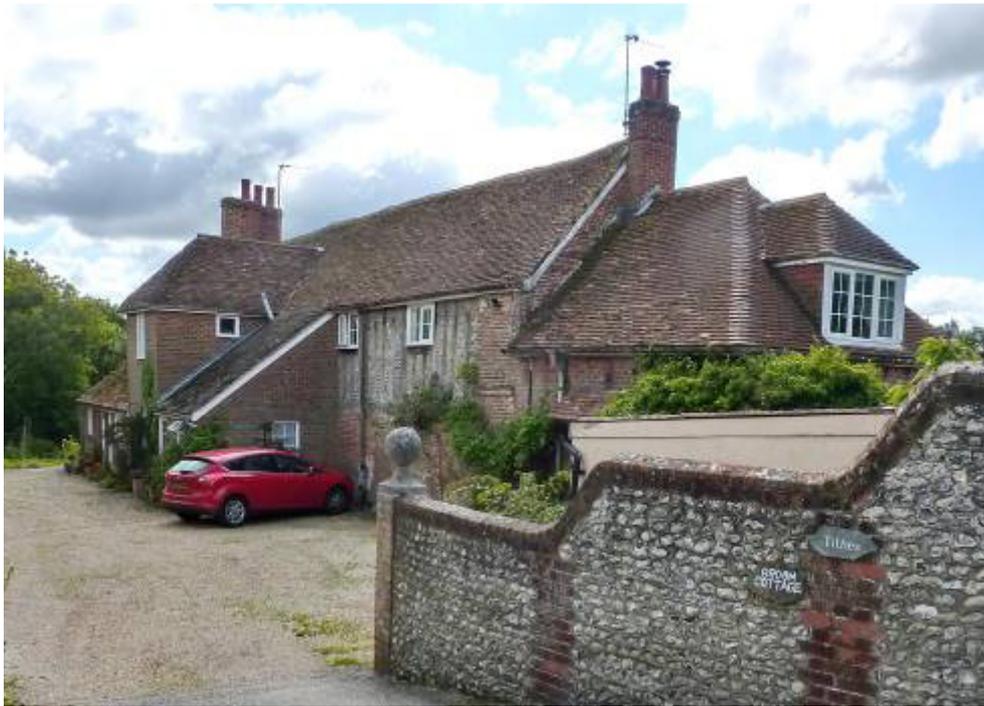
4.21 Other former farm buildings include *Broom Cottage* and *Tithes* (figure 26), formed out of a 17th century timber framed barn, and the buildings, currently derelict, standing opposite (figure 27). The latter has consent for conversion to residential use which should secure its repair and the continuation of its positive contribution to the character of the Conservation Area.

Figure 27: **Redundant farm buildings** on Allens Farm Lane. Planning permission has been granted for the conversion of this building into a dwelling and the implementation of that permission would secure and sustain the positive contribution made by these buildings to the character of the Conservation Area.

6.10 As reported in paragraph 5.4, the historic building stock in the village is generally in good condition but the important cob structure, *Sunrise* is vulnerable and requires monitoring. A saddle stone granary at Manor Farm is in poor condition and will require some repair if it is not to be lost. The condition of dilapidated farmbuildings opposite *Broom Cottage* and *Tithes* should be resolved by forthcoming residential conversion.

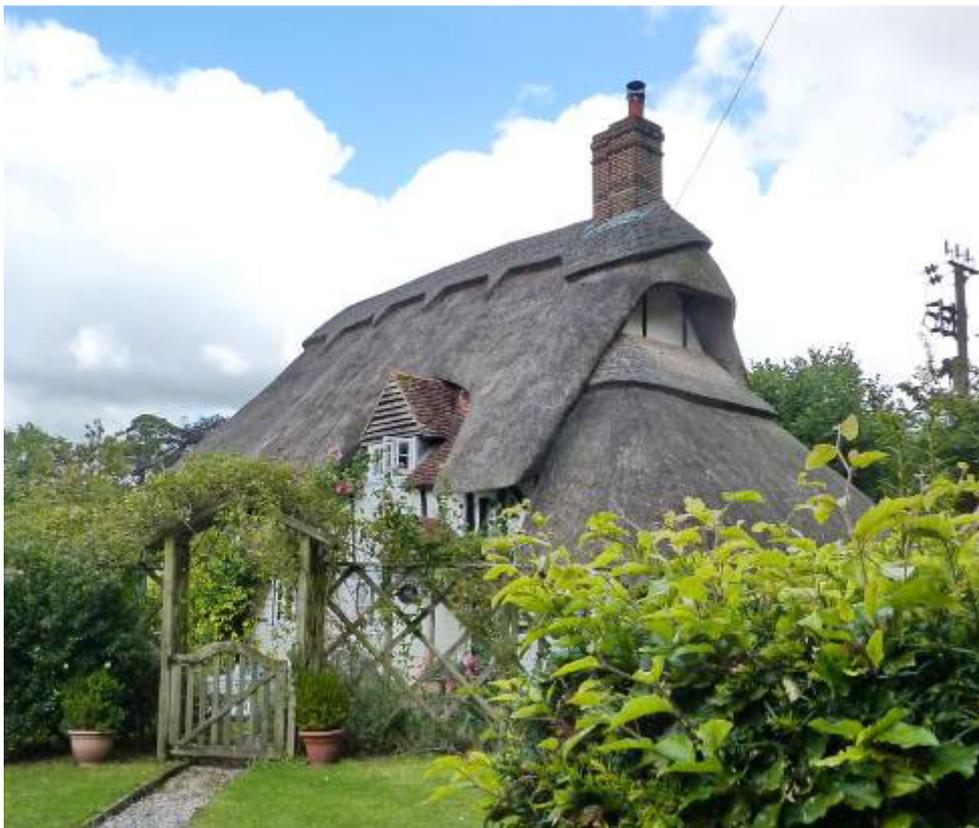
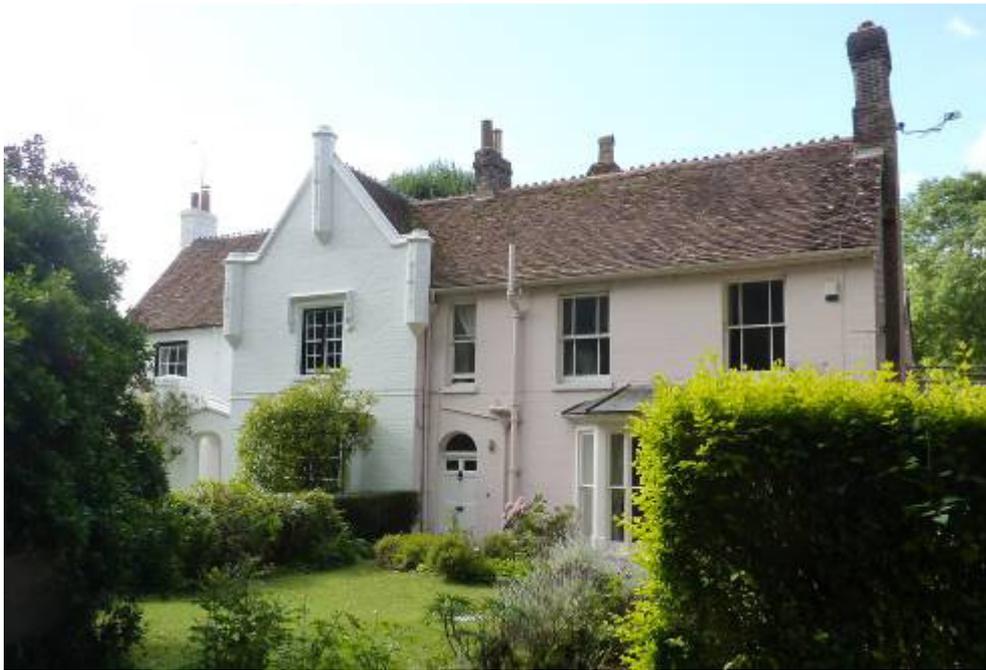
Figures 30 and 31: **The Rectory**, now divided into two dwellings known as The Old Rectory and The Old House.

(figure 29) a thatched cottage with 18th century timber-frame, *The Old Rectory* (figures 30 and 31) a late 18th century building given a gothic 'make-over' in the mid 19th century and *Exton House* (once known as Grove House) (figure 32).

House, divided into two dwellings. Late C18, with early and mid C19 changes and extensions. Painted brick walls in Flemish Garden Wall bond, later part unpainted, plinth, some cambered openings: Gothic stucco facade to part. Tile roof, small area of slate. The north front has two original window openings at the east side, then a Gothic projecting gabled feature with porch in the angle, the mid C19 westward extension of three windows partly masking the earlier regular facade and being forward of it. Two storeys and attic and two storeys, 2.1.3 windows. The Gothic section has hoodmoulds, a bold octagonal corner to the porch with oval chamfered arches, a ground-floor shallow bay with a hipped slate roof on brackets, chamfered reveals, and octagonal projections at the base and head of the gable. Sashes. Studded door. The western Victorian section has a plain arched door beneath a narrow window, a splayed bay to the ground-floor, sashes with narrow side-panes. The rear elevation is irregular, with a lower west side, of two storeys, 1.2.2 above 2.2.2 windows. Sashes, a tall staircase window, and some casements. Glazed doors.

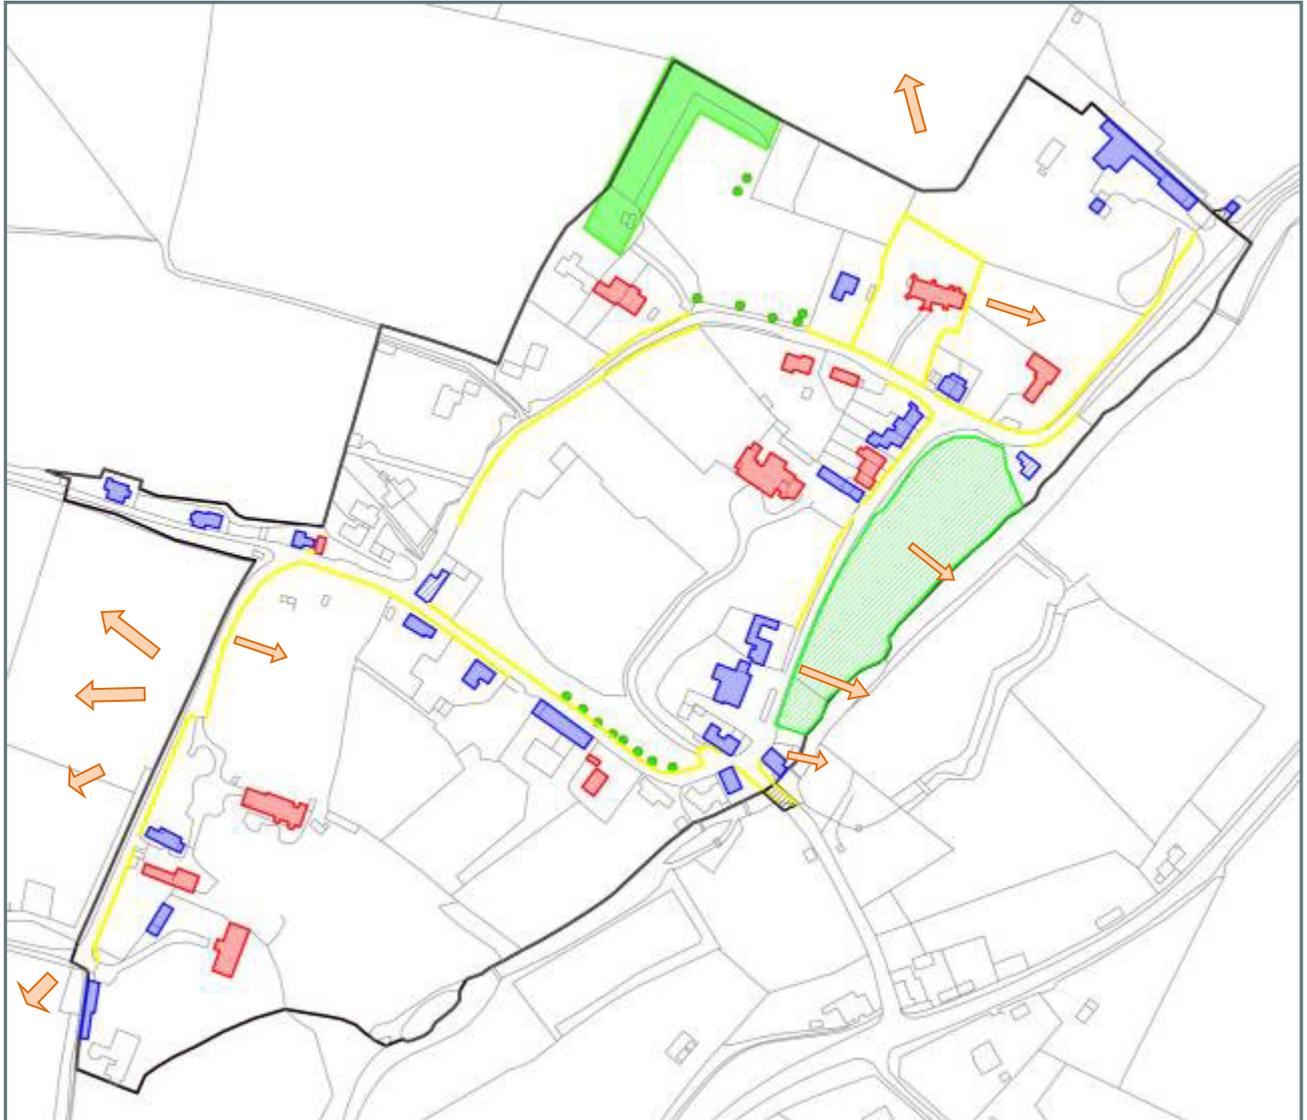
Figure 38: **Map** showing the elements which make a positive contribution to the character of the Conservation Area, including listed buildings (red), positive unlisted buildings (blue), significant boundaries (yellow), tree preservation orders (solid green areas and spots), important open areas (shaded green), and significant views (orange arrows). Buildings eligible for the Local List are shaded in pale blue.

The small extensions to bring the village pond and bridge within the Conservation Area boundary are shaded in black.

4.1 The elements which make a positive contribution to the character of the Conservation Area are mapped on Figure 38, to be found at the end of this document.

4.23 A number of unlisted buildings make a positive contribution to the Conservation Area and are identified in blue on Figure 38. *Corner Cottage* (figure 33) is probably worthy of inclusion on a Local List.

4.31 Trees are very important to the visual character of the village in many places. There are a number of tree preservation orders within the Conservation Area and these are shown on Figure 38.

ACTION 1 – that the Conservation Area boundary be amended to include the Village Pound and bridge, as shown on Figure 38.

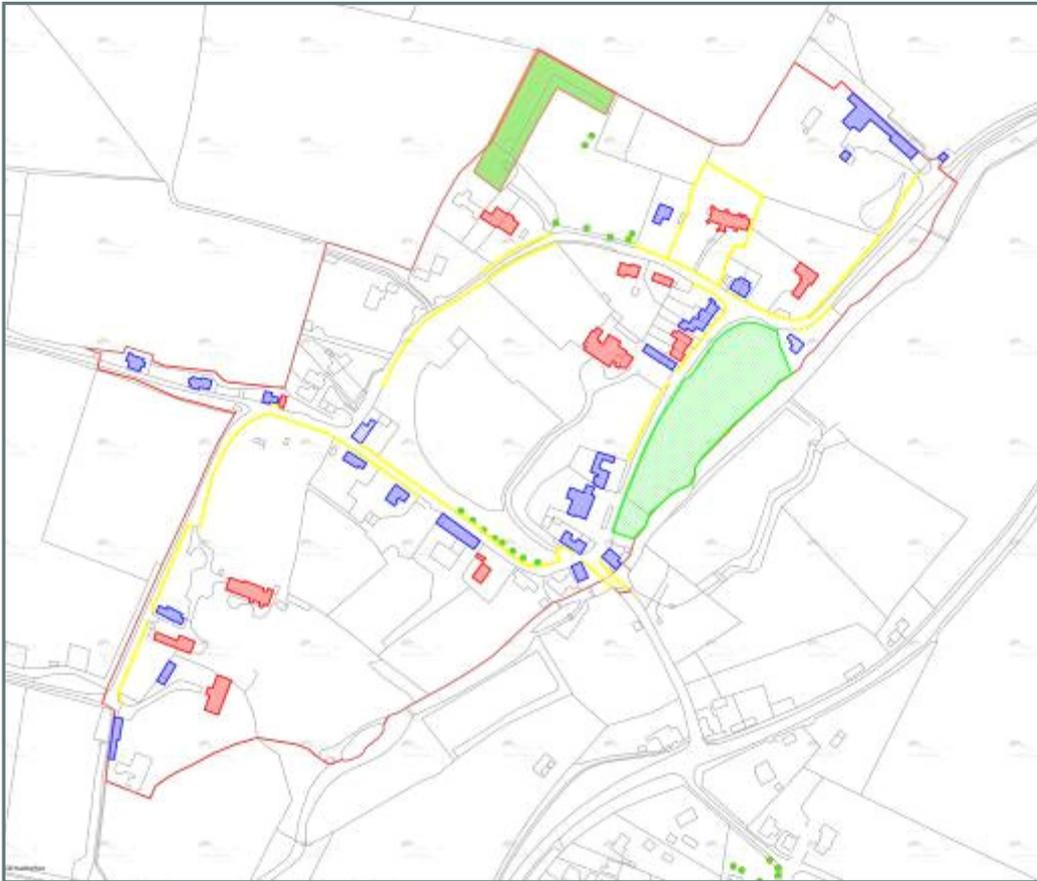
The extensions to the Conservation Area boundary were approved by the National Park's Planning Committee on 12 November 2015 and the revised map below shows the new boundary
