A Technical Assessment

Winchester
City Council

November 2001

HUNTON CONSERVATION AREA - A TECHNICAL ASSESSMENT

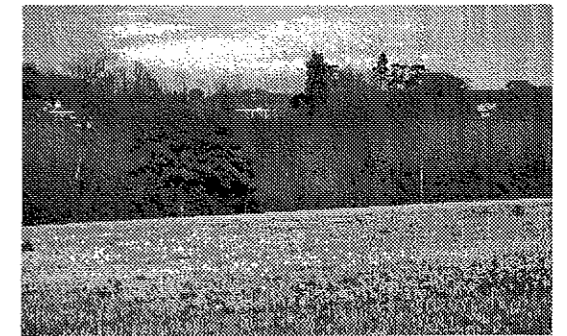
Photograph 1

- 2.3 From the Wonston to Stoke Charity road on the south side of the River Dever, views are possible northwards across the river valley. Because of the screen of trees along the river, the only buildings which are readily apparent within the conservation area are the Church set close to the river, Hunton Manor and a large building within its grounds housing the swimming pool (Photograph 1). Glimpses of the roofs of cottages along Hunton Lane and Hunton Down Lane are also possible.

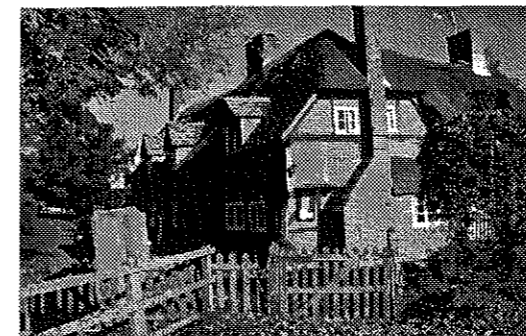
Photograph 2

- 4.2 The oldest domestic buildings within the hamlet are Nos 1 - 3 Hunton Down Lane (Photograph 2) and Nos 5 and 6 Hunton Down Lane. Dating from the 16th Century, both buildings are constructed from timber frames mainly with brick infill and thatched roofs. Nos 1 - 3 Hunton Down Lane was constructed in the early 16th Century in the form of a hall house and was extended in the 17th Century. Its timber frame is filled with brick and wattle and daub and the roof is tiled with a thatched ridge and thatch to the rear extension. Gabled dormer windows with slate tile hanging complete the range of materials. The building is jettied and supported by richly carved corner brackets at either end. The southern elevation facing Hunton Lane contains a Victorian post box set into the wall.

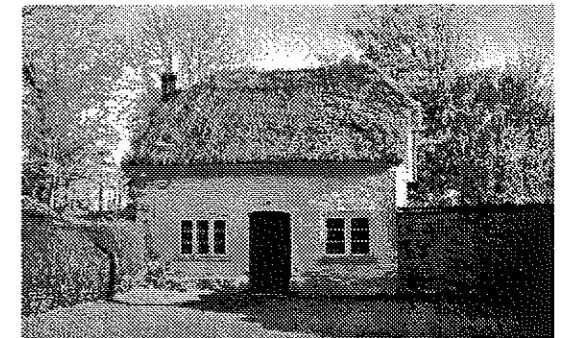
Photograph 3

- 4.3 Nos 5 to 6 Hunton Down Lane stands on the opposite side of the road. It has been dated to the 16th and 17th Century with 19th Century doors and windows. This is also a timber framed building with brick infill, a thatched roof and a number of eyebrow dormer windows. The central chimney stacks contain bread ovens with the rear elevation broken by three further chimneys.
- 4.4 A small square single storey 18th Century building set back from Hunton Down Lane served the hamlet as a school until 1903

(Photograph 3). It is constructed from brick with some timber framing in the gables, the building has a half hipped thatched roof. In front of the building stands a communal pump.

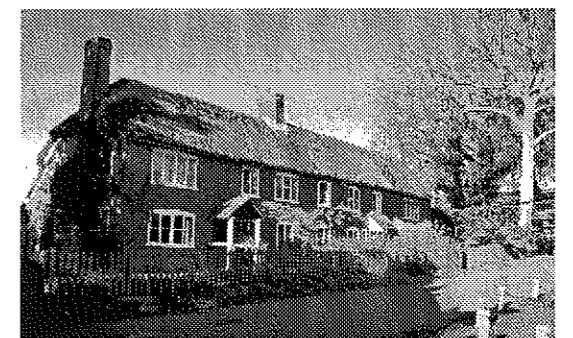
Photograph 4

- 4.5 Nos 7 and 8 Hunton Down Lane lie slightly to the north of this first group of buildings (Photograph 4). This two storey building was constructed in the 18th Century and extended at either end in the 19th Century. It has large casement windows and a half hipped thatched roof. Mainly of brick with a pebbledashed bay, it has a small tile hung thatched extension and a clay tiled cat-slide extension, both at the rear.

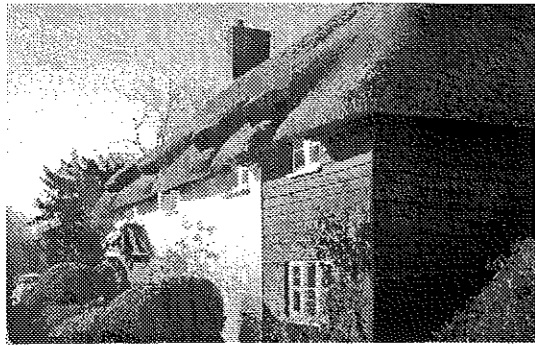
Photograph 5

- 4.6 Box Cottage, situated along Hunton Lane, sits isolated from the group of other Listed Buildings in Hunton Down Lane and dates from the 18th Century (Photograph 5). It is one and a half storeys and has a rendered cob exterior with a section of timber frame weatherboarding at its eastern end. The hipped roof is again thatched and broken by eyebrow dormers.

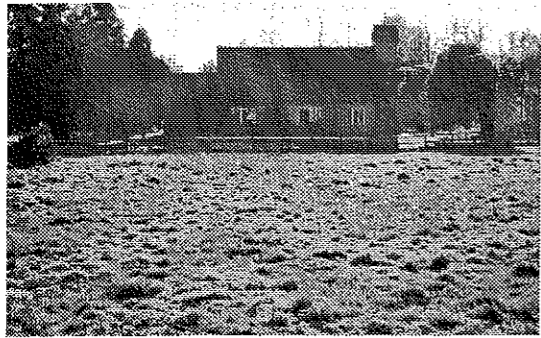
Photograph 6

- 4.7 St James Church has a 13th Century nave and chancel and a small squat tower (Photograph 6). The Church was rebuilt in the 18th Century and again in 1865. Constructed from rubble flint with stone and brick dressings, it has a clay tiled roof. Inside there is a 15th Century piscina and a mutilated 15th Century tomb set into the north wall of the nave.

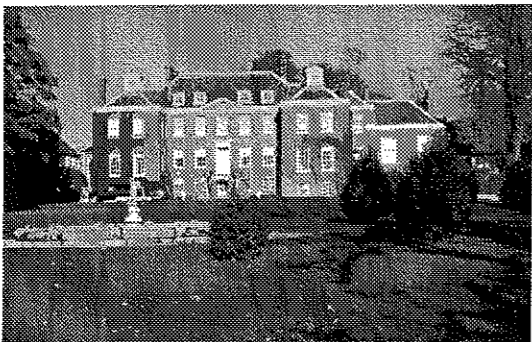
Photograph 7

- 4.8 The northern end of Hunton Down Lane is dominated by the form of Hunton Manor (Photograph 7). This Grade II* Listed Building is a country house dating from the 18th Century, with 20th Century additions. Constructed from red brick with a clay tiled roof it is thought to have been built in 1744. It is in the form of a five bay house with two wings either side and a ballroom on the eastern side. The northern elevation with its flanking wings has a more simple appearance.

- 4.9 The building is three and a half storeys on the southern side and two storeys on the northern side, and as a result the southern elevation can be seen across the valley. The two projecting wings were originally single storeys and were heightened to two storeys, probably in the 1930's and topped with false lanterns which form a prominent feature of the building. The doorway on this elevation and the stairway were reinstated in the 20th Century.

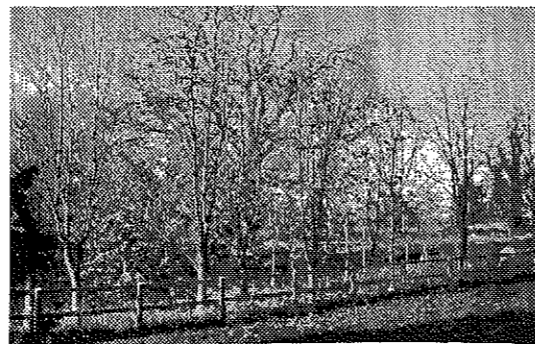
Photograph 9

- 4.11 Hunton Down House is a two storey neo-Georgian property constructed from brick with clay tiles and built in the late 1950s on the site of a previous manor house. To the rear within the garden and not visible from public view points stands an early 16th Century dovecote (Photograph 9). Constructed from flint rubble with stone dressing, it has a pyramidal clay tile roof with a wooden ventilation box at its apex.

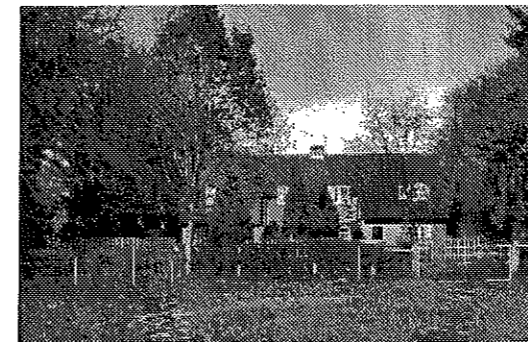
Photograph 10

- 4.14 A second group of 20th Century buildings also provide a degree of uniformity in terms of scale and use of materials which are predominantly of brick with clay tiled roofs. Hunton Down House and New Cottages both make an attractive contribution to the buildings within the hamlet (Photograph 10).

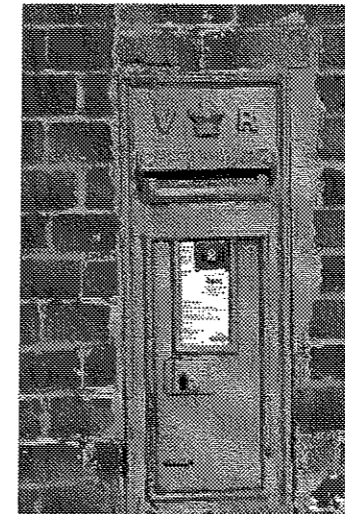
Photograph 11

5.2 Set within the southern elevation of Nos 1 - 3 Hunton Down Lane, a Victorian Post Box (Photograph 11) adds a splash of colour to the brick and timber frame of the building as well as serving an important and functional purpose.

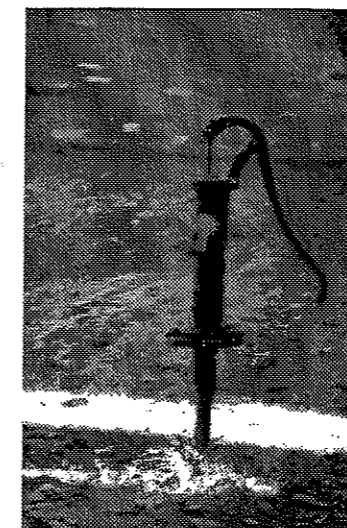
Photograph 12

To the north of the building and in front of the Old School House, a pump which must have provided water for the community is positioned (Photograph 12). The location of these two features emphasises the junction of Hunton Down Lane and Hunton Lane as being the centre of the settlement.

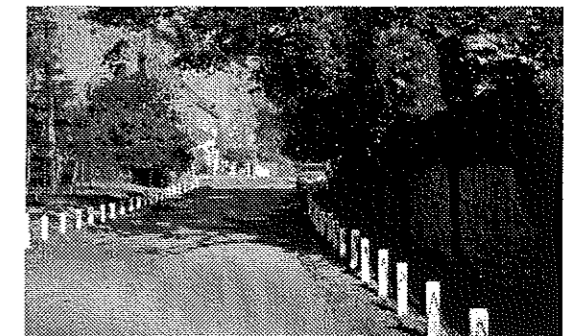
Photograph 13

5.4 Hunton Down Lane, in which the majority of dwellings are situated, has the greatest variety of boundary treatments (Photograph 13). Low chain and timber post fences demarcate the grass verges, wooden paling fencing line the front of the cottages, post and rail fencing mark open areas and a red brick wall, varying in height from between two and three metres stretches along the boundary of Hunton Manor. This mix of domestic and more functional boundaries reinforce the sense of being within a rural settlement.

picket fence fronting the boundary to Nos 5 - 6 Hunton Down Lane continues along the front boundary to Nos 7 - 8 Hunton Down Lane. The long form of this building bounds the lane and is matched by the enclosing effect of the boundary hedge and wall of Hunton Manor. To its north a large Sycamore dominates the street scene before views to the west become open again. However, a row of saplings planted between Nos 7 - 8 Hunton Down Lane and the stable complex have the potential to enclose this space in years to come. The grass verge along both sides of much of the lane allows for the inclusion of low post and chain fencing (Photograph 13) creating a manicured appearance to the lane.

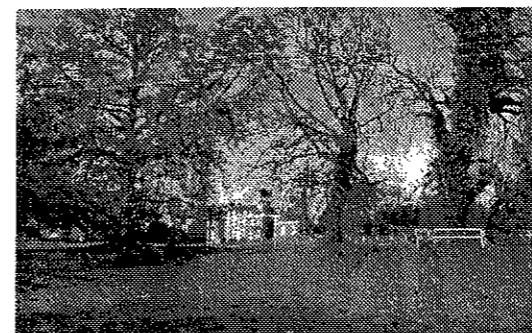
Photograph 14

- 6.2 There are a number of individual trees within the parkland to the south east of Hunton Manor (No.1 on map 5). The majority are deciduous although there are a number of evergreen specimens (Photograph 14). These trees are generally mature and are set in undulating grassed parkland interspersed by full scale horse jumps. New planting has been concentrated in areas to the north east and east of this area and is a mix of deciduous and coniferous species (2 on map 5). Belts of coniferous trees have been planted to the north of the pool house and to the north west and south east of the green house and when established will form dense screens around these buildings. To the east, a boundary of mixed deciduous trees mark the edge of the conservation area and screen views into and out of the conservation area (3).

- 7.5 Moving eastwards views of both Hunton Manor (Photograph 14) and the river begin to compete for attention. The view to the north east is through post and rail fencing across undulating parkland in which mature trees are randomly spaced (Photograph 24). This typical setting for a country house such as Hunton Manor is disfigured somewhat by the numerous horse jumps placed around the parkland. At this point, the river flows very close to the road with the water at almost the same level as the lane separated only by a grass verge. This creates an unusual sense of closeness to the water. The trees on the far bank enclose the majority of views and deflect attention onto the river itself.

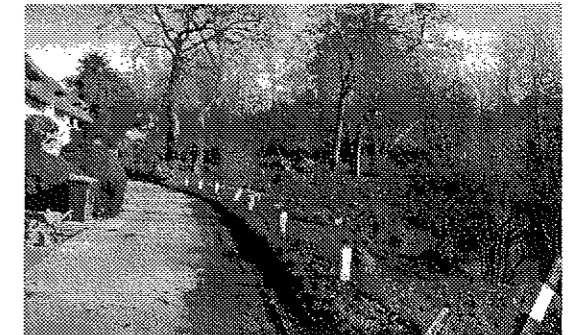
Photograph 15

- 6.3 A small area, south of Box Cottage along Hunton Lane but north of the river, is covered by a group of small deciduous trees within a grassed setting adjacent to the river (4) (Photograph 15). This area links visually to the general screen of trees growing on the south bank of the river. These trees south of the river form a significant area of general coverage of mixed native species (5). They are an important visual barrier, screening Hunton from other settlements such as Stoke

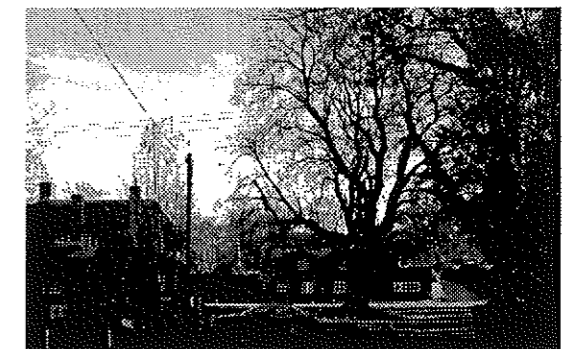
Photograph 16

- 6.4 A single Ash west of the footbridge over the river, marks the start of a thick evergreen hedge running to the entrance of the churchyard (6). To the west of the churchyard gate, a group of mature native mixed deciduous trees stretch along Hunton Lane as far as 2 New Cottages creating a thick and impenetrable screen (7). This tree group contrasts with the mature Horse Chestnut which stands at the centre of a tiny green and in summer completely overshadows the area (8) (Photograph 16).

- 7.14 Views from the west towards the Church are partially screened by the new planting which in time will completely obscure them. Views to the Church then become more intermittent and the row of trees becomes denser and attention is instead channelled downhill towards the timber framed buildings and trees set around the tiny green (Photograph 16).

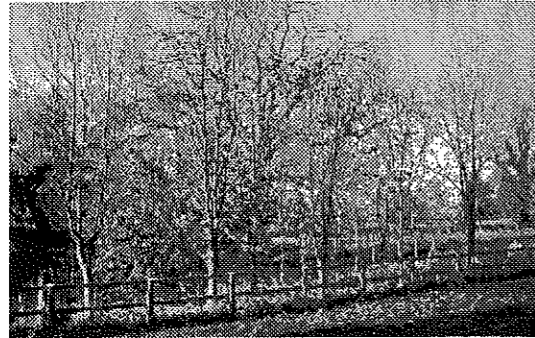
Photograph 17

- 6.5 The trees within the confines of St James Church and several close by within the surrounding field comprise of several species of mainly evergreen trees (9). The Yew to the north west of the Church is in decline and in need of some management work. Within the field surrounding the Church there are a number of mature trees, these have been recently supplemented by a substantial

amount of new planting, linking existing mature trees and extending west of the Church across much of the field (10) (Photograph 17). In time these trees will form a significant feature. A double line of new planting also lines the northern bank of the River Dever.

- 7.11 Despite the open nature of the site there are only short views from the Church to the south. The river is not visible but its position can be determined by the line of new planting on the north bank. The low line of the valley ridge opposite confirms the valley setting. Views to the east of the river as it bends round to pass the Church are marred by the line of chain link fencing protecting the ducks and geese in the area beyond but disrupting the visual continuity of the river landscape. To the west of the Church, avenues of new tree planting are well established incorporating some more mature specimens within the planted area (Photograph 17).

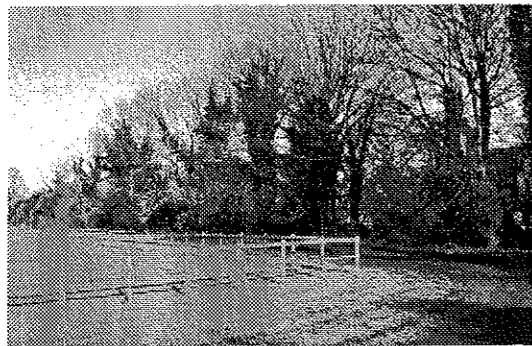
Photograph 18

- 6.6 The field hedge (11) to the north of the Church lining the south side of Hunton Lane stretches as far as the western entrance to the conservation area. The hedge lies adjacent to the grass verge, behind this, broken by one mature Ash, there is a row of approximately 20 saplings planted at regular intervals along the boundary. These trees already provide an attractive feature at the western edge of the conservation area and will continue to do so as they grow to maturity. The end of this row of planting is marked by a single Sycamore standing in isolation at a bend on the northern side of the lane (12). Looking west into the conservation area, a row of mixed deciduous trees screens views across to Hunton Down Lane and the western boundary to the conservation area (13) (Photograph 18).

- 7.13 Approaching the hamlet from the west, a tree belt to the north of Hunton Lane effectively screens the buildings within the conservation area (Photograph 18). However, between New Cottages and the Hunton Down Lane junction, open post and rail fencing again allows views to be gained to the north east over rising ground (Photograph 26). The foreground comprises of rough pasture, along with a horse menage surrounded by post and rail fencing. To the east the farm buildings and stable complex of Hunton Horses, the Manor House and Hunton Down House can be viewed.

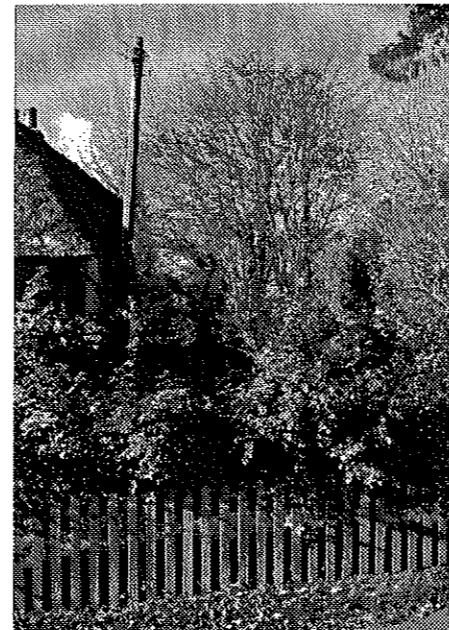
Photograph 20

hedges opposite in the gardens of Nos 5 and 6 Hunton Down Lane and the group of trees (15) south of Nos 7 and 8 Hunton Down Lane. In addition the evergreen tree south of the entrance gate to Hunton Manor and the hedge to the north of the gate also provide all year round colour and variety within the area (16). To the north of Nos 5 and 6 Hunton Down Lane, slightly to the rear of the property, there is a group of Beech and Sycamore forming a pleasant arrangement of trees (17) (Photograph 20).

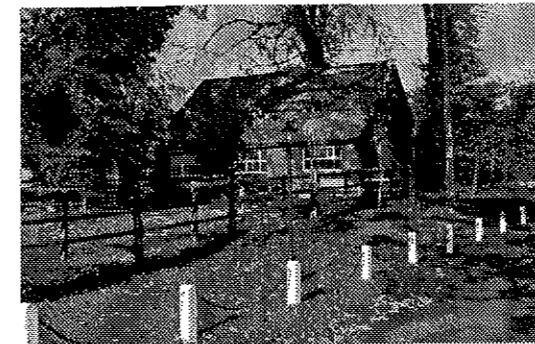
Photograph 22

- 6.8 One of the focal points of the lane is the magnificent Sycamore tree (Photograph 21) just to the north of Nos 7 and 8 Hunton Down Lane which dominates views up and down the lane (18). An area of new planting (Photograph 22) has been established immediately to the north in a line adjacent to Hunton Lane, linking these new trees with the large Sycamore as well as to the group of Beech and Sycamore and smaller holly close to the stable complex. The new planting is destined eventually to replace the older specimens.

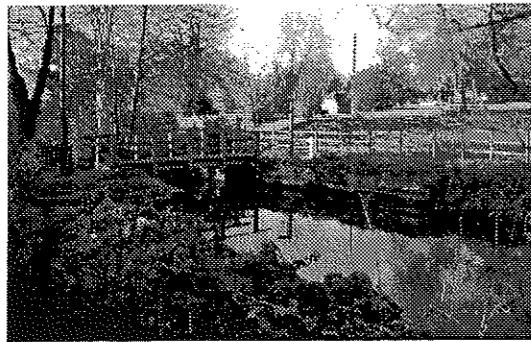
Photograph 25

- 7.8 Views to the north west now comprise of the group of cottages located on Hunton Down Lane (Photograph 25). The dominant form of Hunton Manor can be seen in conjunction with these cottages reducing their impact to a subservient role yet creating an attractive grouping of buildings within a rural setting. The cottages are partially hidden by the undulating foreground, making the thatched roofs of the lower group of cottages the most striking feature with the soft lines and irregular, rambling forms of the buildings adding to their charm.

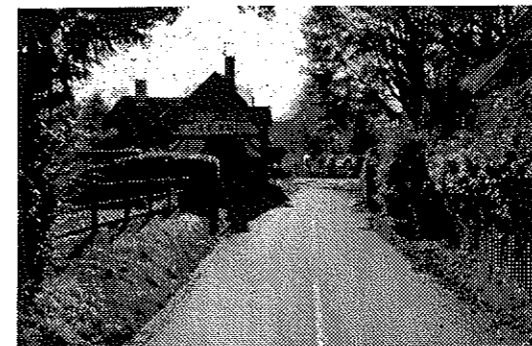
Photograph 27

- 7.15 From the bottom of Hunton Down Lane looking north, Nos 1 - 3 Hunton Down Lane and Nos 5 - 6 are set slightly back from the lane, framing and balancing the view and channelling it northwards. Beyond Nos 1 - 3 Hunton Down Lane, and hidden initially, is the Old School House with a communal pump set slightly in front within a grassed area. Evergreen vegetation dominates at this point providing all year round colour with large deciduous trees forming the background. The southern elevation of Hunton Manor further up the lane invites further investigation, while looking southwards the focal point is the open land adjacent to the river (Photograph 27).
