*- A Technical Assessment*

**Winchester**  
City Council

*April 1997*

**HURSLEY CONSERVATION AREA - A TECHNICAL ASSESSMENT**

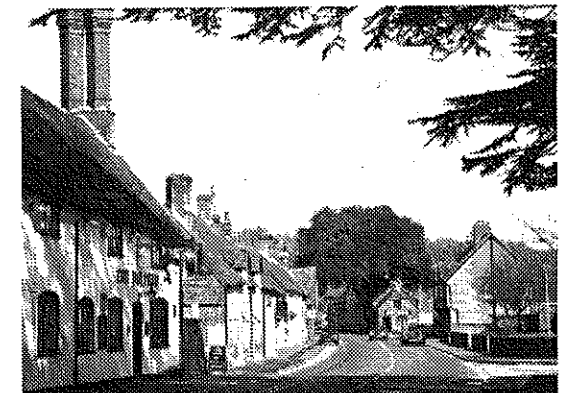
Photograph 2

constructed or encased in brick with red plain clay tile roofs, casement windows and solid or panel doors. Several of these buildings; 79 Hursley, the Dolphin Inn and 31 Hursley, have been rendered or colourwashed.

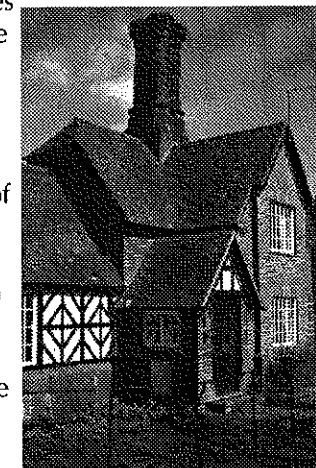
Photograph 3

7.2 Church Lodge (Photograph 3) stands at one of the entrances to Hursley Park, to the west of the Church at the centre of the village, and incorporates several of the features that makes Hursley distinct. It is an attractive one and a half storey building with decorative gabled ends and is constructed mainly from red brick and clay tiles with a mock timber frame extension. It has the distinct moulded brick chimney stacks found on a number of other buildings within Hursley. The building can be seen across the recreation ground from the A3090 with the chimneys and roof line being particularly visible against the back drop of trees which denote the Park Pale. The detailing on this building reflects that which is found on some of the Listed Buildings within the Conservation Area and, therefore, contributes to the continuity of features on historic buildings within the village.

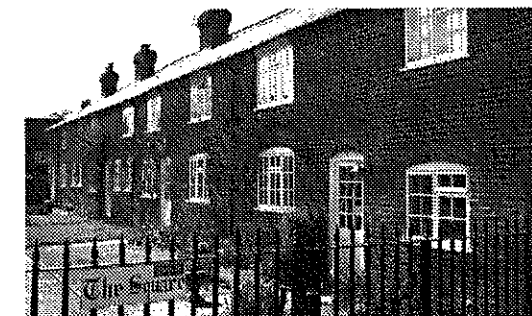
Photograph 4

7.3 The Square (Photograph 4) is formed by two terraces of houses set parallel to one another

with an informal courtyard of gardens linking the two. It is situated to the rear of the properties lining the A3090 with access from Collins Lane. Formerly the Hursley Union Workhouse, the buildings were substantially altered and renovated in the early 1980's to provide residential accommodation. The red brick walls and slate tiles of the buildings, along with their massing, allow the two terraces to fit comfortably among the surrounding Listed Buildings.

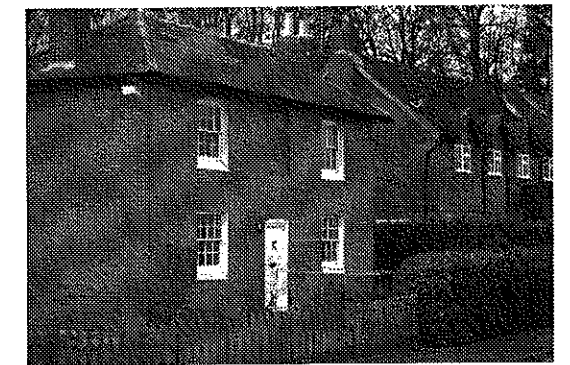
Photograph 5

7.4 21 Hursley (Photograph 5) lies at the northern end of the Conservation Area, adjacent to the A3090 and is one of the last buildings visible on exiting the area.

It is a simple late 18th Century two storey detached cottage constructed from red brick and slates and on account of its location, acts as a reminder of the buildings within the heart of the Conservation Area.

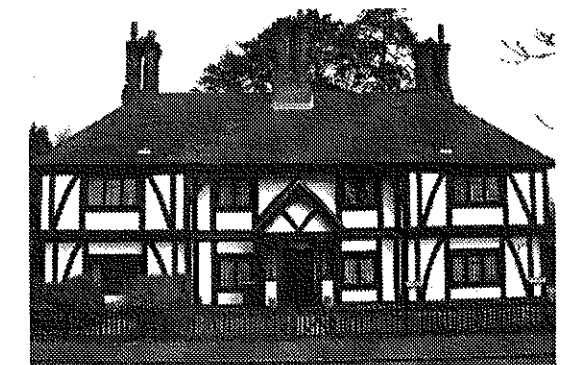
Photograph 6

7.5 Three late Victorian Cottages, Tudor Cottages (Photograph 6) and 33-34 Hursley (Photograph 7) lie to the eastern side of the A3090 and are all unlisted. Tudor Cottages

appears as one building but is in fact three cottages and is constructed in a mock Wealden style with leaded windows and moulded brick chimney stacks. The black timber and white render of this building and its tall chimneys makes it a distinctive building within the street scene and the detailing on it is repeated in other buildings within the Conservation Area. Nos 33 and 34 Hursley are a modest pair of cottages and incorporate many of the details found in Hursley within their design. The timber frame at second floor level compliments that of Tudor Cottages.

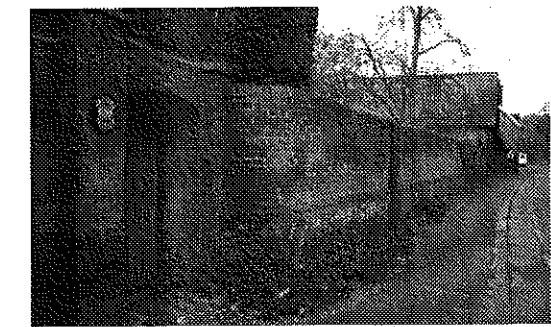
Photograph 10

- 9.3 There are a number of boundary walls throughout the Conservation Area which provide a strong visual link and enclosure to

the street. These tend to be either red brick, or flint walls and should be retained.

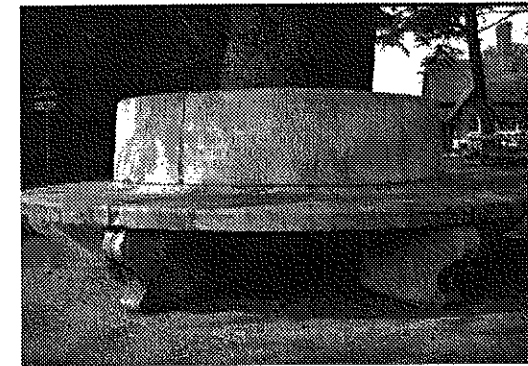
Photograph 11

- 9.6 In October 1914, Hursley Park provided the Divisional Headquarters for the 8th Division. On 4th and 5th November 1914, the Division marched from Hursley Park, through Southampton Lodge Gate at the south of the estate and on to Southampton Docks for embarkation to France. A stone seat around the base of a Cedar tree was erected by Sir George Cooper to commemorate this significant event (Photograph 11). It is prominently located on a small triangular area of grass at the junction of the A3090/Poles Lane.

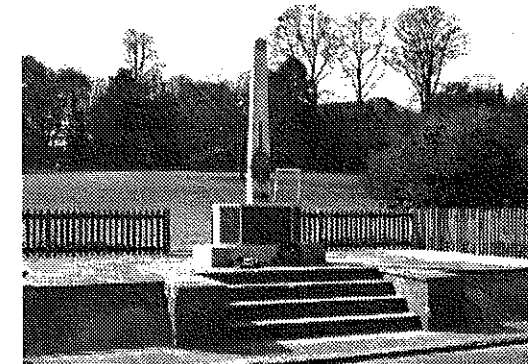
Photograph 12

- 9.7 An obelisk with brass plaques on a stone platform comprises the war memorial, (Photograph 12) which is located on the eastern boundary of the recreation ground, opposite No 36 (see Map 7).

- 12.7 The war memorial to the north of the village, requires some minor repairs and establishment of a maintenance programme to ensure that it remains in good condition.

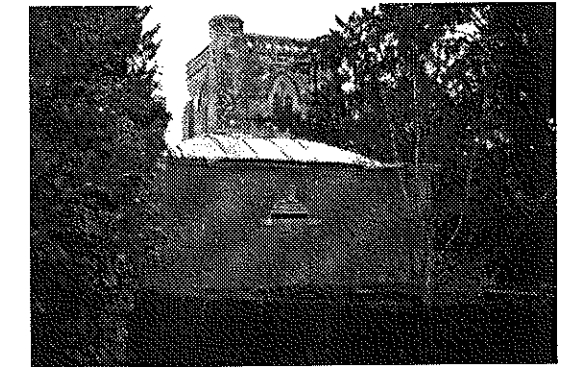
Photograph 13

Century (see Map 7). It was erected for the Heathcote family and was built by the first Sir Thomas Heathcote who inherited the estate when Sir William Heathcote died. It is constructed of brick and the lunette window includes an inscription to John Keble 1866.

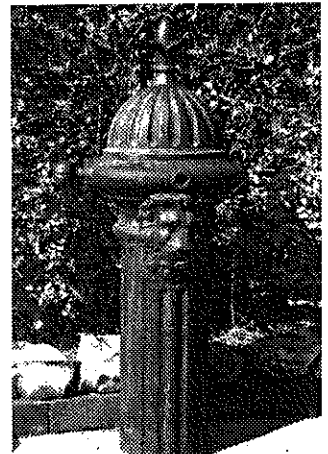
Photograph 14

It was once fed from a 180ft well and tank on high ground, north east of Cromwell House. It is noted in Hampshire County Council's Publication "Hampshire Treasures" and is worthy of retention as a feature of interest within the Hursley Conservation Area (see Map 7). A similar conduit at Northend was removed in the early 1960's.

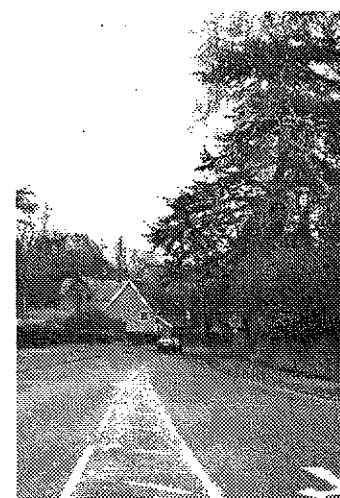
*Photograph 17*

- Flint wall in the southern part of the Conservation Area. This once formed the western boundary to the grounds of the former South End House, now occupied by a 1970's housing development. The wall is a strong visual feature and an 'entrance' to the village (Photograph 17).

the continuous boundary flint wall of the South End Close. When approached from the south, it is the height, density and variety of parkland species achieved by this group which denotes their importance within the street scene (Photograph 17). Approached from the

- A small group of trees comprising Holly, Sycamore and Hornbeam in front of the southern gable end of the Masonic Hall. This group, together with the trees opposite at South End Close, provide an important feature at a focal point of the southern part of the Conservation Area (Photograph 17).
- Cedar tree at the southern boundary of the Conservation Area. This is a very prominent tree at an important road junction. It is particularly significant when approached from Poles Lane, or from the main road when leaving the village. A commemorative seat is located around the base of this tree.

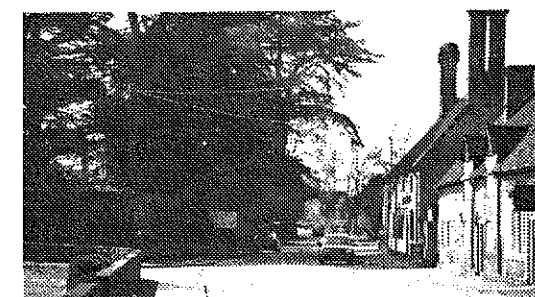
*Photograph 18*

north, it is the mature, distinctive form of the Cedars, opposite the Dolphin Inn and Meredun Close, which dominate this focal point of the Conservation Area (Photograph 18). As the main road bends to the right, the increased tree coverage emphasises the change in character, from the built-up part of the village to an area of lower density as one begins to leave the settlement.

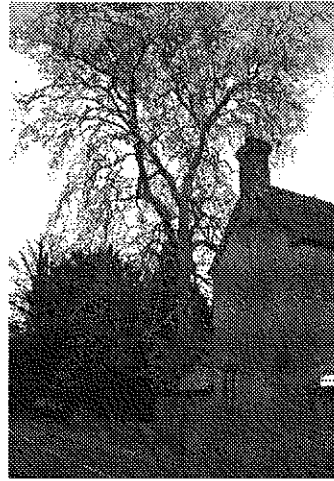
Photograph 19

- Mature Plane at the entrance to Cromwell House. This is a very prominent feature within the street scene, particularly when approached from the south (Photograph 19).

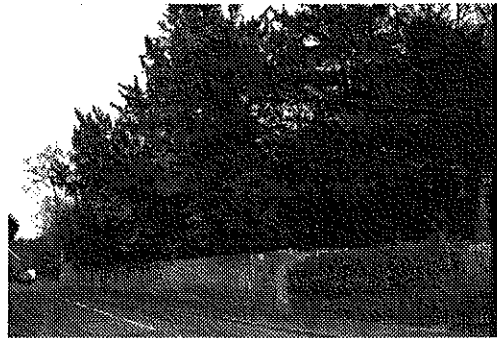
Photograph 20

- Group of predominantly Yew trees behind the long red brick garden wall of Cromwell House. The trees, together with the wall, provide a dominant feature within this part of the Conservation Area (Photograph 20). They also provide a wooded setting to the unlisted, but distinctive, properties known as Tudor Cottages.

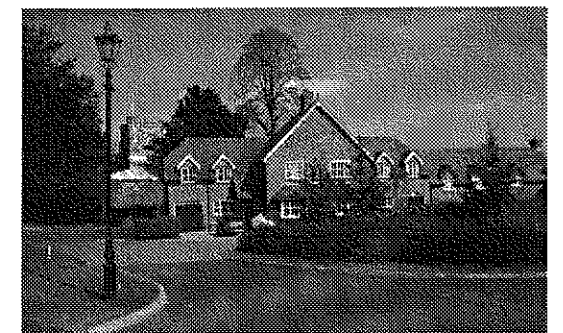
Photograph 23

- 11.6 Meredun Close, a 20th Century development, on the former nursery site and part of the Vicarage grounds, rises north westward. It is situated behind the houses fronting the main road, bounded on the west by the mature trees of Park Pale and thus the Conservation Area boundary. Initially the private spaces are defined by well detailed high brick walls set hard up against the pavement edge creating a pinch point adjacent 100 and 101 Hursley. Beyond this the public space broadens out with open plan front gardens. The space nevertheless, is well contained through the enclosure provided by the buildings and strategically placed maturing landscape. This space is complemented by views through to the Church tower and Mausoleum to the north. From Meredun Close a narrow treed footpath runs north between the Mausoleum and Church to the east and the Vicarage to the west. This well used confined narrow space provides an important footpath link from IBM's headquarters in Hursley House to the southern part of the village (Photograph 23).

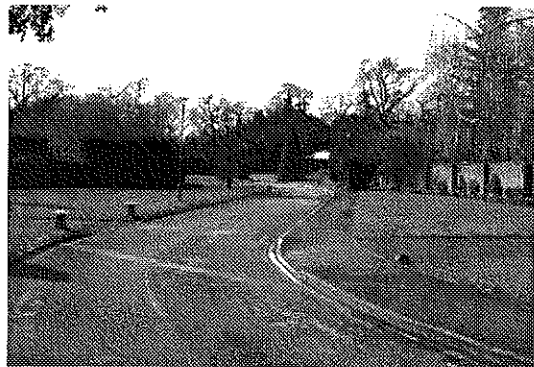
Photograph 24

11.7 South End Close runs east and south from the main road and provides an altogether different and totally separate spatial feel from the rest of Hursley. Originally the grounds of Southend House, a large building in a parkland setting, now demolished, its present landscape layout reflects its former image (Photograph 24). With its well defined boundary of mature trees on all sides and high brick or flint walls to the west and north, its low density, large houses in individual large plots, open grassed frontages, provide a tranquil, albeit private, space with only the noise of the traffic intruding. This area is entirely contained, providing a strong sense of enclosure. Through the boundary trees the countryside beyond can be seen to the south.

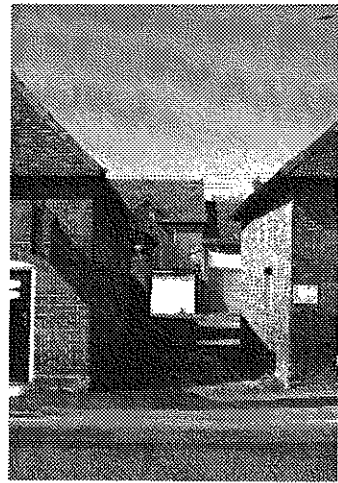
Photograph 25

11.10 The public space of the highway is clearly defined by the buildings, with occasional important glimpses through to the west to the new development of Meredun Close and Park Pale beyond (Photograph 25). To the east farmland directly abuts the edge of the Conservation Area boundary at Pelican Court

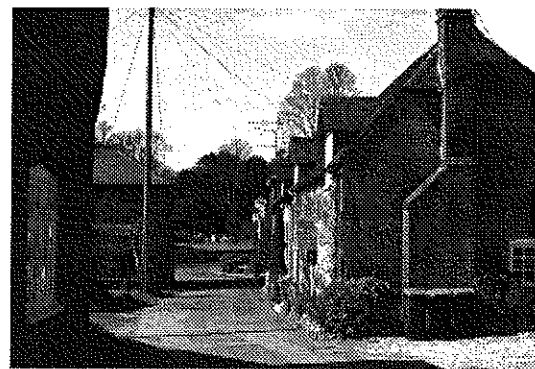
Photograph 26

important viewpoint, down the narrow lane, across to the flint wall of the churchyard and the mature trees beyond (Photograph 26). Looking out of the Conservation Area at this point eastward, the trees and hedgerow either side form an arch at the brow of the hill.

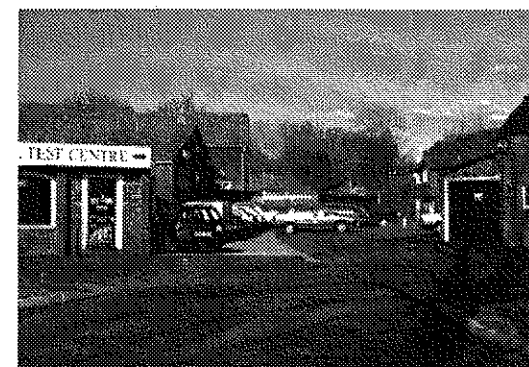
Photograph 27

11.16 The Conservation Area includes the lower part of Port Lane. It commences as a narrow street without pavements, the 1.8 metre brick wall of the public house to the west and one and a half storey cottages to the east. There are important views of the rising land and

trees beyond. The street scene deteriorates where the unfenced tarmac of Hursley Garage "leaks" into Port Lane and the A3090. The private space of the garage forecourt when viewed westward from Port Lane towards the Church relates poorly to the Lane and to the main road, having access and being visible from both. This area presents a visually disruptive gap to both Port Lane and the A3090 (Photograph 27).

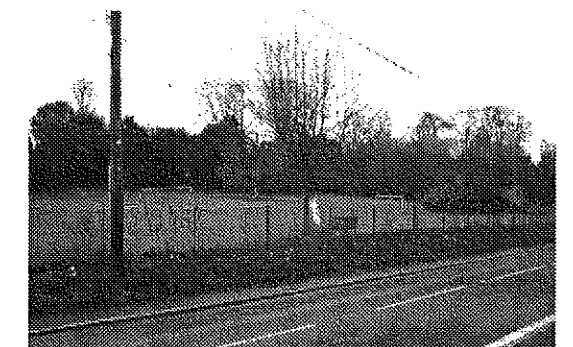
Photograph 28

recreation ground boundary fronting the main road consists of chainlink fence on top of a grass bank (Photograph 28). Although an attempt has been made to add vegetation inside the fence the inappropriateness of the boundary treatment is unfortunate. The space provided by the recreation ground is important not only in itself for use as an open communal space but also as a visual open area for the houses opposite and the passerby. The space is well contained on three sides by mature trees but presents a weak boundary to the road frontage.

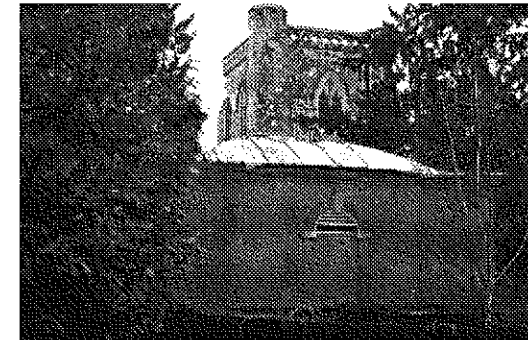
Photograph 29

- 12.6 The original lead roof of the mausoleum has failed. Some interim measures have been taken to provide temporary support and patch repairs with the aid of Hampshire Building Preservation Trust, City and County

Councils. Further finance and a long term strategy is needed in order to secure its future and prevent further deterioration. (Photograph 29)

- 13.8 • Restoration at the Mausoleum.
- Repairs and maintenance to the War Memorial and its setting.
- Appropriate tree management/new planting and general landscaping.
- Volume and Speed of Traffic.
- Undergrounding of overhead wires and cables.

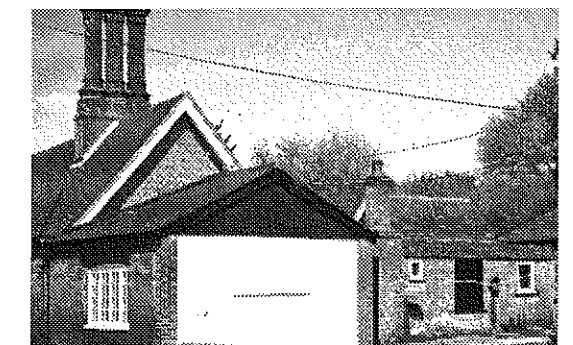
Photograph 31

- 12.11 Within various parts of Hursley, groups of overhead wires constitute aerial clutter, detracting from views within the street scene, features of architectural interest, trees and spaces. Where possible, the undergrounding of cables should be pursued to result in an enhancement of the street scene.
