# *Itchen* *Stoke*

*CONSERVATION AREA*

*- A Technical Assessment*

**Winchester**  
City Council

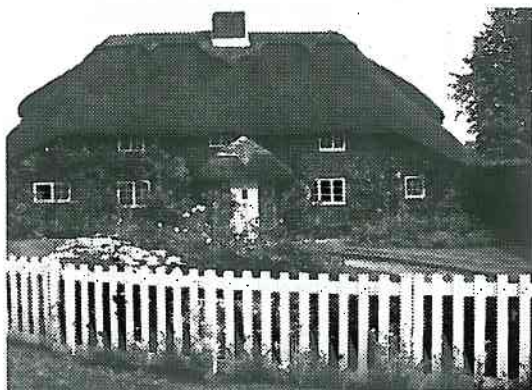
*Photograph 1*

- 4.5 140 Rivers Keep (Listed) was once occupied by the River Keeper (Photograph 1). A very

prominent property within the street scene with a high degree of symmetry. The detail of the ridge piece is reflected in the thatch detail of the hipped porch which is a 20th Century addition.

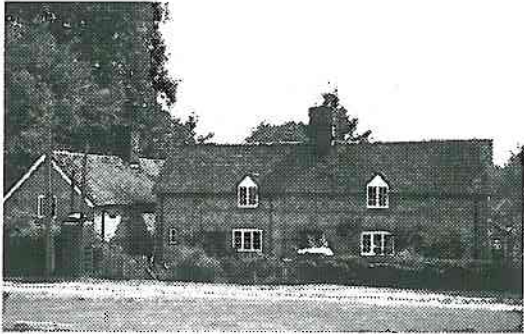
*Photograph 3*

- 4.8 The 19th Century properties are scattered throughout the village but in particular, tend to be grouped around the church and the 'green'. Materials show a significant move away from the thatched cottages of earlier periods. A much greater use of flint, and gabled roofs of plain clay tiles prevail.
- 4.9 Located to the south of the green and along Water Lane, the two pairs of cottages comprising 153-156 (Listed) are typical of this period (Photograph 3). Constructed of flint with brick dressings, these one and a

half storey cottages have gabled plain tiled roofs with simple patterned bargeboards. The roofscape incorporates a central brick ridge stack and small gabled dormers with 2-light, 6-pane casements which are set across the eaves. At ground floor level the windows are 3-light, 6-pane casements and these, together with the central solid wooden doors, have cambered brick arches.

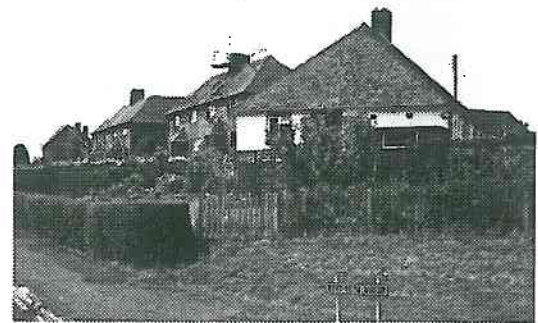
*Photograph 5*

4.14 The area served by the Itchen View cul-de-sac has a distinctive 20th Century feel which is very different to the older core of the conservation area. Built as Local Authority housing, Itchen View comprises a number of semi-detached, two storey houses and one storey bungalows (Photograph 5). The houses are mostly constructed of brown brick, hipped plain brown tiled roofs, central stacks, hipped tiled and brick porches, brown casement windows and modern wooden panel doors.

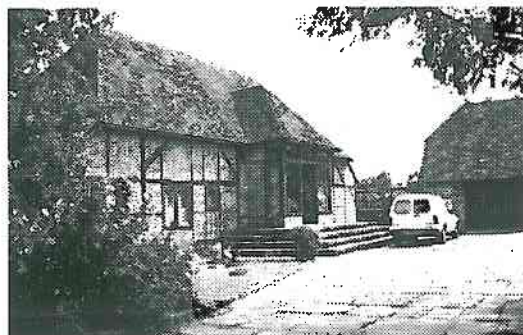
*Photograph 8*

- 4.18 Giles Barn, once a barn as the name suggests, was converted to residential use in the 1980's (Photograph 8). It comprises a single storey timber framed building with brick infill and a hipped tiled roof. The garage has flint and brick walls with a half-hipped tiled roof. A flint and brick boundary wall abuts the public footpath which leads to the river. Framed by Silver Birch, Ash and Eucalyptus trees, Giles Barn provides

interesting built features at the end of this rural lane.

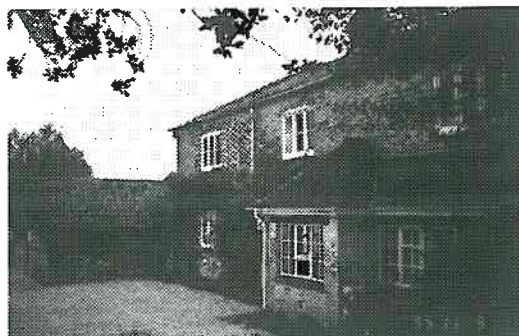
*Photograph 9*

- 4.19 Lane End, formerly Poplars Farm, is a two storey detached property of brick with a slate roof (Photograph 9). A local historian has cited this property as a former shop and post office. The eastern elevation can be seen from across the old cricket ground at the bottom of Water Lane.

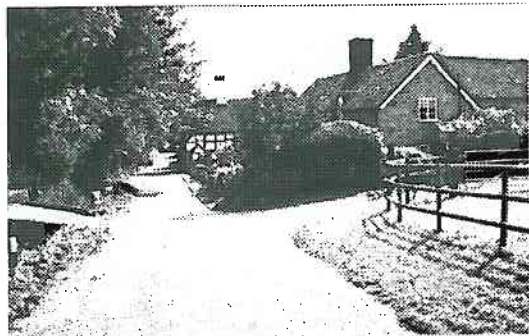
*Photograph 18*

- 7.11 The well-treed, rural lane comprising Water Lane invites further discovery. The lane gradually descends past the 'green', brick and flint cottages and the timber framed Shallows which protrudes out into view (Photograph 18). At the bottom of the lane,

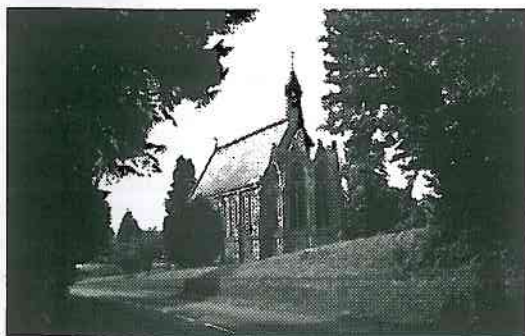
*Photograph 23*

by the trees behind the wall and trees of the church yard, frame an important view of the eastern elevation of the church (Photograph 23).
