CONSERVATION AREA

A Technical Assessment

August 1997

Winchester City Council Planning Department
Avalon House, Chesil Street,
Winchester,
SO23 0HU

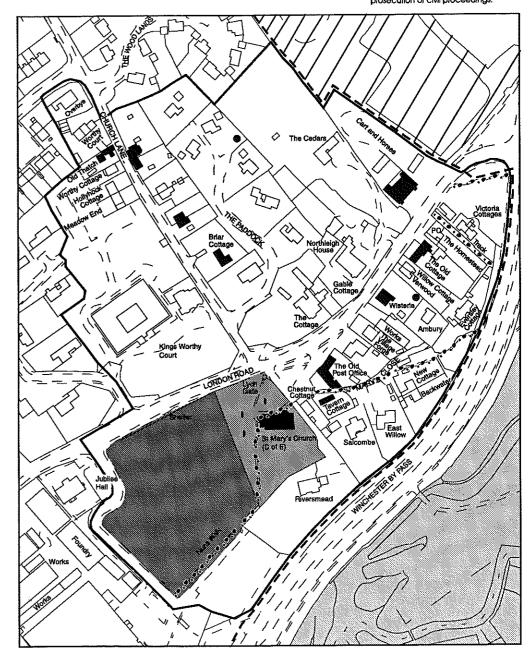
MAP Existing

Conservation Area Boundary

Winchester District Local Plan (WDLP)

Tree Preservation Order

Listed Buildings

- 2.1 Kings Worthy is located approximately two miles north of Winchester (Grid Ref SU 49 32) and is set within the upper Itchen Valley on the north western side of its floodplain (see map 1). The conservation area was designated in July 1985 and encapsulates the historic core of the village. Around 40 residential buildings and a number of commercial properties lie within its boundaries (see map 2).

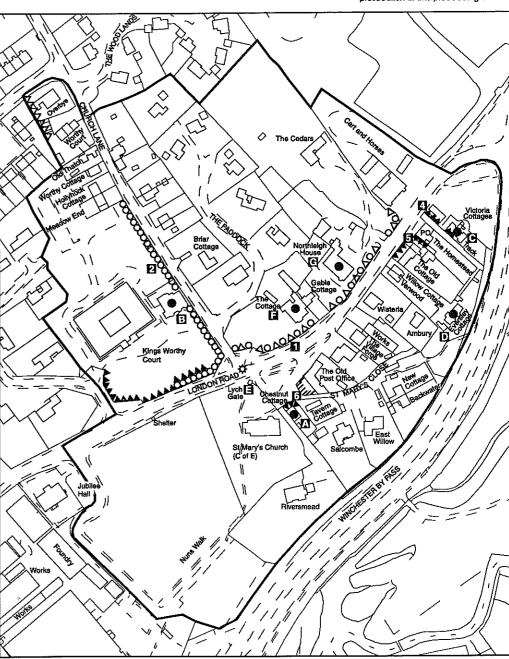
- Brick & Flint wall 🚹 London Road
- Brick wall
- Flint wall
- Railings
- **Palings**
- Church Lane
- Adj Overbye
- Adj Reading Room/ Victoria Cottages
- **El** Kings Worthy PO/ The Old Cottage
- Chestnut Cottage Chestnut

- On the northern side of London Road a flint and brick wall (1 on Map 4) of varying heights stretches from The Cart and Horses Inn to the junction of Church Lane (Photo 11). This is predominantly of flint with brick lacing courses and half round brick coping. The wall varies in height along its length and adjacent to 'The Cottage' it is topped by a low close boarded timber fence. The hedge is backed by evergreen hedgerow, Horse Chestnut and Sycamore trees for part of its length and small trees adjacent to 'The Cottage'. There is a variety of height amongst the vegetation along this boundary.

On the western side of Church Lane, a red brick wall (2), which at its maximum height extends to two and a half metres, forms the boundary to Kings Worthy Court (Photo 12). This wall, mainly of Flemish Garden Wall bond, extends for some 140 metres along Church Lane. The small buttresses at the base give a clue to the fact that for part of its height it serves as a retaining wall. The wall

- The wall decreases in height where it joins the flank wall of Kings Worthy Court and then continues at a height of about two metres to the junction with London Road. The boundary of Kings Worthy Court facing London Road is made up of a low wall topped by railings and backed by evergreen and deciduous vegetation.
- The western boundary of 'Overbye' follows the boundary of the conservation area and is marked by a two metre high flint wall (3) with brick coping (Photo 13). Although the

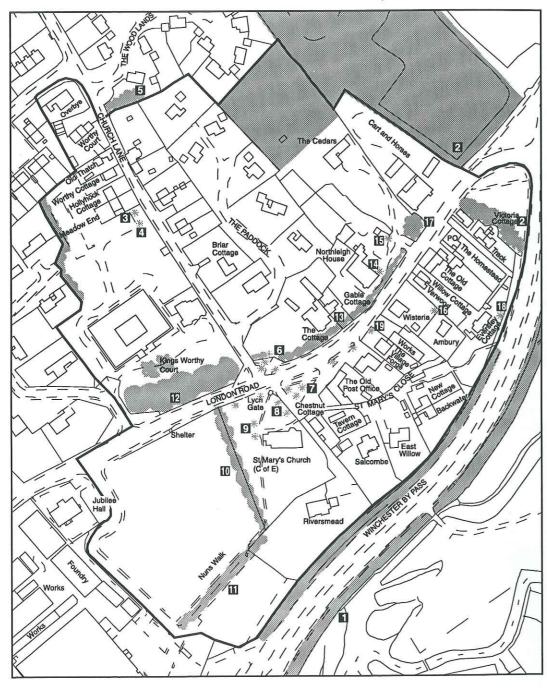
Individual Trees

Important Groups of Trees

- 6.1 Within Kings Worthy Conservation Area, trees, shrubs and hedges provide a valuable contribution to its character. Groups of trees provide a backdrop for the conservation area as a whole and enhance the setting of a number of buildings. Some individual trees are significant features in their own right. Individual trees and groups of trees are identified on Map 5 and are cross-referenced to the text.

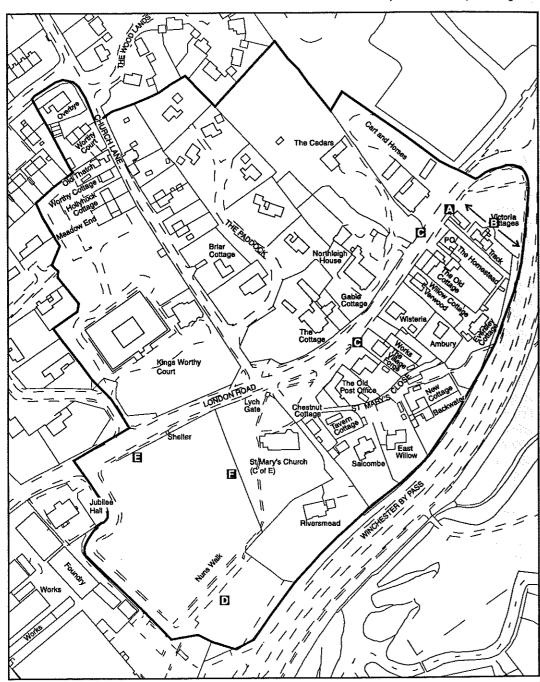
- A Reading Room
- **E** North Eastern Boundary
- Commercial Premises
- Peeks Car Park

- Boundary, London Road
- St Mary's Church

- The Reading Room (A on Map 6) was converted to a dwelling in the early 1980's but is currently unoccupied (Photo 28). Consequently the building and the surrounding grounds have fallen into disrepair. Its prominent location at the north eastern entrance of the conservation area means that it is important that a use should be found and repairs carried out to the building in order to enhance this part of the conservation area. In addition, the boundary treatment around the building needs strengthening, particularly adjacent to London Road, given the semi-rural nature of the settlement this is often best achieved by planting rather than more urban walls and fences. The railings along the western elevation of the building and which continue along the boundary of Victoria Cottages, could be an attractive feature if they were renovated.

- 9.10 The following enhancements are shown on Map 6 and should be given consideration:
 - repairs to the Reading Room and associated boundary treatment,
 - strengthening the boundary at the eastern approach to the conservation area,
 - alternative boundary and surface treatment, improvements to shopfronts and forecourt signage, commercial premises along London Road,
 - boundary improvements at Peek's car park,
 - boundary improvements at St Mary's Church.
