*U*pham

CONSERVATION AREA

A Technical Assessment

Winchester
City Council

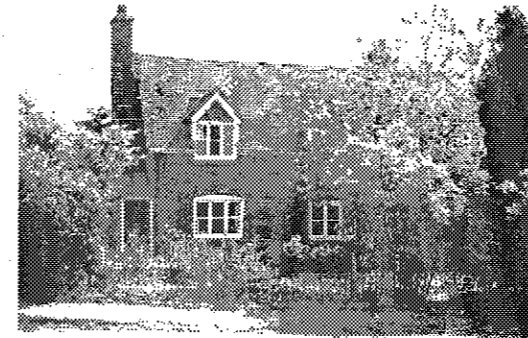
Photograph 2

- 4.3 The 17th Century buildings all have timber framed cores which subsequently have been encased in brick. Rays Farmhouse (Photograph 2) and Farthing Cottage are both constructed of brick with random blue brick headers and are four storeys in height. Gabled dormer windows are set across the eaves line and the roofs are of clay tiles. Both buildings have casement windows and brick chimneys with clay chimney pots.

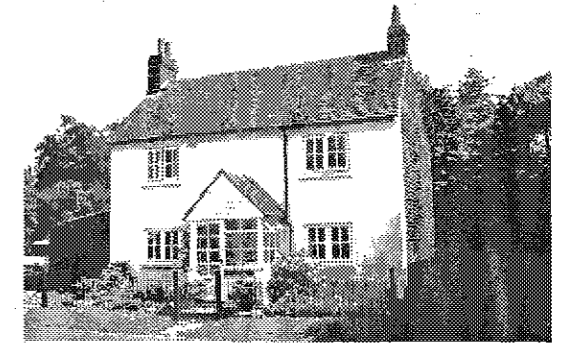
Photograph 3

- 4.4 Ivy Cottage (Photograph 3) is two storeys in height with a clay tiled roof and clay chimney pots. It has a stucco front elevation and a date plaque bearing the date 1754, tile hung rear and side elevations, which is a feature also found on Farthing Cottage. The 17th Century central portion of Little Croft is

constructed of brick which has been painted and is of one and a half storeys in height with a thatched roof. The 19th Century extensions either side are clay tiled with hipped ends.

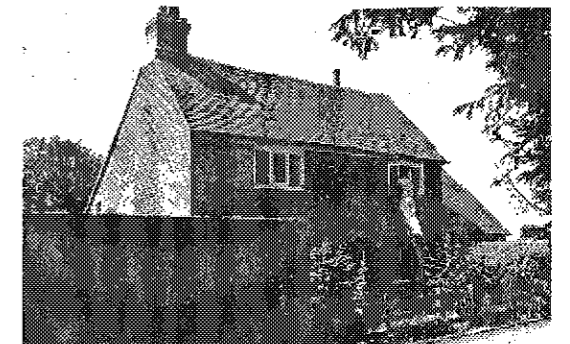
Photograph 4

- 4.5 There are a number of 18th Century Listed Buildings which are dispersed around the village. Fir Tree Cottages and The Old Fir Tree are sited adjacent to each other in Upham Street and The Old Fir Tree, formerly an inn, is named after the fir tree which stood in the garden of 1 Fir Tree Cottages. All the 18th Century dwellings are two storey in height, with hipped, clay tiled roofs and are constructed from brick. A number are constructed in Flemish Bond with blue brick headers some of which have been colourwashed. Many have 19th and 20th Century extensions.
- 4.6 Gardeners Cottage (Photograph 4) is of late 18th Century origin with a 20th Century extension. It is a two storey building with blue headers in a Flemish Bond, a clay tiled roof and a small porch with brick sides and a pitched leaded roof. Set close to Church Street the attractive brick work of Gardeners

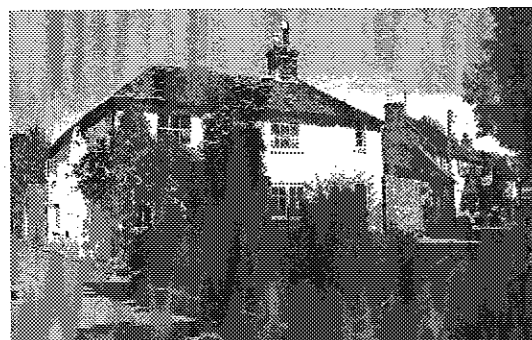
Photograph 5

- 4.7 Pond House (Photograph 5) occupies a prominent position at the corner of Shoe Lane and was originally Upham Stores and Post Office. It is constructed from brick which has been colourwashed and has a hipped clay tiled roof. This building has a mix of sash and casement windows and a panelled door with a trellis work surround. The boundary wall and plain wrought iron railings defining the front boundary are also Listed. Adjacent to Pond House, 1 Shoe Lane is Listed and additionally contributes to this attractive group of buildings.

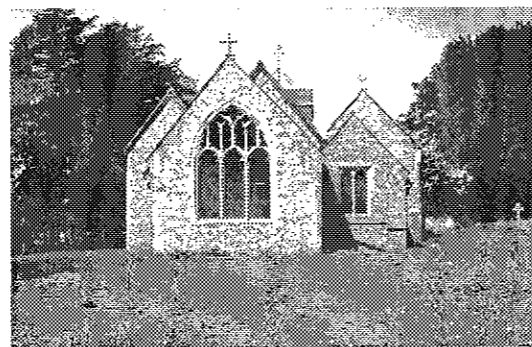
Photograph 6

- 4.15 The Church (Photograph 6) which stands at the centre of the village dates from the 13th Century but was restored in 1881. The church itself is of flint with stone dressing while the squat 19th Century tower is built of brick in a Flemish Bond with blue headers. A Listed 19th Century tomb chest lies to the east of the church. It is constructed from stone in a gothic style and surrounded by cast iron railings with elaborate heads.

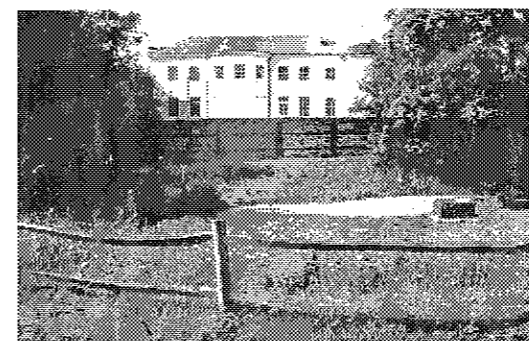
Photograph 7

- 5.2 Upham House (Photograph 7) is situated on the eastern edge of the village in extensive grounds and originally formed part of an estate which included Newlyn, Bigpath, Ashton, Street End and Ower Farms. This is a three storey building with a shallow slate roof, sash windows with some blind windows, a semi-circular bay on the northern elevation, with a round lantern on top. From within the village, the northern elevation of Upham House can be viewed with the village pond, trees and banded brick and flints walls in the foreground and the building creates a significant feature in the street scene. From the public footpath to the south of the village, there are long views of the southern elevation of this property set in its parkland setting.

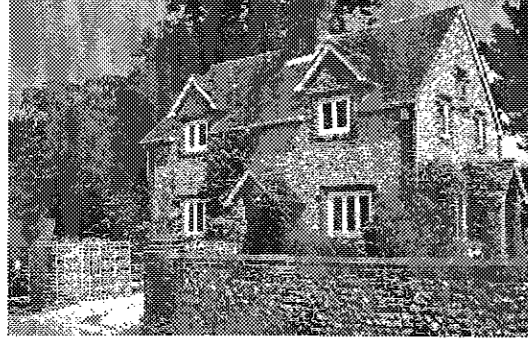
Photograph 8

5.9 Birds Cottage and Church Cottage are situated next to each other on the northern side of Church Street, opposite Gardeners Cottage and adjacent to the Church. Church Cottage (Photograph 8) is shown on the 1879 Ordnance Survey map as two properties, although it is one today. It is a one and a half storey flint building with brick quoins and window surrounds, casement windows, plain gabled dormers and a clay tiled roof. There are gabled porches on the east, west and south elevations and attractive brick moulded hoods over the windows.

D Flint boundary wall to Church Cottage. Approximately one metre in height, it is capped with shaped bricks and has brick piers. Although broken by a small stretch of wooden paling fence, the wall defines the boundary of the property and complements the flint walls of the cottage and the wall opposite.

echoes the flint wall which runs along the southern side of the road (Photograph 8).

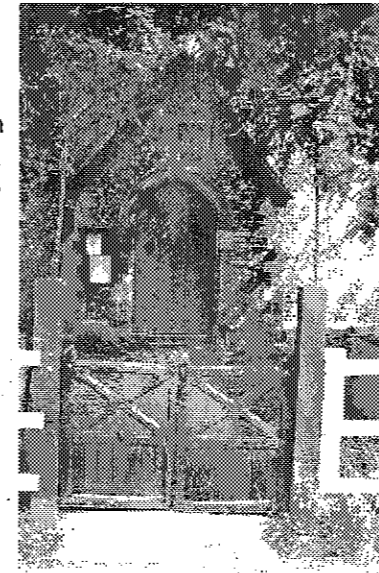
Photograph 9

7.2 At the entrance to the church (Photograph 9) there is a double gate made from wood with an elaborate iron lamp holder forming an archway over the gate itself. Framed by two large Yews either side of the path to the church door, the gate is an attractive feature and helps provide a setting for the church.

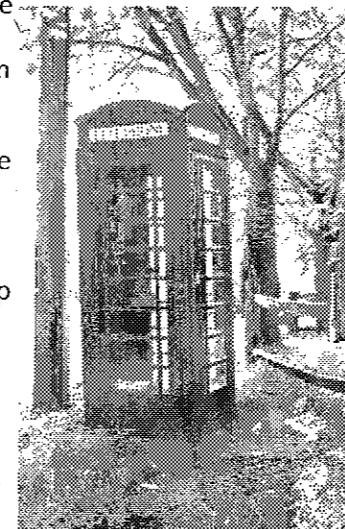
Photograph 10

7.6 Listed Telephone Box of Type K6, constructed from cast iron and designed in 1935 by Sir Giles Gilbert Scott (Photograph 10). The phone box is located adjacent to the pond and provides a distinct feature within this attractive location.

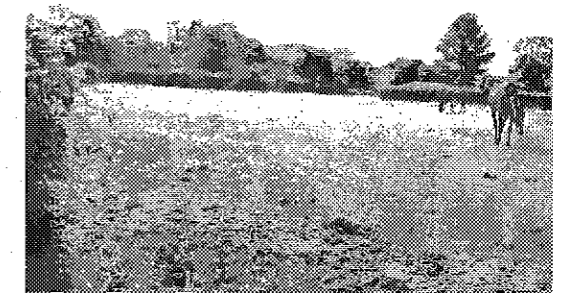
Photograph 11

7.7 Open areas within the central island bounded by Shoe Lane, Upham Street and Church Street. Two fields, one west of the Old Rectory and the second north east of the Church, (Photograph 11) form important open spaces which physically separate groups of dwellings and contribute to the intrinsic rural character of the conservation area.

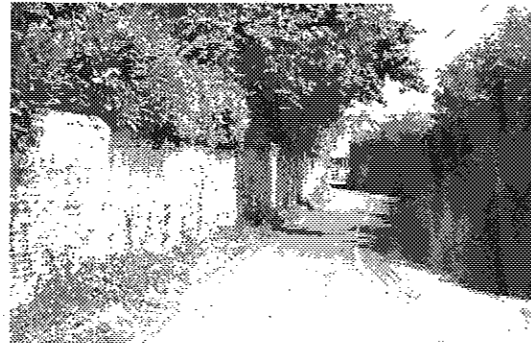
Photograph 12

G An extensive mixture of flint and brick walls form the boundary to The Manor House (Photograph 12). This extends from north to south past the junction of Church Street with Upham Street. North of the junction, the wall is approximately two to two and a half metres in height

with brick capping and some vertical brick sections. This is replaced by a red brick wall which then runs as far as the entrance to the Manor. To the south of this the flint walls of the barn continue

the hard boundary. The walls create a significant and attractive boundary which help to define the street scene.

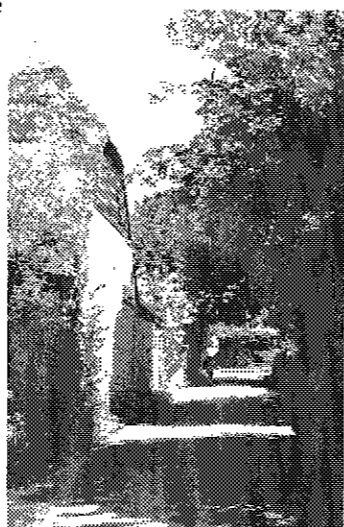
Photograph 19

Complementing this vegetation, the red brick wall and flint walls either side of the lane also channel the views southwards. The Listed barn within the grounds of the Manor House forms part of the wall on the western side of the lane and its flint walls containing string courses, barge boarding and thatched roof create an interesting feature within the street scene (Photograph 19).
