# Conservation Area Character Appraisal and Management Plan

## West Meon February 2017

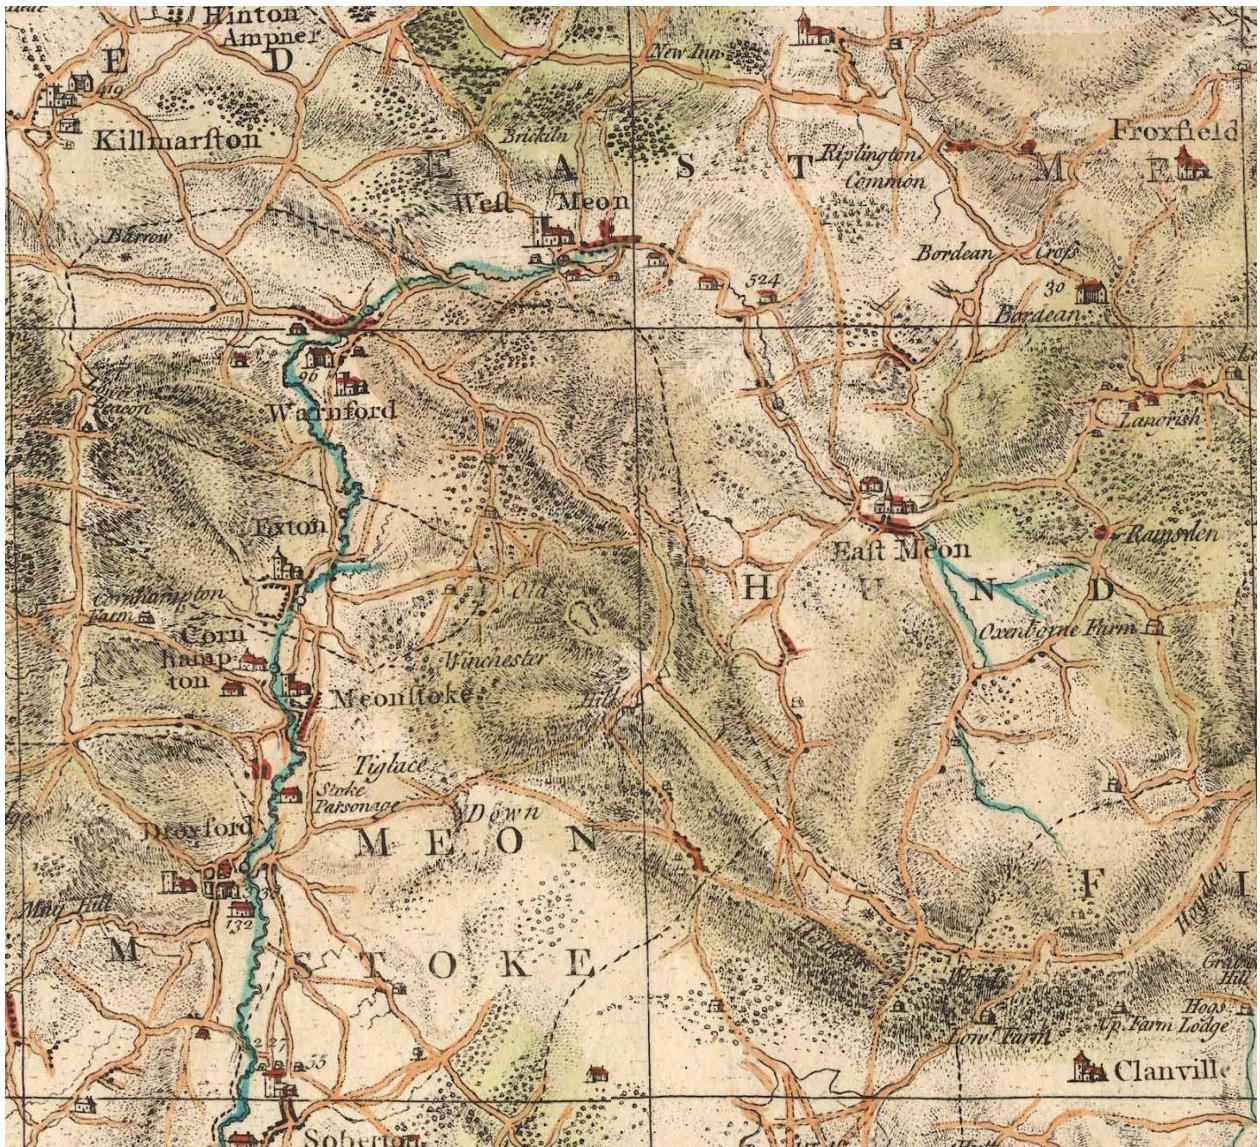
Figure 3: Isaac Taylors Map of Hampshire, published in 1759

3.6 Isaac Taylor's map of Hampshire, published in 1759 (figure 3), shows the settlement sitting within a network of lanes linking it to the neighbouring villages. However, shortly after his survey, the turnpike linking Gosport to Alton was created and, as the A32, this remains the main road running up the Meon Valley. The greater significance given to this road is apparent on Greenwood's map, published in 1826 (figure 4).

4.8 Taylor's Map of Hampshire (Figure 3), published in 1759, depicts the village in a network of rural lanes. The present main road follows a long standing route-way, running up the valley. Originally, the principal route is likely to have veered east at West Meon, towards East Meon.

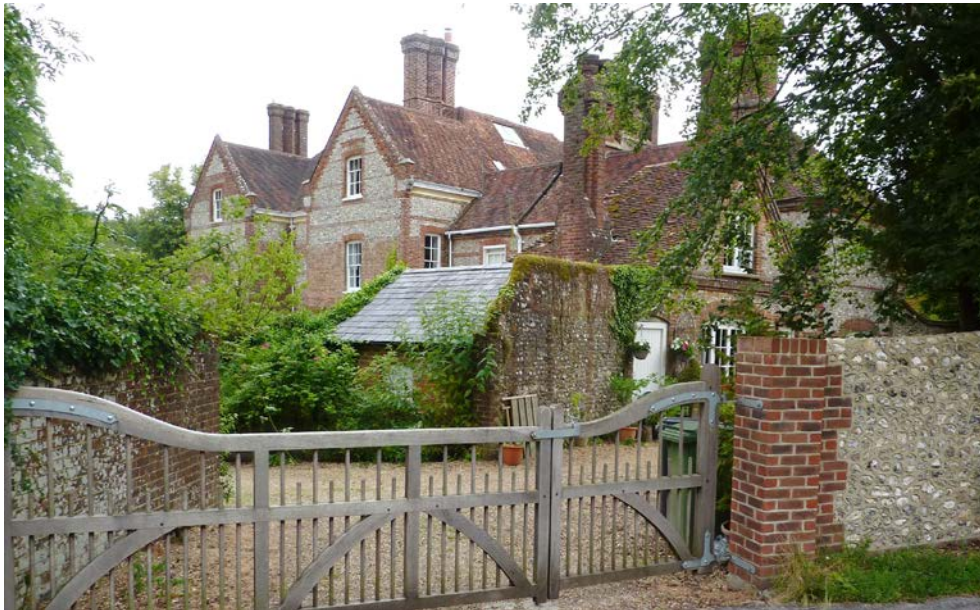
Figure 8: **West Meon House** and associated service buildings; the house is early 18<sup>th</sup> century in origin, with 19<sup>th</sup> and 20<sup>th</sup> century additions and alterations. Flint is used in the construction of the walls, mixed with malmstone, stone quoining and brickwork to produce a most attractive, mellowed character. The large chimney stacks, Tudor in style, were added in the late 19<sup>th</sup> century.

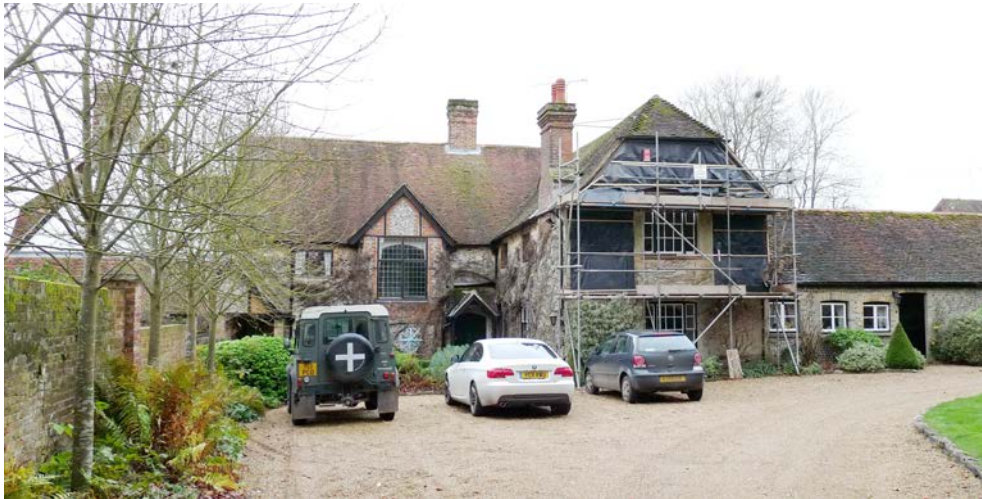
Figure 12: **The Court House**, Church Path, is a late medieval timber-framed hall and wing, with later alterations made in the 16<sup>th</sup>, late 18<sup>th</sup> and 19<sup>th</sup> Centuries. The associated farm buildings have all been converted into residential use. It is one of two surviving medieval structures in the village, the other being Garden Cottage.

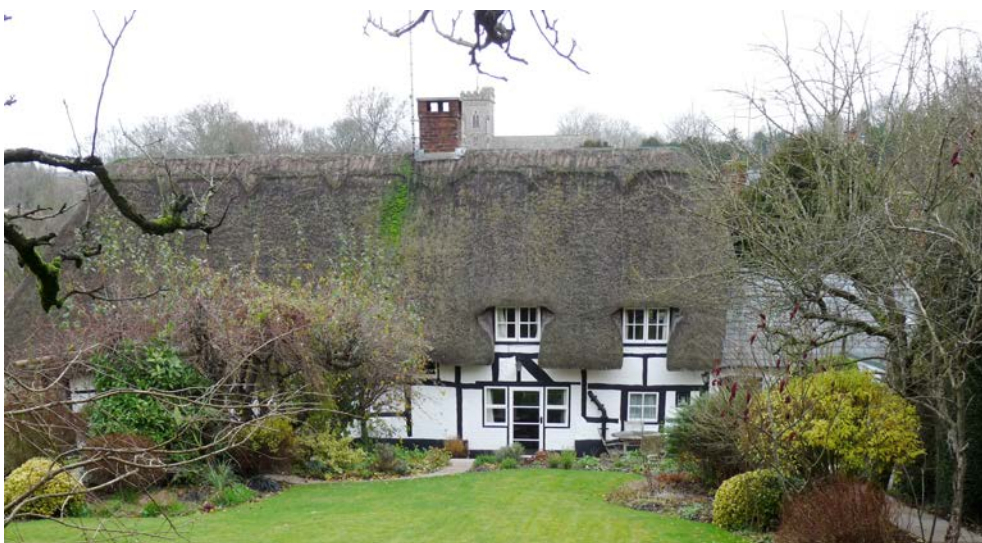
Figure 13: **Garden Cottage**, Warnford Road. Along with the Court House, one of the two oldest surviving buildings in West Meon. Garden Cottage began life as a three-bay hall house. This earliest phase of the structure has been dated by dendrochronology to 1441. The cottage was later extended and altered with the addition of two extra bays, the insertion of a chimney, and the insertion of a first floor within the open hall. This happened sometime between the mid 16<sup>th</sup> Century and mid 17<sup>th</sup> Century.

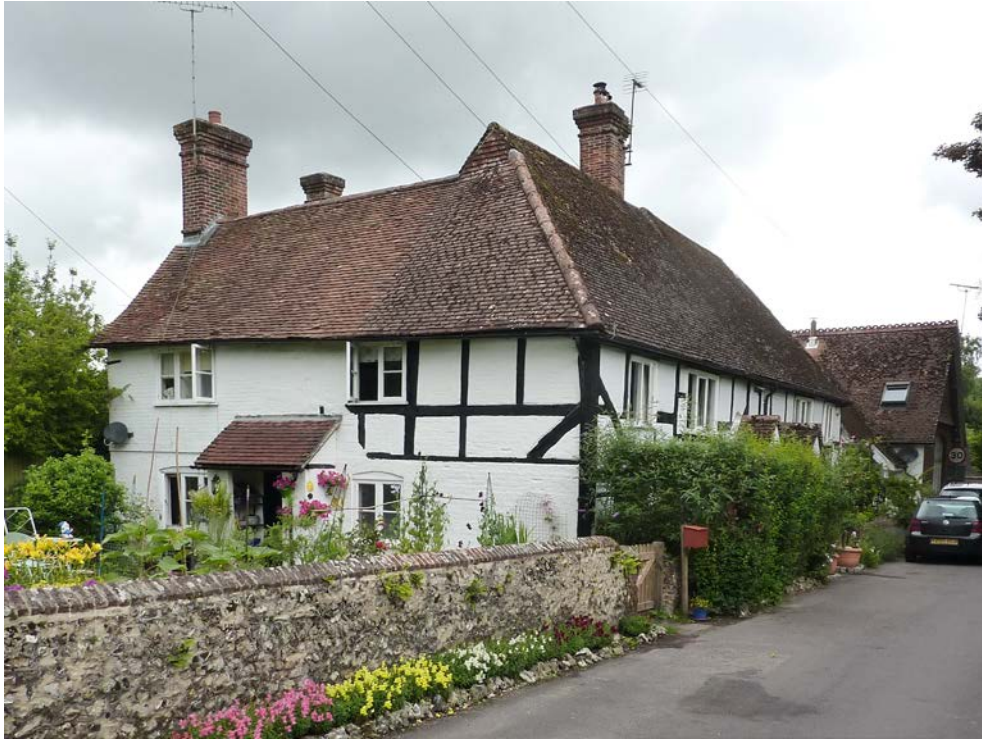
Figure 14: **1, 2 and 3 Station Road.** Originally a single dwelling of late 16<sup>th</sup> century origin, with 19<sup>th</sup> Century rear extensions. The steeply pitched main range was originally thatched.

4.32 In other cases, reed roofs with decorative block ridges have been substituted for the original long straw, including *Springfield Cottage*, *The Cross*, and *Benhams*. In some cases, including *1, 2 and 3 Station Road*, *Warnford Corner* and *Little Thatch*, long straw thatch has been entirely replaced with clay tile.

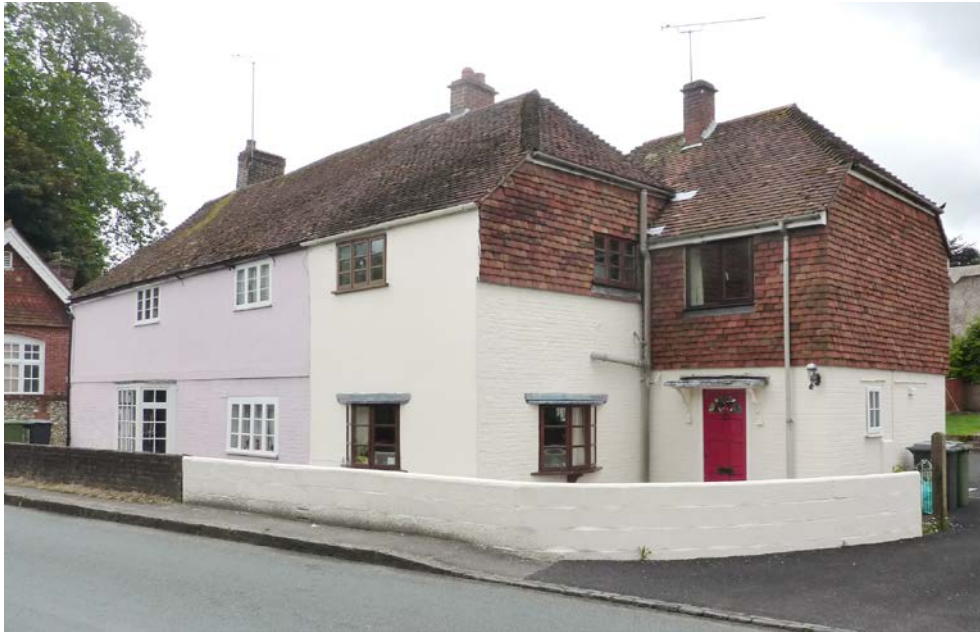
Figure 16: **Rose Cottages**, Warnford Road, of timber-framed origin but re-clad in the early 19<sup>th</sup> Century.

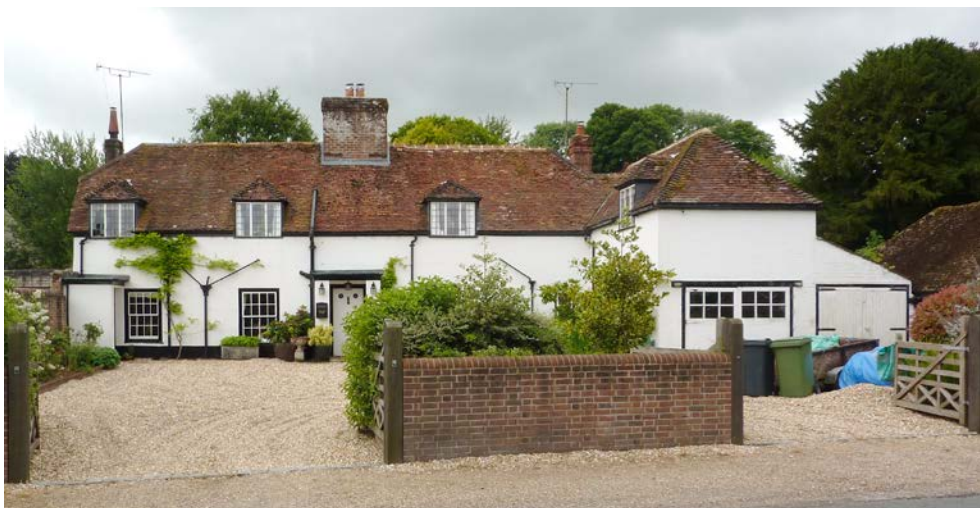
Figure 17: **The Old Forge**, Warnford Road. A house and forge, the latter now raised in height and converted to use as a garage. Beneath the early 19<sup>th</sup> Century cladding is a 17<sup>th</sup> Century timber-frame

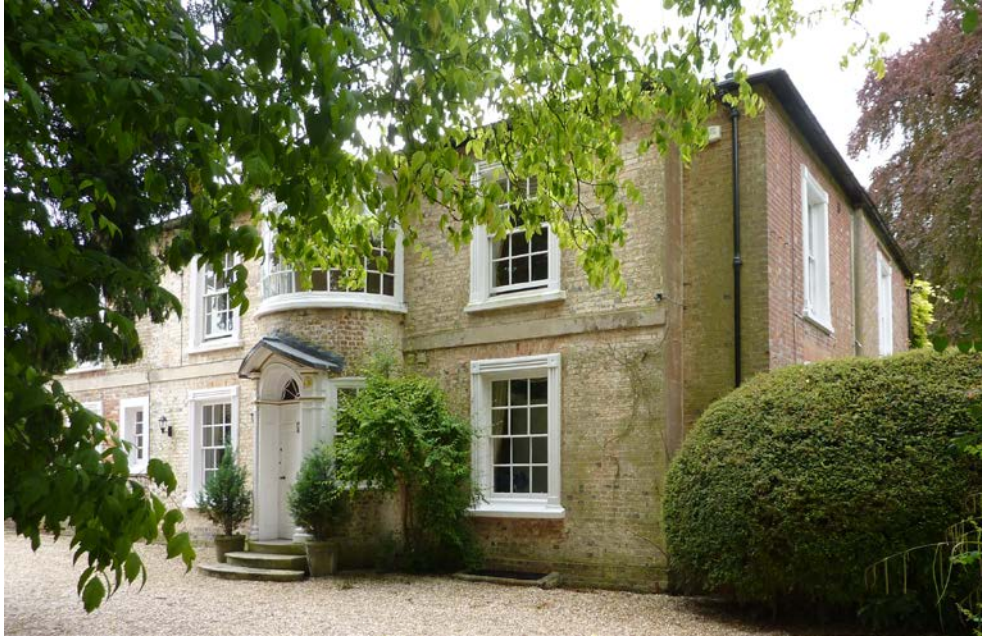
Figure 18: **West Lodge**, Warnford Road. House and service wings of early, mid and late 19<sup>th</sup> century date. The semi-circular two-storeyed central bow on the front elevation, incorporating a classical doorcase, is a particularly attractive and unusual feature.

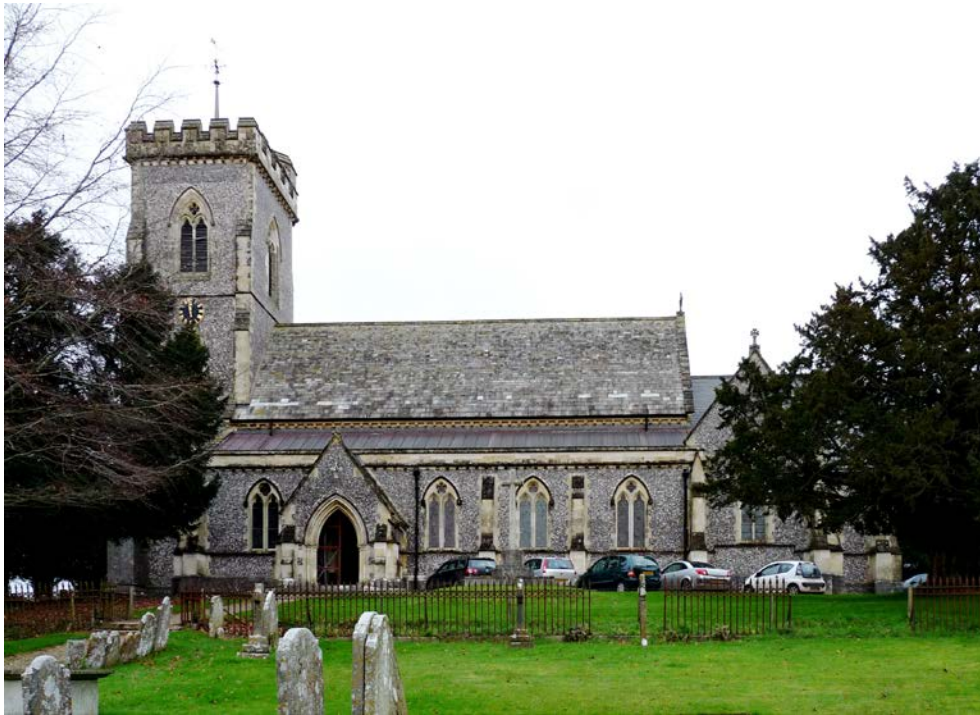
Figure 20: The Parish church of **St John the Evangelist** was designed by George Gilbert Scott in a 'second pointed' (Decorated) Gothic style. The church was built in the 1840s to replace the original church.

3.9 The original parish church, which was probably Saxon in origin, was demolished in the 19<sup>th</sup> century and its successor, St. John the Evangelist, was built to the designs of the Victorian Gothic Revival architect, George Gilbert Scott, a little to the north between 1843 and 1846.

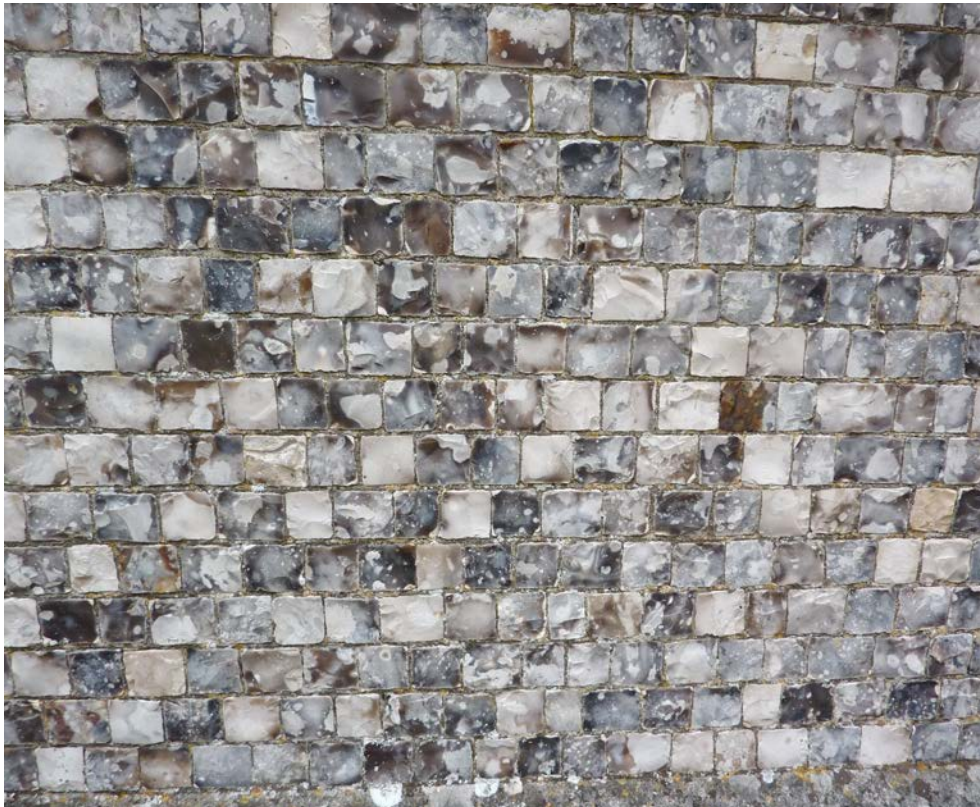
Figure 21: very high quality flintwork, using squared and coursed, knapped flints.

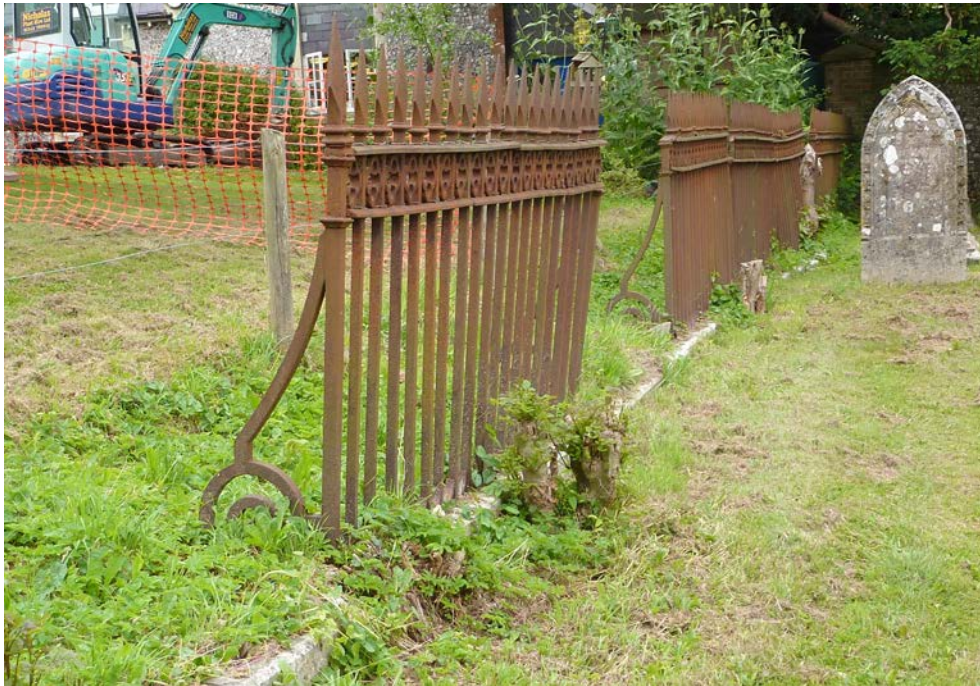
Figure 22: **Railings and gates** in the churchyard.

The railings are mid-19<sup>th</sup> century castings, presumably contemporaneous with the church. They are Grade II listed in their own right. They are complemented by the gates and lanterns in the surrounding walls. All are in poor condition and missing important elements; the railings appear on the SDNPA Buildings at Risk Register. Restoration would form a worthwhile enhancement for the village.

5.6 The repair of the surviving churchyard railings, supplemented by reinstatement of the missing sections (figure 22) would represent a very striking enhancement of the most significant open space within the Conservation Area, as well as improving the setting of the listed church and removing a structure from the National Park’s Buildings at Risk Register. Reinstatement of the missing lanterns on the gate piers would constitute ‘icing on the cake’.

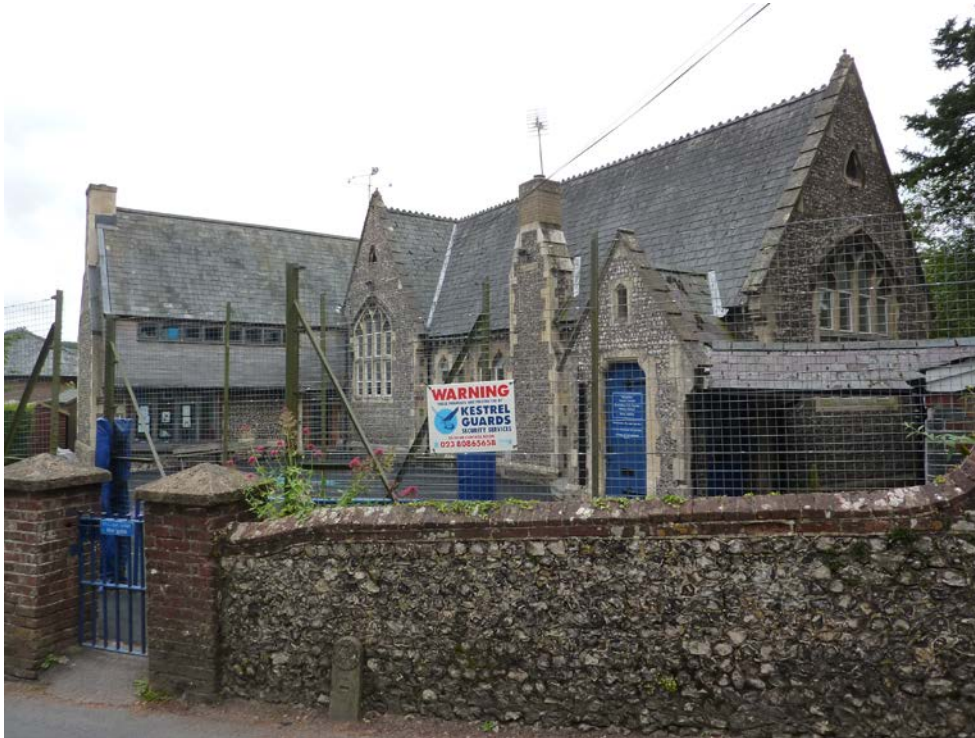
Figure 25: **The Village School**, Church Lane, of 1852-3, sits close to the church and is also built in a Gothic style. The high wire fence and warning signs degrade the setting of the listed building and represent a significant visual intrusion into the Conservation Area. Their removal would be welcome.

5.12 The current security fencing around the school is ugly, visually intrusive, and detrimental to the character of the Conservation Area. It also detracts from the setting of a number of historic buildings (figure 25). It was presumably erected to address a perceived need but it less than clear whether that need still exists and, if it does, whether it might be addressed in a far less obtrusive manner.

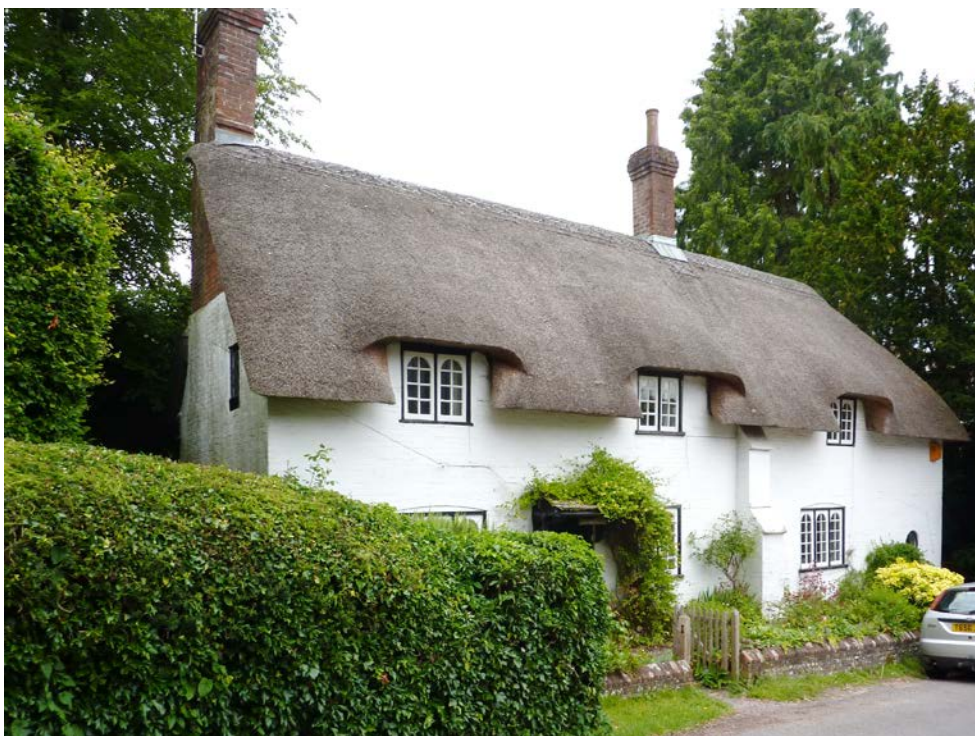
Figure 27: **The Cross**, at The Cross: Hidden behind the early 19<sup>th</sup> century brick cladding is a 17<sup>th</sup> century timber-frame.

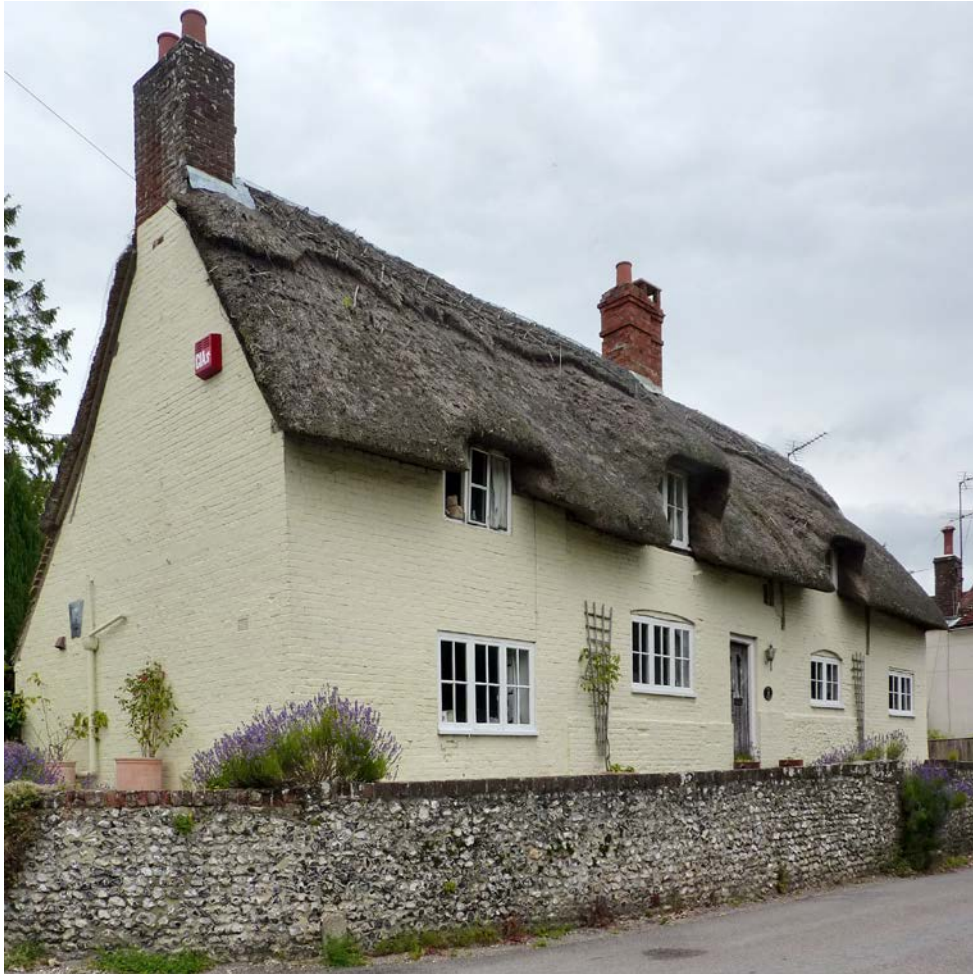
Figure 28: **Springfield Cottage**, The Cross. Another 17<sup>th</sup> century timber-frame with 19<sup>th</sup> century brick cladding

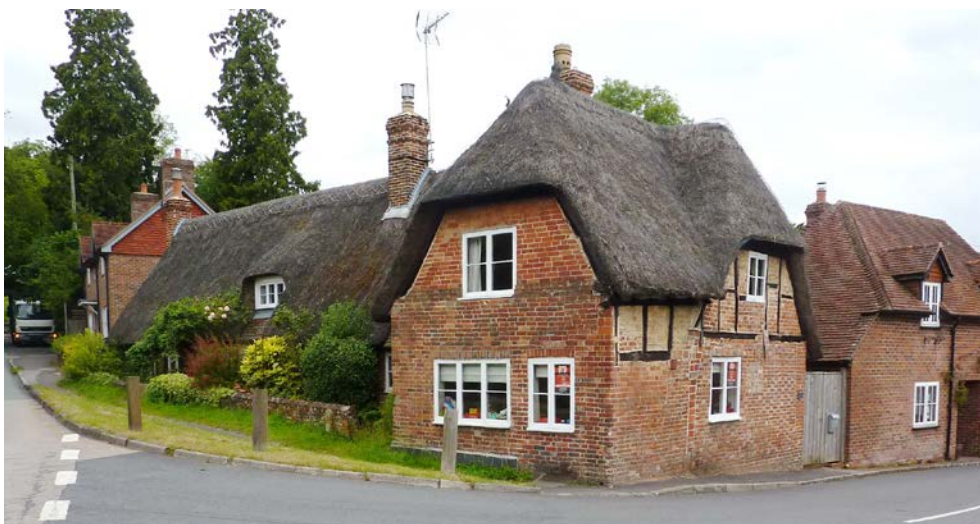
Figure 35: **Riverside**, High Street: At the core of this group is “Riverside”, a four-bay 18<sup>th</sup> century house. In the 19<sup>th</sup> century, the prominent gabled wing was added to the east end and a projecting shop-front followed in the 20<sup>th</sup> century, perhaps replacing an earlier one. The group is Grade II listed. At the west end of the range is a gabled brick wing of the last century; this is excluded from the listing. Good historic photographs exist of this building and some reinstatement of lost features could form a worthwhile enhancement project.

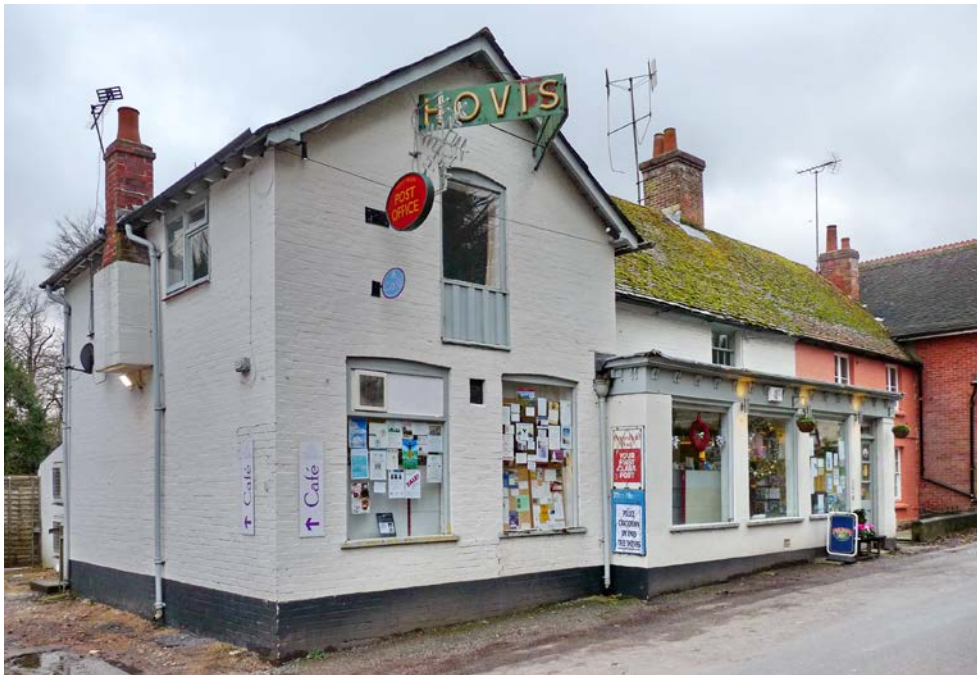
Figure 36: **Brook Lodge and Gobions**, East Meon Road. A 17<sup>th</sup> century timber framed core with late 18<sup>th</sup>, early 19<sup>th</sup> and 20<sup>th</sup> century extensions

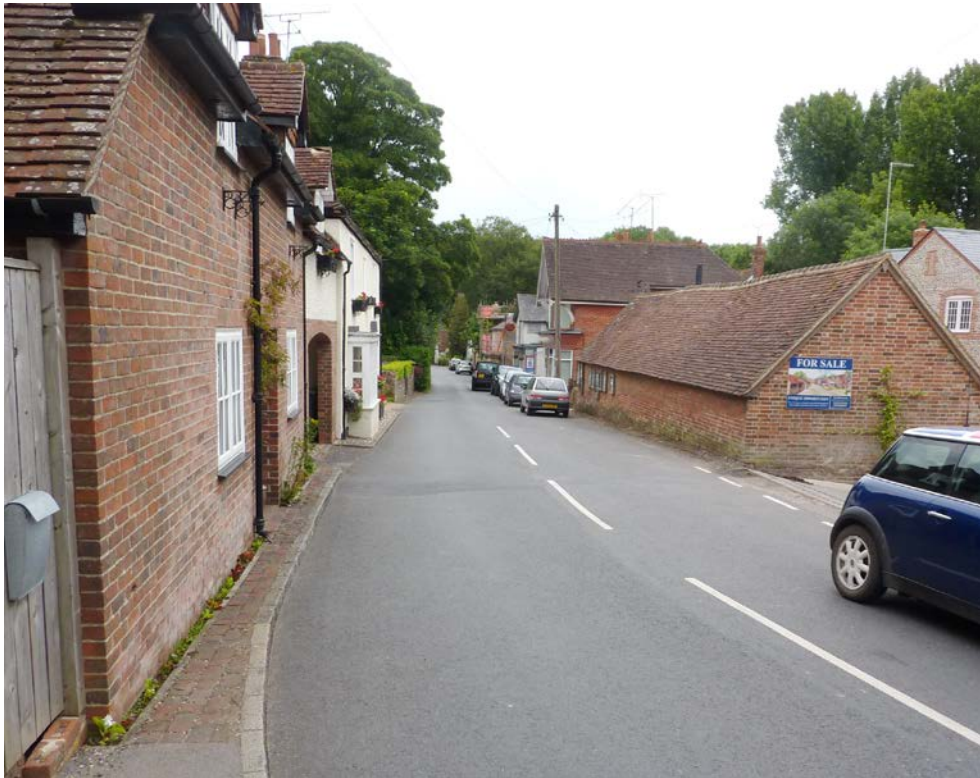
Figure 38: **The Baechus**, East Meon Road. An early 19<sup>th</sup> century brick facade hides a 17<sup>th</sup> century or earlier timber frame which is still exposed on the gable end.

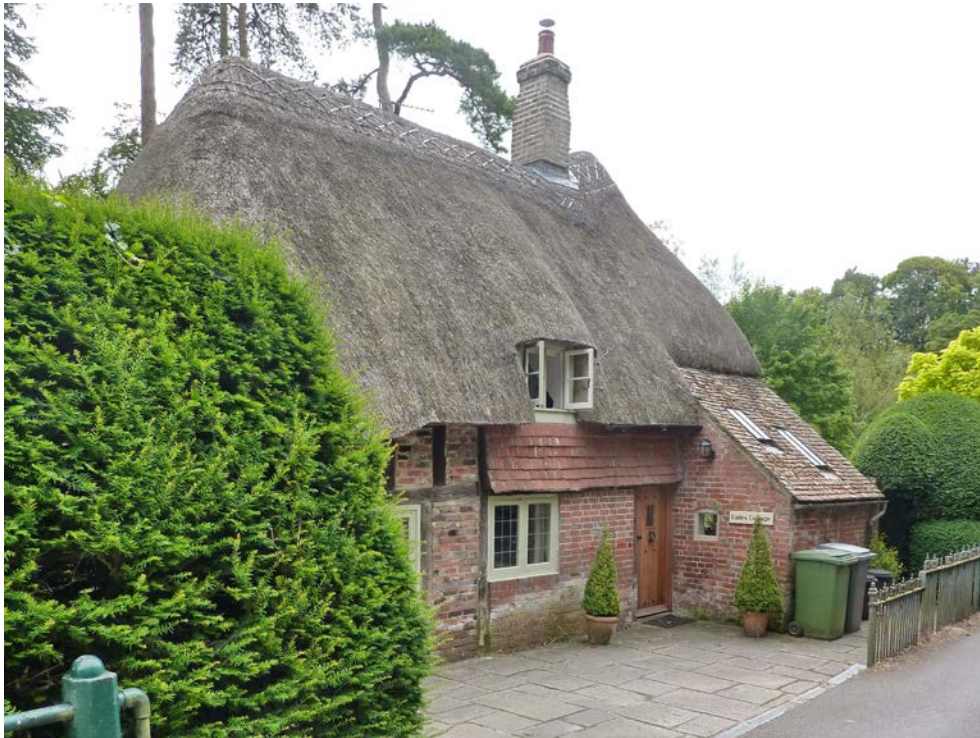
Figure 49: **Shafts House**, East Meon Road. Timber-framed in origin and clad in brickwork in the 18<sup>th</sup> century

5.7 Works to *The Red Lion* may lead to removal from the vulnerable category of the Register. *The Mill House* and *Shafts House* were identified as being vulnerable because of a general lack of maintenance to all parts of the buildings and necessary repairs to the rainwater goods.

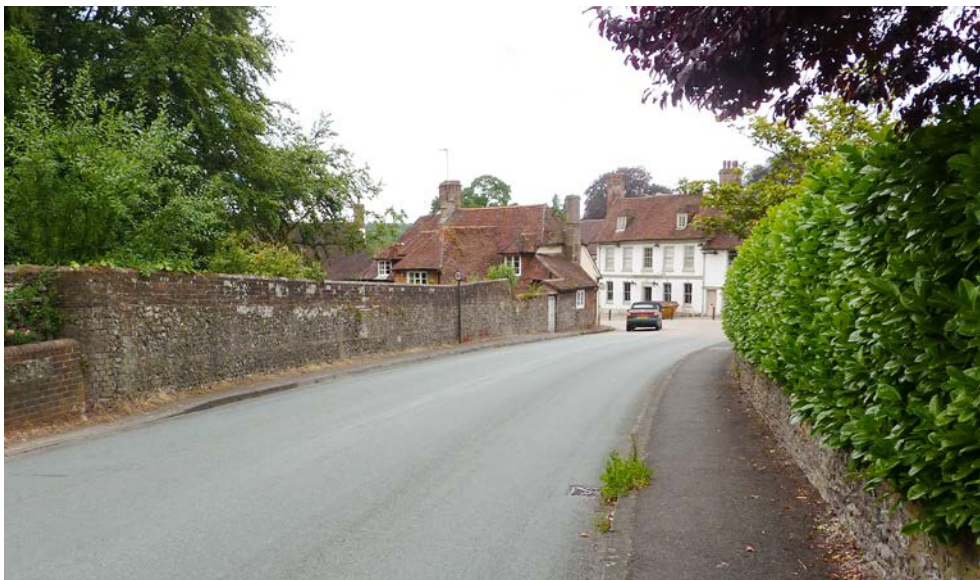
Figure 53: **Streetscene at The Cross in the 1960s.**

It is striking to note how tree and shrub growth has transformed this view over a relatively short period. Instead of forming a backdrop to a visually cohesive building group, as before, planting has now almost entirely obscured the cottages behind The Cross

Cross itself, which is an Edwardian feature. Shrub growth has substantially encroached upon this space in recent years. (Figures 53 & 54)

5.3 The core of the settlement is formed by the junctions of Warnford Road, Church Lane and The Cross. It is apparent from historic photographs of this area that it was originally much more obviously the centre and focal point of the village than it is now; this diminution has come about because trees and shrubs have been allowed to grow to a point where they obscure the primary visual importance of the area (figures 53 & 54).

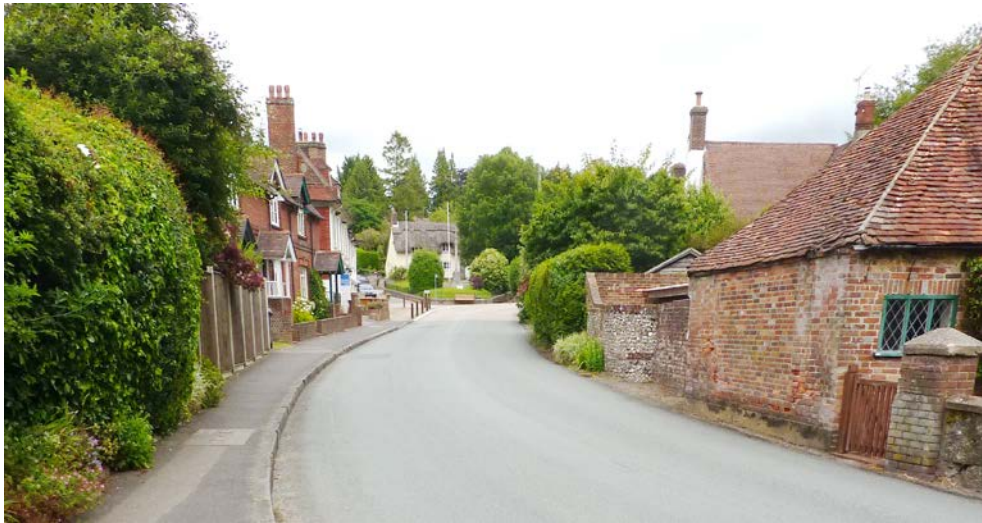
Figure 56: **Graziers**, Warnford Road. A 17<sup>th</sup> century timber frame with early and late 19<sup>th</sup> century cladding.

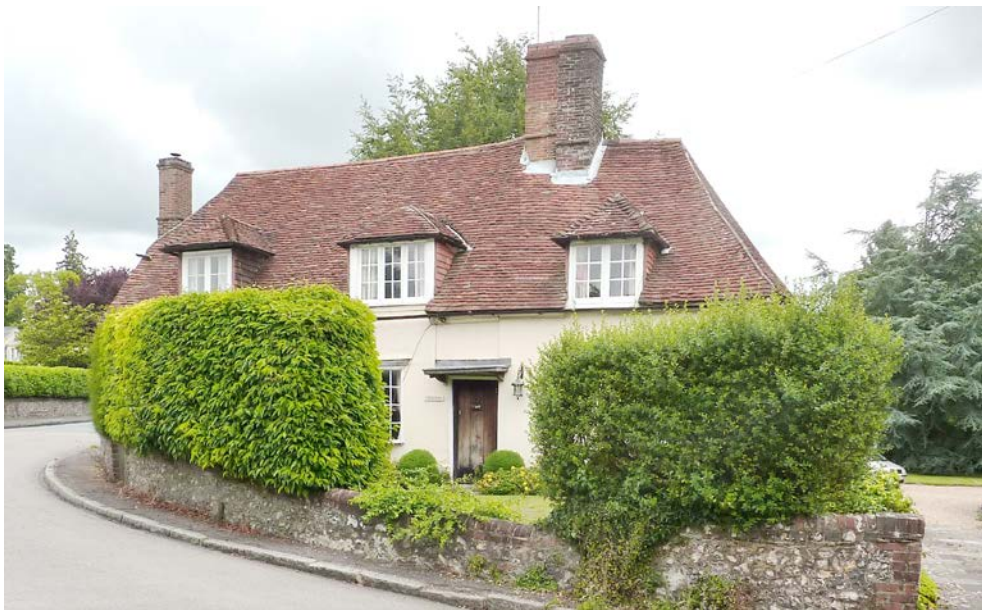
Figure 57: **Hatch Cottage**, Warnford Road. The 17<sup>th</sup> century timber frame remains visible on the front but the back was clad in the early 19<sup>th</sup> century.

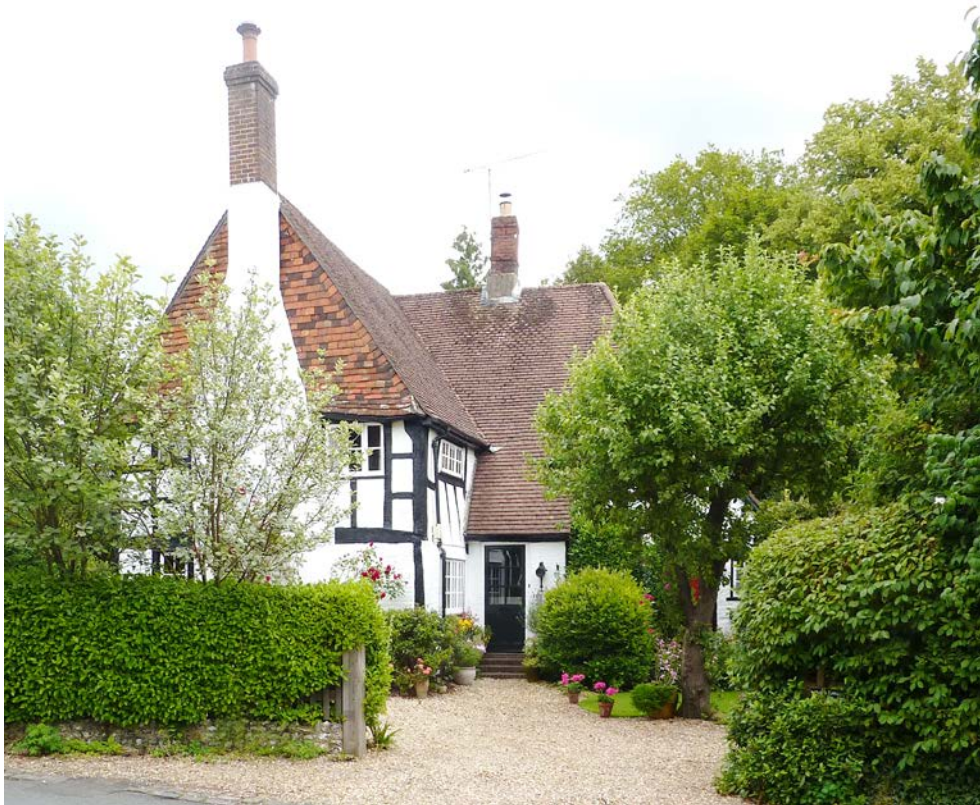
Figure 58: **Mill House**, Warnford Road. Mill and House. 18<sup>th</sup> century in date with late 19<sup>th</sup> century extensions and alterations.
