Diagram showing the internal layout of an Atlas Florida M Home, the changes made, and photos showing some of the works

APPENDIX HG 10

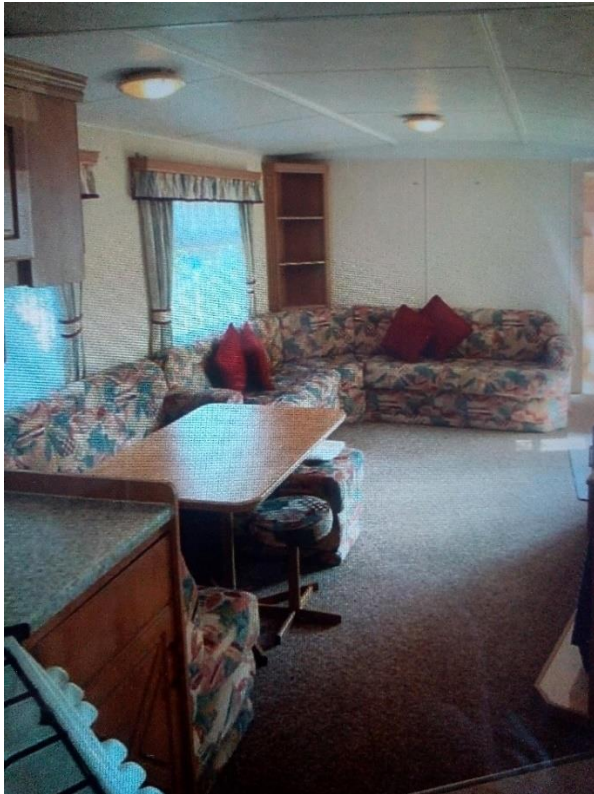
Two photos of an original Atlas Florida Mobile Home

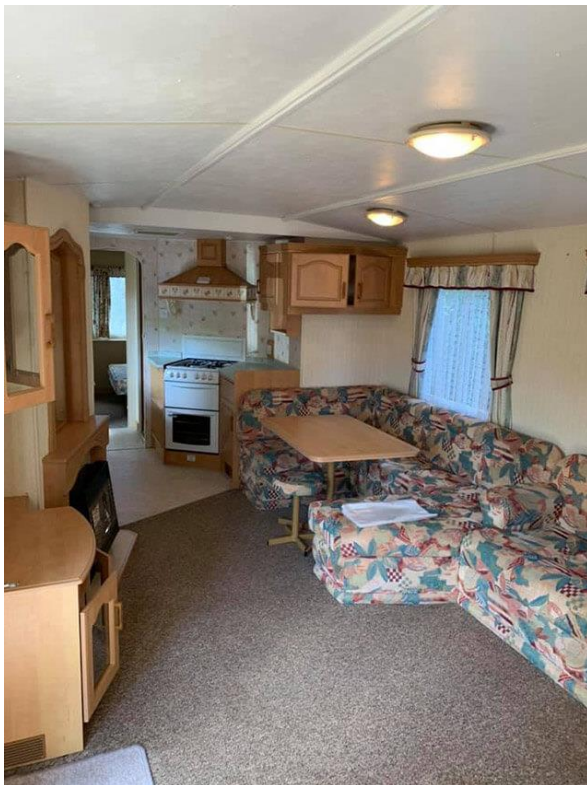
Looking towards the lounge with the bedroom and toilet at the far side (Diagram A)

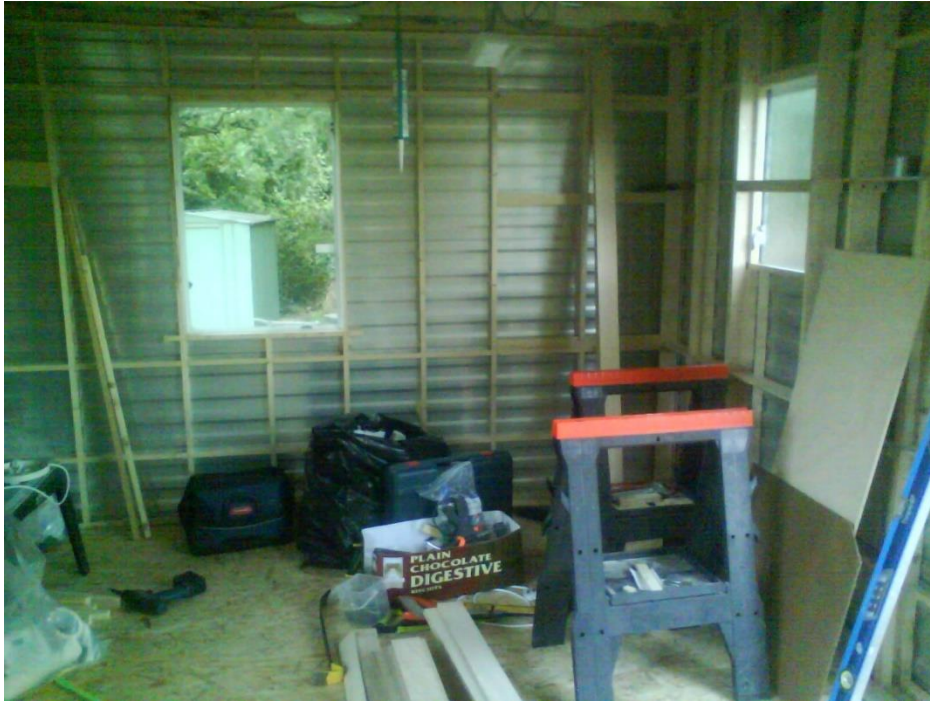
View of the Mobile Home at The Greenhouse where the bedroom and toilet had been removed with new stud wall being constructed

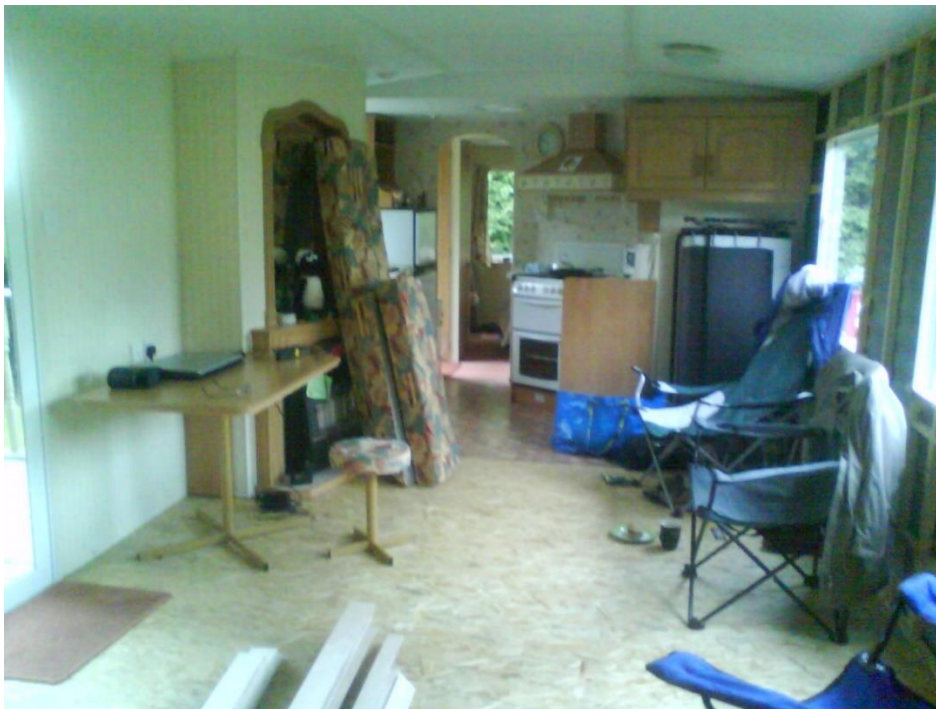
View looking towards the kitchen area before it was revised.

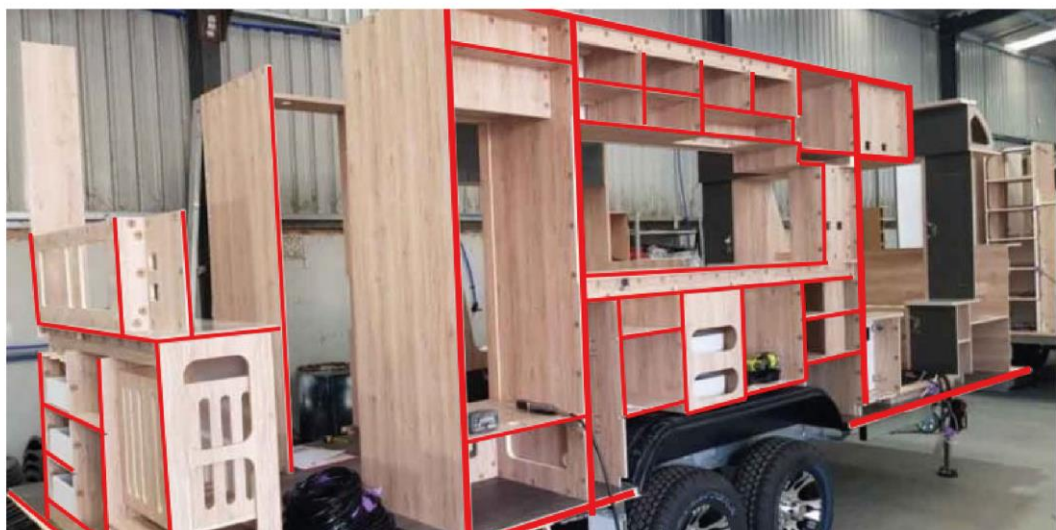
Example of a M.H without the exterior fitted.

The areas highlighted in red show where the exterior would be joined to the M.H, also showing how the interior plays a vital role when it comes to structural integrity. and where the staples would be placed.
