REGULATORY REFORM (FIRE SAFETY) ORDER 2005 HOUSING FIRE RISK ASSESSMENT

Company Name: Winchester City Council

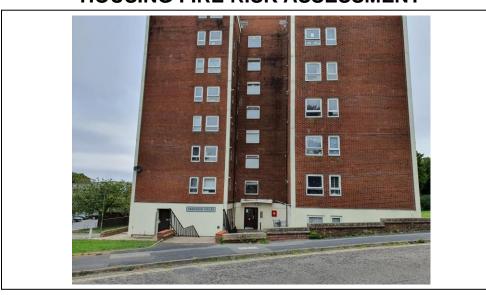
The purpose of this report is to provide an assessment of the risk to life from fire in these premises, and, where appropriate, to make recommendations to ensure compliance with fire safety legislation. The report does not address the risk to property or business continuity from fire.

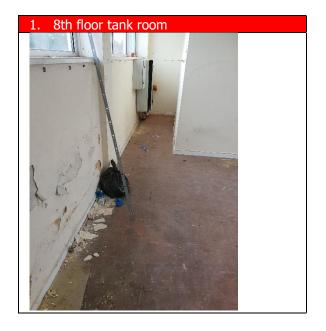
4. Photographic evidence
