PHILIP HUGHES ASSOCIATES
HISTORIC BUILDINGS CONSERVATION CONSULTANTS
OLD MANOR STABLES, TOUT HILL, WINCANTON, SOMERSET BA9 9DL
Tel: 01963 824240 Email: info@pha-building-conservation.co.uk www.pha-building-conservation.co.uk

BUTTERCROSS MONUMENT

REPORT on REPAIRS and PIGEON DETERRENTS

January 2024

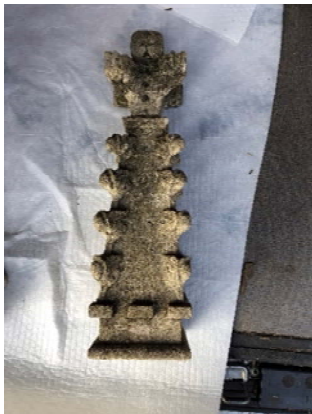
Fig 3 – Pinnacle from 4th stage.

- Two pinnacles including finials from stage 4.
- Two finials – one from stage 3 and one from stage 4.
- The statue of Saint Bartholomew from the east facing side of stage 4.
- 3 pieces of the broken gable finial from the east facing side of stage 2.
- Smaller fragments from various places.

Generally, we will seek to replace missing pinnacles and finials with new stone. It has been identified that Winchester City Council retain two pinnacles from the inner columns on the 4th stage and a finial from each of the inner and outer pinnacles on the 3rd and 4th stages and these will be refixed in place where currently missing. The finials that have become detached retain relatively short rods that fixed them in place. The existing rods will be removed and new longer rods installed to provide a firm fixing. The condition survey has identified a number of loose finials and this is perhaps indicative that all are fixed with insufficiently long rods. We would therefore propose to carefully dismantle all finials to determine the length of the rods and to replace these with longer rods and refix them in place using resin.

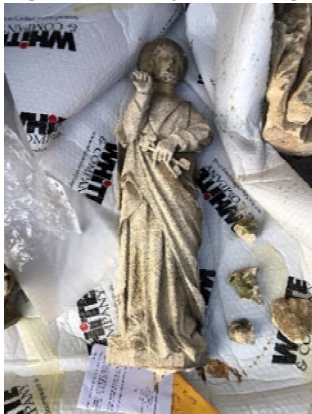
Fig 6 – Statue of St Bartholomew.

- 3.2. At mid height there are four statues, one on each face, of St John the Evangelist, William of Wykeham, Lawrence de Anne and Alfred the Great. It is understood that St John the Evangelist predates the Gilbert Scott restoration and that the remaining three were added by Gilbert Scott. Above these there are a further 8 smaller figures of the Blessed Virgin and Saints Bartholomew, John, Lawrence, Maurice, Peter, Swithun and Thomas. The figure of Saint Bartholomew on the east elevation is missing.

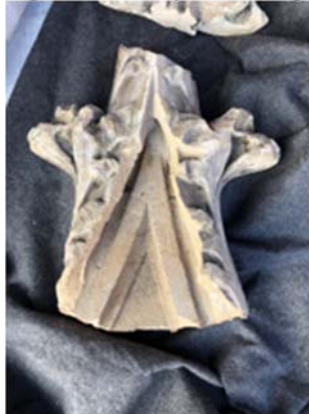
Fig 7 – lower part of gable arch finial.

- 2.5. The cross has suffered damage including the loss of pinnacles and the recent detachment and fall of one of the gable pinnacles above the arched opening on the first stage of the east elevation.

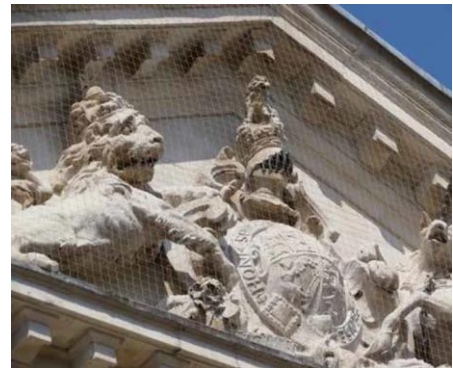
Fig 28 – netting on a historic building

- **Netting** – enclosing the monument with netting would prevent the pigeons from alighting on the structure and is considered to be the most effective method as it completely prevents access. Pigeon netting is extensively used for this reason and, in some situations, can be relatively discrete if consideration is given to the colour and location of the netting. Regularly spaced fixings are needed to keep the netting in tension which need careful consideration.

- 9.9. Netting needs to be fixed in a particular way. The netting needs to be kept taught for it to be effective and this is usually achieved by putting in place a tensioned stainless steel wire or rope to the perimeter of the area that the net is then tightly clipped to. The tensioned wire or rope is normally fixed in place with eye bolts fixed to the structure and must be placed so that there are no gaps the perimeter. This is clearly problematic for the monument because fixings in to the structure are undesirable and because the monument is highly intricate with few regular surfaces to seal the netting perimeter to which limits the areas that netting could be used. The drawing below (fig 35) shows where netting could be used if installed as flat panels to protect the stage 3 statues. Fixing points are shown with red crosses and are placed to align with joints in the masonry to limit damage. The netting is available in three colours: black, stone and translucent and stone would potentially be the least obtrusive (see fig 28 above)

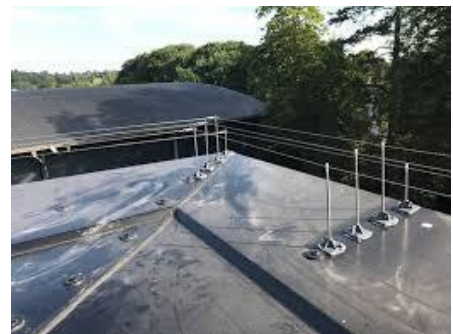
Fig 29 – bird wires with supporting posts.

The wires are supported on spring loaded posts and the posts usually need to be mechanically fixed in to the structure so that the wires are kept in tension. It is possible to glue the posts in place but this requires a smooth surface and are not as reliable as mechanical fixings.

Bird wires are most suitable for flat even surfaces where they can be easily installed with uninterrupted runs.

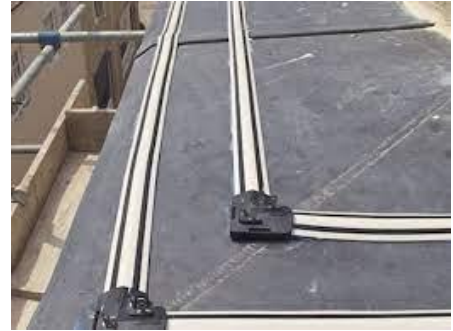
Fig 30 – bird shock tracks.

- **Shock track** – these are similar to bird wires but they will also give the birds a shock. These are very effective but they are complicated to install, requires maintenance and a permanent power supply to be taken across to the monument.

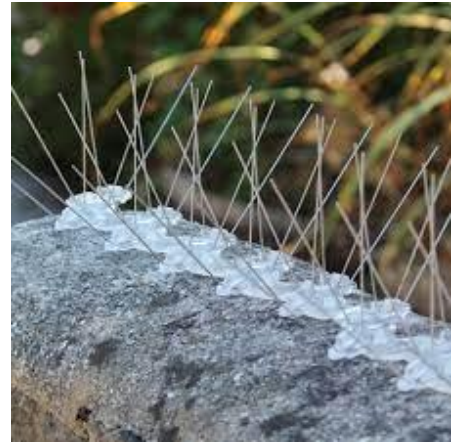
Fig 31 – spikes attached to the top of a wall.

- **Spikes** – upward facing spikes are inexpensive and considered one of the most effective ways of preventing birds from landing. However, their application could potentially detract from the appearance of the monument if visible. The spikes would need to be glued to the surface of the monument

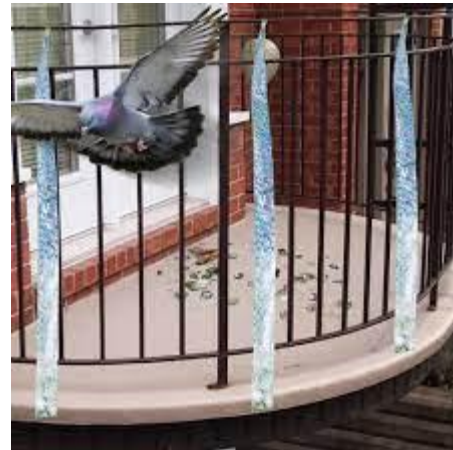
Fig 32 – reflective tapes.

- **Reflective surfaces** – reflective materials, such as CDs or tapes, reflect light which scares the pigeons. These work by being reflective shiny surfaces that are in constant movement that scare the pigeons.

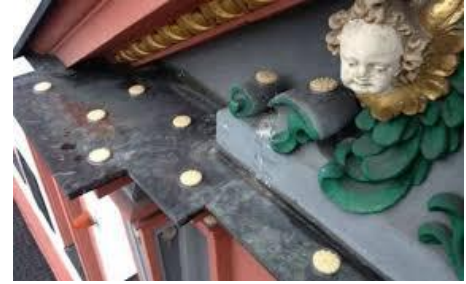
Fig 33 – Optical gel trays fixed on top of a cornice.

- **Optical gels** – optical gels work by triggering a sensory response in the pigeons by emitting UV light which appears as flames or smoke to approaching birds. The gels can also contain strong smelling odours (such as citronella, peppermint oil and beeswax which also repels the birds. The gel comes in plastic dishes and these need to be adhered to the surface of the monument either which would need to be carefully considered.

The gels have a fairly short usable life and need to be replaced after approximately 1 to 2 years.

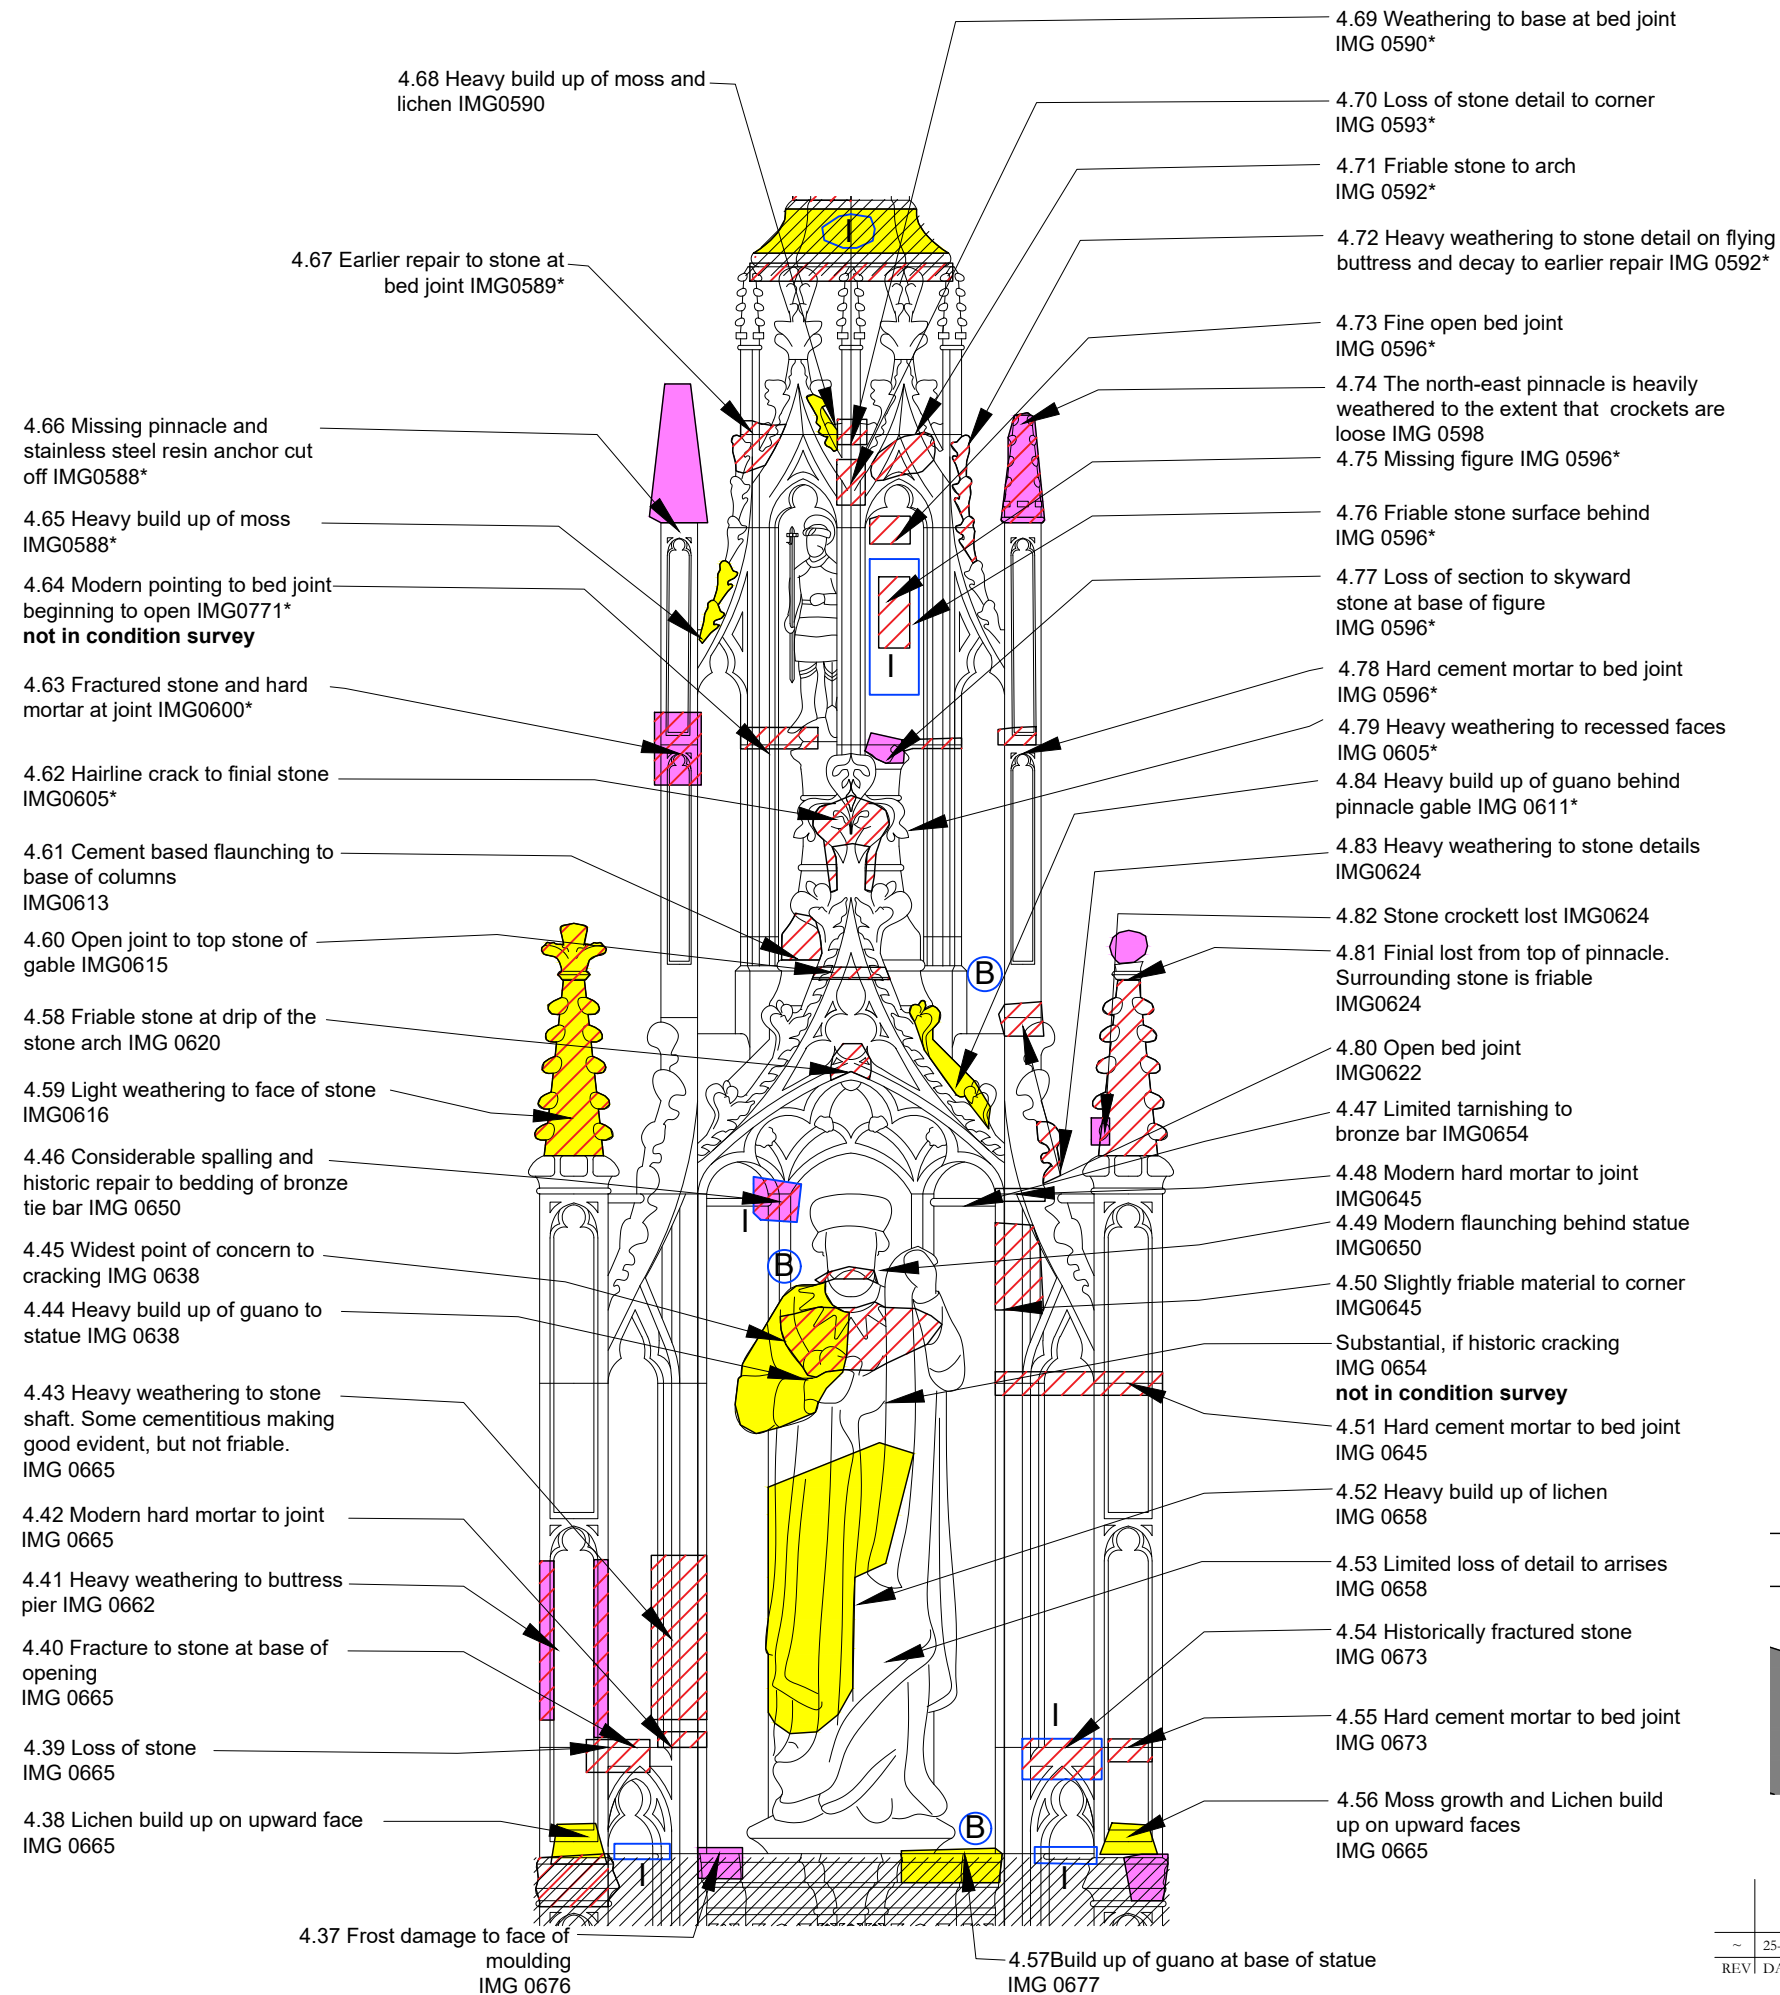
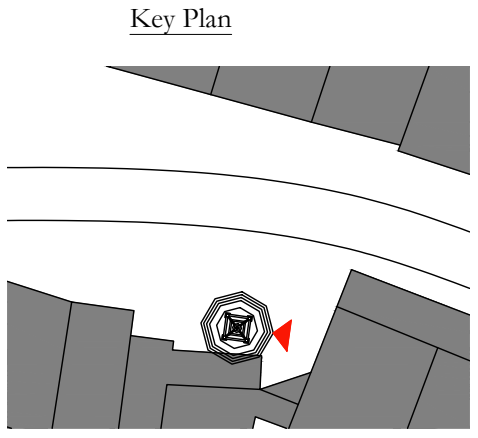
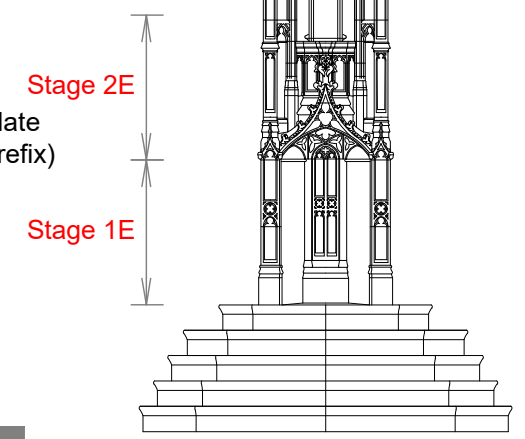
DRAWING TITLE
 Stage 1E and 2E
 Condition Survey Repairs

4.4 Modern mortar repair at base remain sound
 IMG 0710
