SPARSHOLT CONSERVATION AREA

CHARACTER APPRAISAL AND MANAGEMENT STRATEGY

ADOPTED MARCH 2008

Winchester
City Council

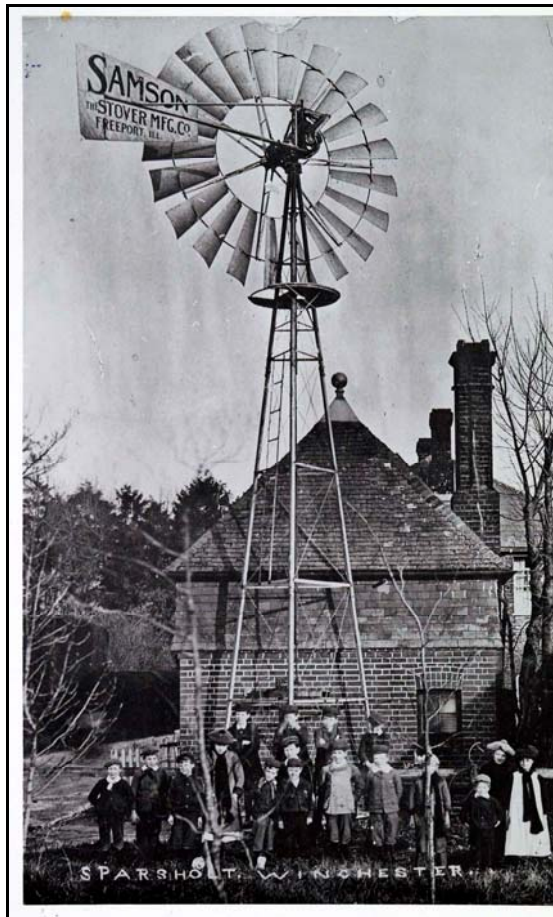
Photo 8: The Well House – Built 1897

4.1.12 During the 19th century a number of important buildings were added to the village which still only comprised the church and a surrounding scattering of cottages. In 1850 a village school was built for the parish off Woodman Lane, being paid for by Sir Frederick Harvey Bathurst. The original 'Parish House' was also built during this period in lower Woodland Lane to house vagrants or people passing through to their own village. In 1897 a new Well-house was built in front of the school to celebrate Queen Victoria's jubilee. Paid for by public subscription, a small windmill powered the extraction system, which until then had relied upon a bucket being drawn to the surface by two men on a treadmill.

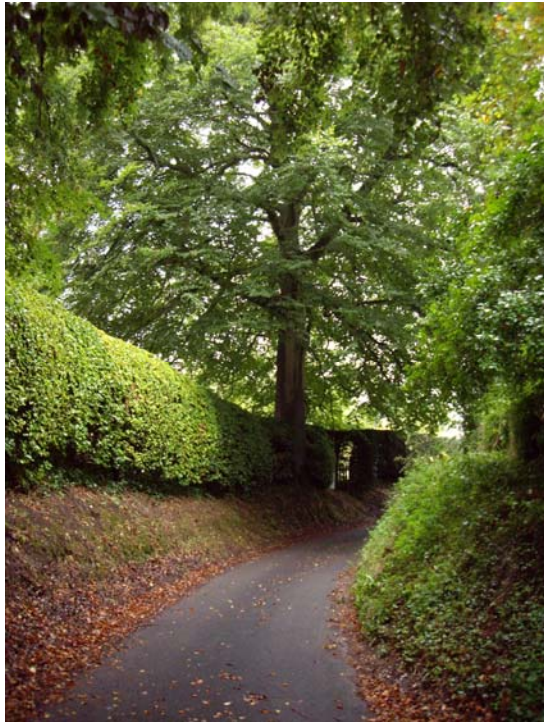
Photo 11: The narrow, sunken lanes (Home Lane)

5.3.2 The roads in the village are narrow lanes most often bordered by high banks and hedges and this is a key characteristic of the conservation area. This creates an enclosed feeling and restricts views within the village other than those of the church, which is notable in many views across rooftops and trees. In the more open areas of the village, especially at the outskirts, more views are possible over the surrounding farmland. The commanding views to the south and south west from Moor Court Lane allow the hilltop setting of the village to be fully appreciated. A few large open spaces, such as the fields between Home Lane and Lock's Lane, also relieve the sense of enclosure and allow additional views across the village. Important views are shown on the Townscape Appraisal Map.

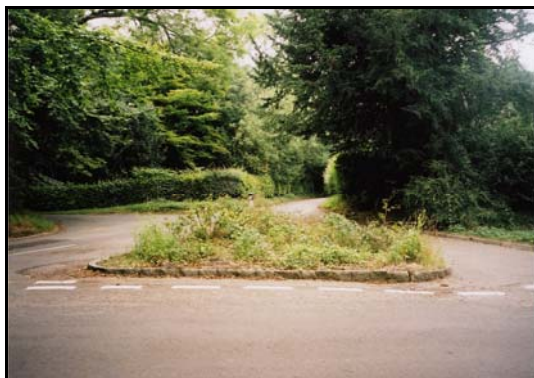
Photo 14: An untidy traffic island

- The triangle of land at the western end of Home Lane is currently in an untidy condition. A modest planting scheme similar to that on the traffic island to the east of Woodman Lane is recommended.
- The roadside boundary treatment to the Plough Inn could be improved by removing the suburban style fence and low concrete block wall and replacing with low traditional flint wall or a hedge such as hawthorn, beech, holly, blackthorn or other locally indigenous species.

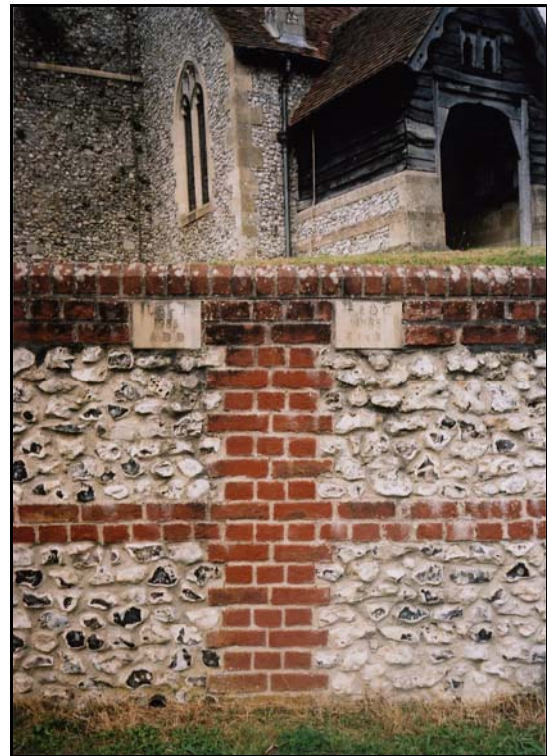
Photo 16: Brick and flint wall at St Stephen's Church

5.5.5 Most of the boundaries in the village are formed by hedges although there are a few instances of walling. In particular the brick and flint wall around St Stephen's Church makes an interesting visual impact. The wall is listed grade II although it has been recently rebuilt or substantially repaired with the plaques set into the wall bearing recent dates. Good examples of flint walling are also seen to the west and north of Pie's Cottage and the entrance to Sparsholt Lodge and opposite the Church has a low rubble stone wall.

with a 19th century wrought iron lamp overthrow between them. There are 5 stone tomb chests in the churchyard which are grade II listed and date from the 18th century.

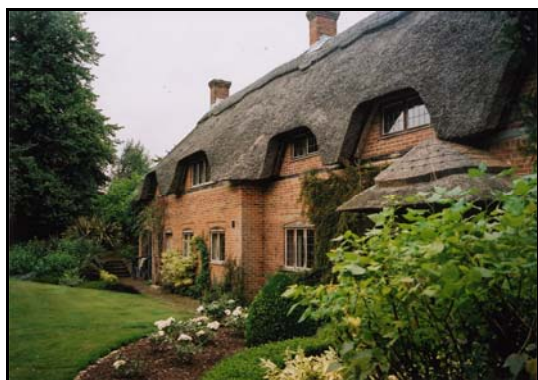
Photo 18: Pies Cottage, Home Lane

6.3.3 Whilst positive buildings are mostly examples of houses built from the 18th to 19th centuries, of special note is Pie's Cottage, Home Lane. Pie's is one of the oldest houses in the village and legend has it that the cottage stands on Saxon foundations. The building retains some 15th century brick and timber framed construction and has a thatched roof. Originally two small cottages, it is not listed because at some stage it was

rebuilt and extended, as can be seen by the changes in brickwork where the walls can be seen to have been heightened. Its large garden is enclosed to the west and north by a traditional flint wall.

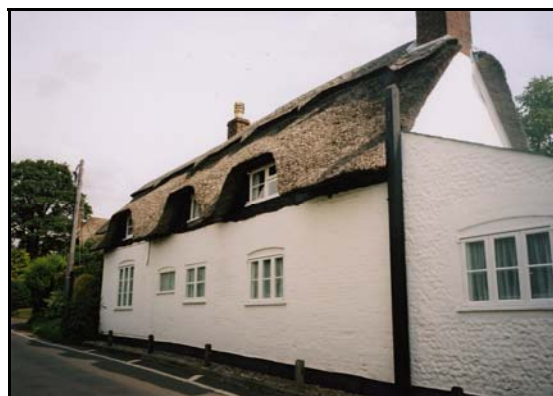
Photo 22: uPVC windows on The Woodman, Woodman Lane

character of the residential properties, particularly where they have been identified as making a *positive* contribution.
