REGULATORY REFORM (FIRE SAFETY) ORDER 2005 HOUSING FIRE RISK ASSESSMENT

Address: Matilda Place Scheme, Gordon Road, Winchester, SO23 7TD.

Assessment date: 22nd October 2020.

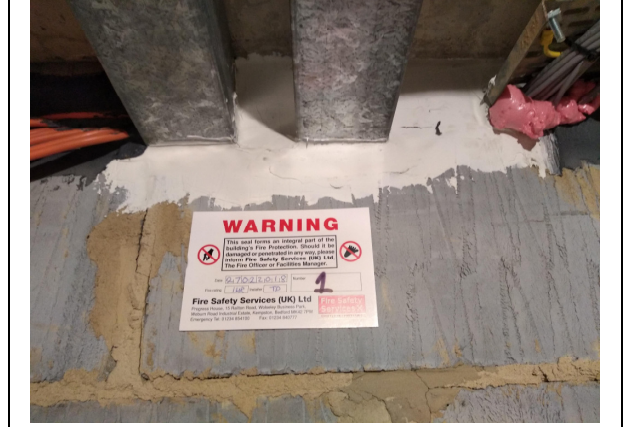
2. Fire stopping in ceiling void.

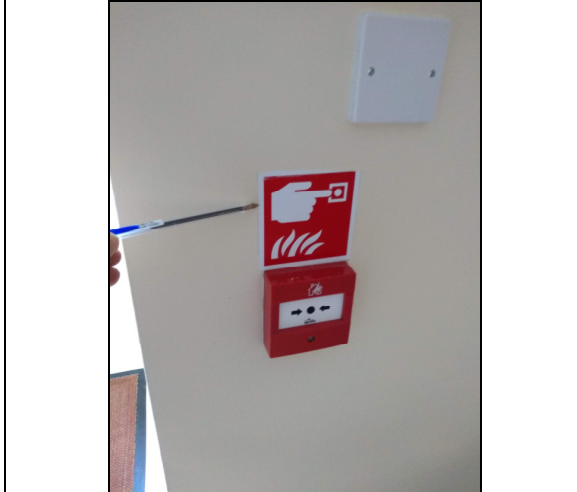
3. Call point sign no photoluminescent.

E16	Is the use of non specific door opening devices managed appropriately? i.e. doors wedges open .	Yes.		L	
E17	Is there a reasonable standard of fire safety signs and notices?	Yes.	However, some of the call point signs are not photoluminescent – Compliance Officer to replace with new signage.	L	N.B. Action planned.

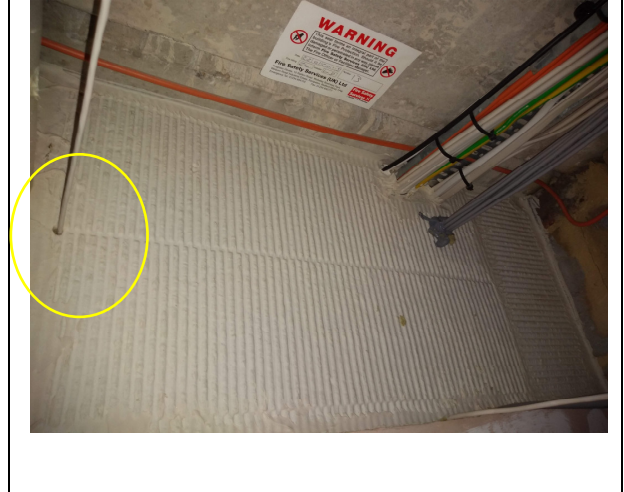
4. New cable in ceiling void.

E: Means of Escape:					
Ref No	Compliance Question	Yes, No or NA	Remedial Action Plan (RAP) and Comments	Risk Rating	RAP Completed
E1	Are there sufficient exits for the number of people present that lead to a place of ultimate safety?	Yes.		L	
E2	Are all gangways and escape routes free from obstruction and free from combustibles? <i>Note: Escape routes should be free from obstructions such as portable heaters of any type, cooking appliances, upholstered furniture, coat racks, temporarily stored items, waste bins, electrical equipment (other than security and emergency systems) etc.</i>	Yes.	Some of the residents will have reduced mobility, corridor width considered suitable for walkers & wheelchairs.	L	
E3	Are floor surfaces in escape routes free from tripping, slipping and fire hazards?	Yes.		L	
E4	Is compartmentation of a reasonable standard?	Yes.	One area above false ceiling which indicates a cable (telecoms) has been put through the fire-stopping – Tbc.	L

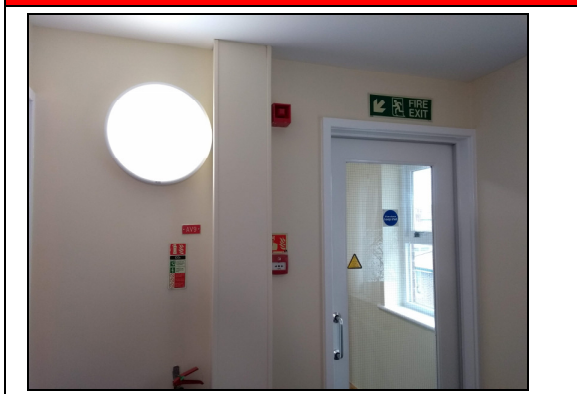
5. Signage to end of corridor.

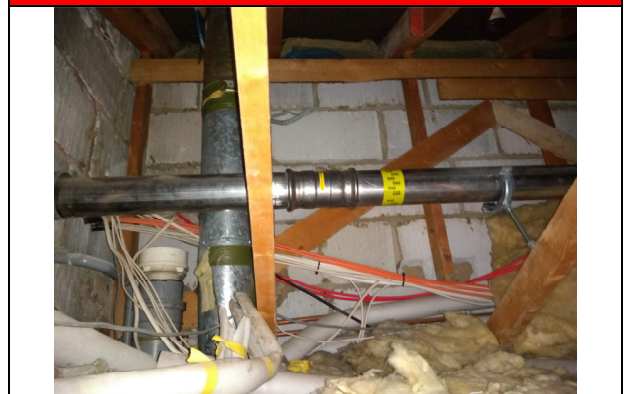
6. Gas pipe in ceiling void.

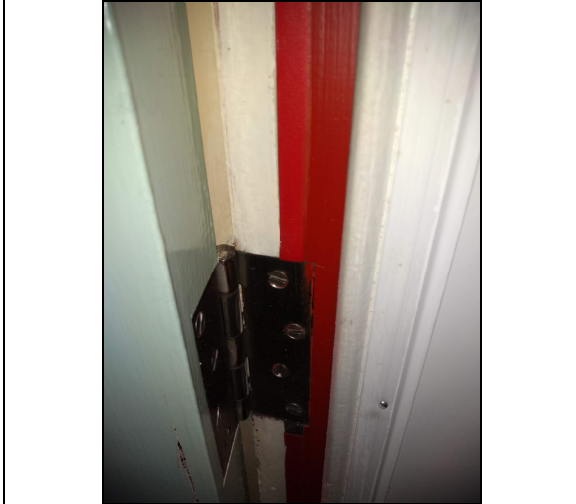
9. Flat door hinge & intumescent seal.

Ref No	Compliance Question	Yes, No or NA	Remedial Action Plan (RAP) and Comments	Risk Rating	RAP Completed
E15	<p>Are all internal fire doors in good condition, fitted with appropriate devices and in working order? In accordance with BS8214: 2008. Fire Doors on escape routes should be fitted with self-closing devices and labelled 'Fire Door - Keep Shut' (blue 'mandatory' safety sign).</p> <p><i>Note: The fire resistance of a door assembly is determined by subjecting a full-size construction to test in accordance with the procedures laid down in the appropriate fire resistance testing standard, i.e. BS 476-22 or BS EN 1634-1. The test standard requires the tested construction to be fully representative of the assembly to be used in practice in terms of materials and methods of construction, size, number of leaves and mode of operation including all glazed openings. Automatic fire doors must be labelled 'Automatic Fire Door - Keep Clear' (blue 'mandatory' safety sign)</i></p>	No.	<p>The are two fire-doors on the 1st & 2nd floor corridors (adjacent flats 14 & 23) which are not fully closing against 100% of the perimeter seals of the frame, which means smoke could break through from one compartment to another.</p> <p>Recommendation: The two doors (or cold smoke seals) are repaired or replaced so that there is a tight seal of door to the smoke seals.</p> <p>Also, the kitchen off the activity room does not have a fire-door fitted. Although this room is within a fire compartment it is recommended that a FD30 with top glazing is fitted.</p>	Medium.

No.	Issue which requires actioning	Timescale suggested	Responsible Officer	Actions taken & date completed.
1	Two fire-doors on corridors are not are not fully closing against the perimeter seals of the frame, adjacent flats 14 & 23, which means smoke could break through from one compartment to another. Recommendation: The two doors (or cold smoke seals) are repaired or replaced so that there is a tight seal of door to the frame.	3 months.	Property Services: Planned Team/ Compliance Officer.	Broadchalk Door Services has inspected the doors for repair.
2	Flat door letter plates: The letter plates do not have an intumescent seal which creates a weakness in the door if there was a fire. Recommendation: the flat doors are replaced with FD30s with intumescent material integrated into the letter plate.	12 months.	Property Services: Planned Team	<i>Doors have already been surveyed as part of 4 year fire-door replacement programme.</i>

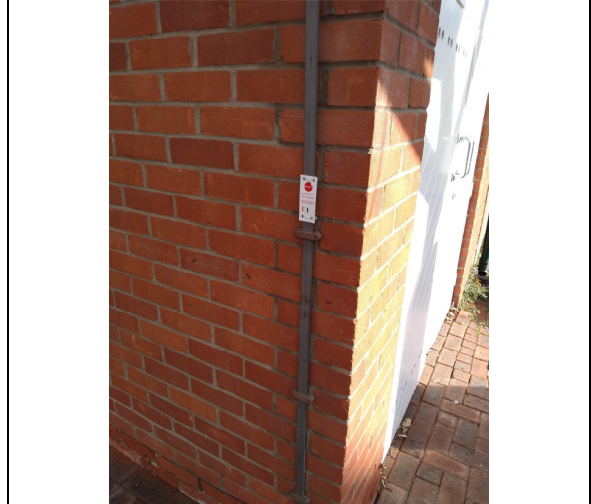
10. Lightning protection strap.

B4	Is lighting / heat producing equipment stored or located away from combustibles?	Yes.		L	
B5	If fitted are lightning conductors periodically tested?	Yes.	Supporting documents not seen.	L
